BROMBOROUGH VILLAGE CONSERVATION AREA APPRAISAL AND MANAGEMENT PLAN

APPENDICES

Prepared for Wirral Council by Donald Insall Associates Ltd, 2007 – Wirral Council 2009

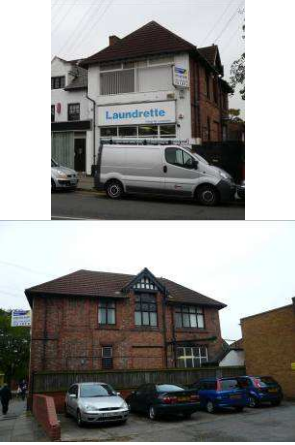
52 (Laundrette)

Late C19th. Former substantial two-storey house, now Village Road Laundrette, of common brick with pressed red brick to reveals. East elevation: Former gable end fronting street, now much altered. Replacement roof of interlocking profiled tiles. Roof now hipped, with loss of projecting gables to east and west elevations. North elevation: Single projecting gable to east elevation, with 9 light window containing some original glass and infilled opening with sandstone lintel below. Chimney stack has tumbling-in brickwork, now capped at eaves level.	<ul style="list-style-type: none"> ▪ Fair condition ▪ Much altered from its original form ▪ Unsympathetic modern interlocking profiled tiles ▪ Unattractive 'shop' front to ground floor with unattractive windows to first floor ▪ Surface wiring, alarm housings and rainwater goods all detract from its appearance ▪ Replacement of roof and alterations to the street elevation have altered the architectural composition and it now sits awkwardly with its neighbours 	C

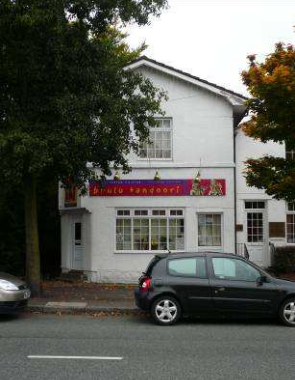
No/NAME	WIRRAL UPRN	PHOTO	DESCRIPTION	CONDITION/COMMENT	CONTRIBUTION
32-34 (Bhula Tandoori)

Late C19th. Two-storey, single bay with gable end fronting street. Entrance door set at an angle within SE corner. Secondary door to east elevation, possibly leading to separate accommodation above. White painted render beneath slate roof. White painted bargeboards to overhanging eaves.	<ul style="list-style-type: none"> ▪ Poor condition ▪ Elevation to street in fair condition, although signage less than sympathetic to building and bargeboards require repair and redecoration ▪ South elevation alongside pathway to church yard reveals building in poorly maintained condition with, for example, boarded up windows ▪ Replacement uPVC windows of modern design, not wholly sympathetic 	B
28 (Offices of Horner Downey & Co)

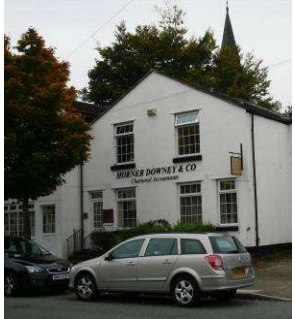
Late C19th. Possibly former agricultural building, now offices. Gable end fronting street, with two storeys of two bays. Entrance door to left hand bay, additional window to right hand bay forming a symmetrical composition. White painted render beneath slate roof.	<ul style="list-style-type: none"> ▪ Fair condition ▪ Replacement uPVC windows of modern design, not wholly sympathetic ▪ Render cracking and breaking away from walls in small areas - cause should be investigated and remedial action taken to prevent further deterioration ▪ Signage unobtrusive and sympathetic to building ▪ Forms part of a group with Nos 26 and 18 	B

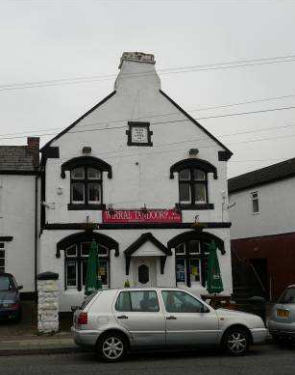
Built 1868. Former Mission Hall and Reading Room, now a restaurant. Two-storeys, two bays, with gable end fronting street. Windows have heavy, painted stone, chamfered mullions and transoms with a shallow arched head and carved finials to heavy hood moulds, set with wooden-framed lights. Unusual shaped chimney. High level plaque reads "To Him that Loved Us".	<ul style="list-style-type: none"> ▪ Good condition ▪ Replacement uPVC door of modern design, not wholly sympathetic ▪ Surface wiring and fixtures detract from the character of the building ▪ Forms part of a group with Nos 26 and 28 ▪ Signage less than sympathetic (cf Nos 26 and 28) ▪ 1868 above side door removed in 2004/5 	B

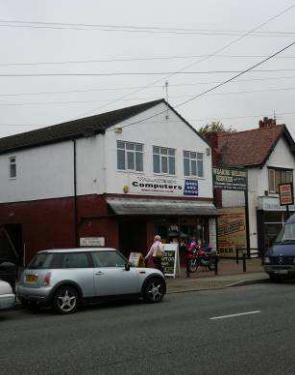
12-16 (Valatech Computers)

C20th. Two-storeys with gable end fronting street. Built of brick beneath a slate roof, the upper storey being rendered and painted white. Three windows to upper storey, shop front to ground floor.	<ul style="list-style-type: none"> ▪ Fair condition ▪ Appears to be a C20th building on the site of an earlier building ▪ Of a similar scale to neighbouring buildings to the north but more plainly detailed 	C
24			Not accessible at time of inspection
