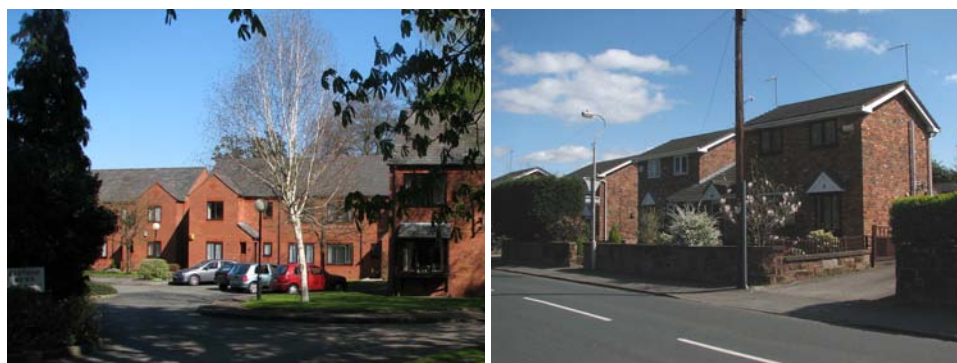
(left) Eastham Mews housing; (right) Vicarage Row

6.2.2 Both Eastham Mews and Vicarage Row developments are apparently based around standard modern housing layouts and very little concession has been made regarding their choice of materials or detailing. Eastham Mews housing has slate roofs, but Vicarage Row has basic concrete tiled roofs. The brick chosen in both developments is neither of a high quality nor matching in colour and texture to the historic buildings in the village. Details such as fenestration and eaves treatment are also standard and not related to their locality. Whilst the materials and detailing detracts from the quality of the conservation area, the effect of this is mitigated by the small size of the developments, their visual detachment from most historic buildings and for the retention of older features such as stone front boundary walls. However, whereas Eastham Mews has pleasant grounds and the modern buildings nestle behind its boundary wall, visually separated from the village, Vicarage Row is at the prominent corner of Ferry Road and Eastham Village Road and has very few redeeming features

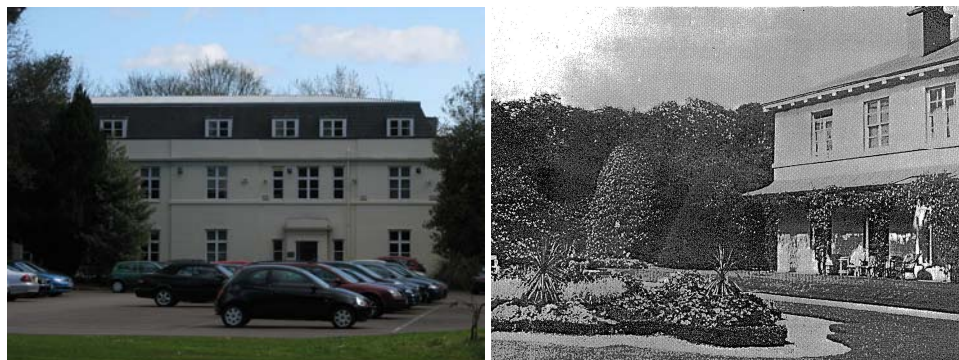
6.3.1 The terraced housing positioned directly onto the road allows little scope for extensions that make a significant impact on the character of the conservation area, although rear extensions can be still be unattractive when visible across open fields behind the houses. A greater threat to the area is the effect of extensions to the larger, unlisted buildings. Eastham Hall (formerly Hooton Mount) is sadly virtually unrecognisable from the building that was built in the middle of the 19th century. The symmetry of the main

south-west facing façade has been lost as a result of the significant extension to the north. Similarly the addition of a third floor within a modern mansarded roof has adversely affected the proportions of the façade. The quality of the modern materials used is not sympathetic with the original character of the building or that of the village as a whole.

Eastham Hall (Hooton Mount) today compared with a photograph taken in around 1920

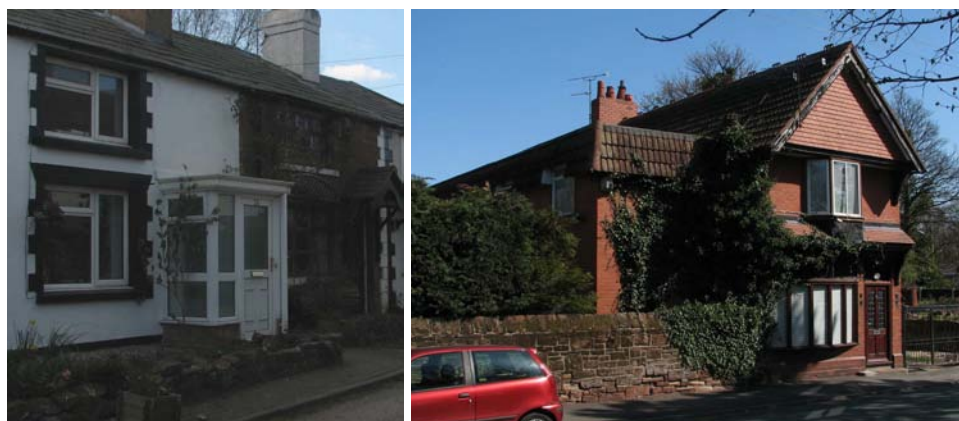
(left) the additional of a porch onto the front of a terrace can be damaging to the visual rhythm in the group; (right) a larger extension which changes the character of a building.

- 6.3.7 A few unsympathetically constructed porches exist within the village. Where a porch or large side extension is added onto a building, unless carefully designed, it can change the character of a building and therefore potentially reduce its positive contribution to the conservation area. Some additions can completely overwhelm the original character and form of the building leaving the building to appear (at least at first glance) to be modern.

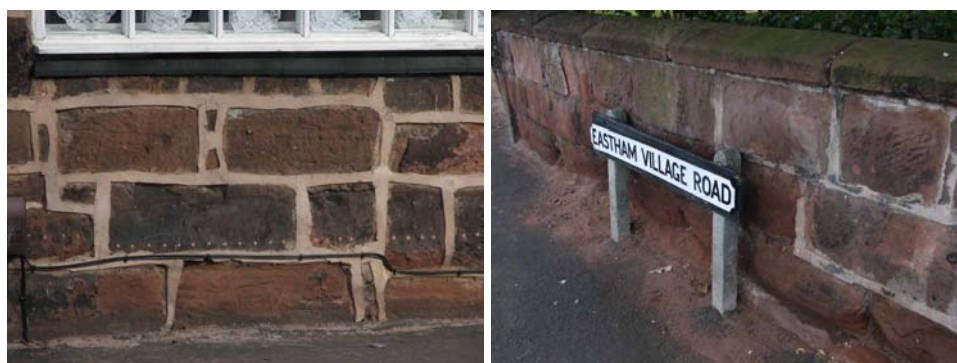
- Changes to chimneys, most notably reduction in their height and loss of pots.
- Rendering of brick and stonework.
- Damage to historic building fabric as a result of changes to the traditional building materials. The use of hard pointing and impermeable coatings generally accelerate the rate of decay of the softer historic materials, most notably sandstone. In certain instances the effect of this phenomenon threatens not only the physical fabric but also the appearance of that part of the conservation area.

- The insertion of injected damp proof courses into stonework. This practice is generally ineffective and damaging to the appearance of the building.
- Painting of Victorian brickwork. This detrimentally changes the character of the building. Lime washing (or painting with a modern breathable alternative) of stone / older more friable brickwork is likely to be a traditional way of preserving the building's fabric and therefore may be appropriate in some instances.

(left) the visually detrimental effect of the insertion of an injected damp proof course and poor quality pointing; (right)
