BROMBOROUGH VILLAGE CONSERVATION AREA APPRAISAL AND MANAGEMENT PLAN

PART 1 – CONSERVATION AREA APPRAISAL

Prepared for Wirral Council by Donald Insall Associates Ltd, 2007 – Wirral Council 2009

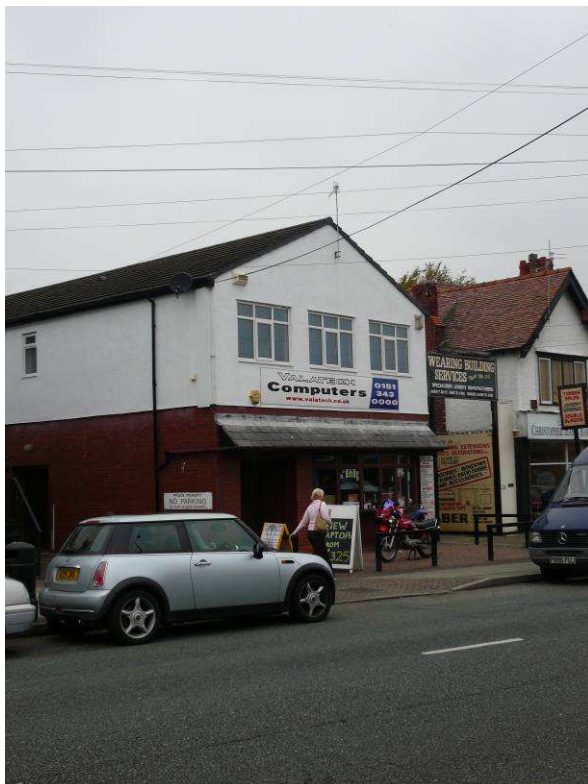
The building housing Valatech Computers (Nos 12-16 Bromborough Village Road) marks the north-eastern corner of the conservation area, the boundary running immediately to the left of the Wearing Builders Services sign

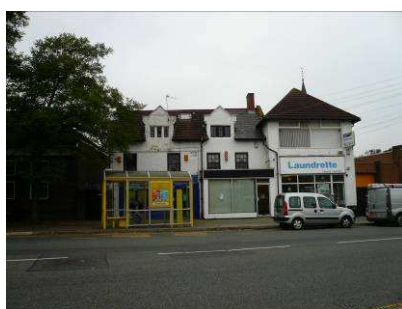
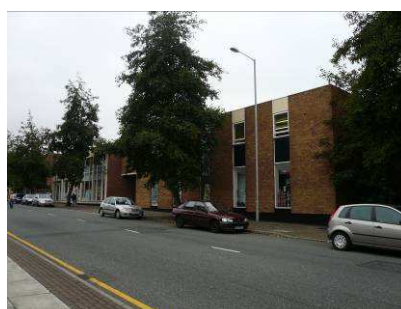
The boundary runs along the edge of the car park adjacent to No 52 Bromborough Village Road (Village Road Laundrette, left), behind Nos 36-46 (centre, excluded from the conservation area) and re-emerges along the pathway adjacent to Nos 32-34 (Bhulu Tandoori, right)

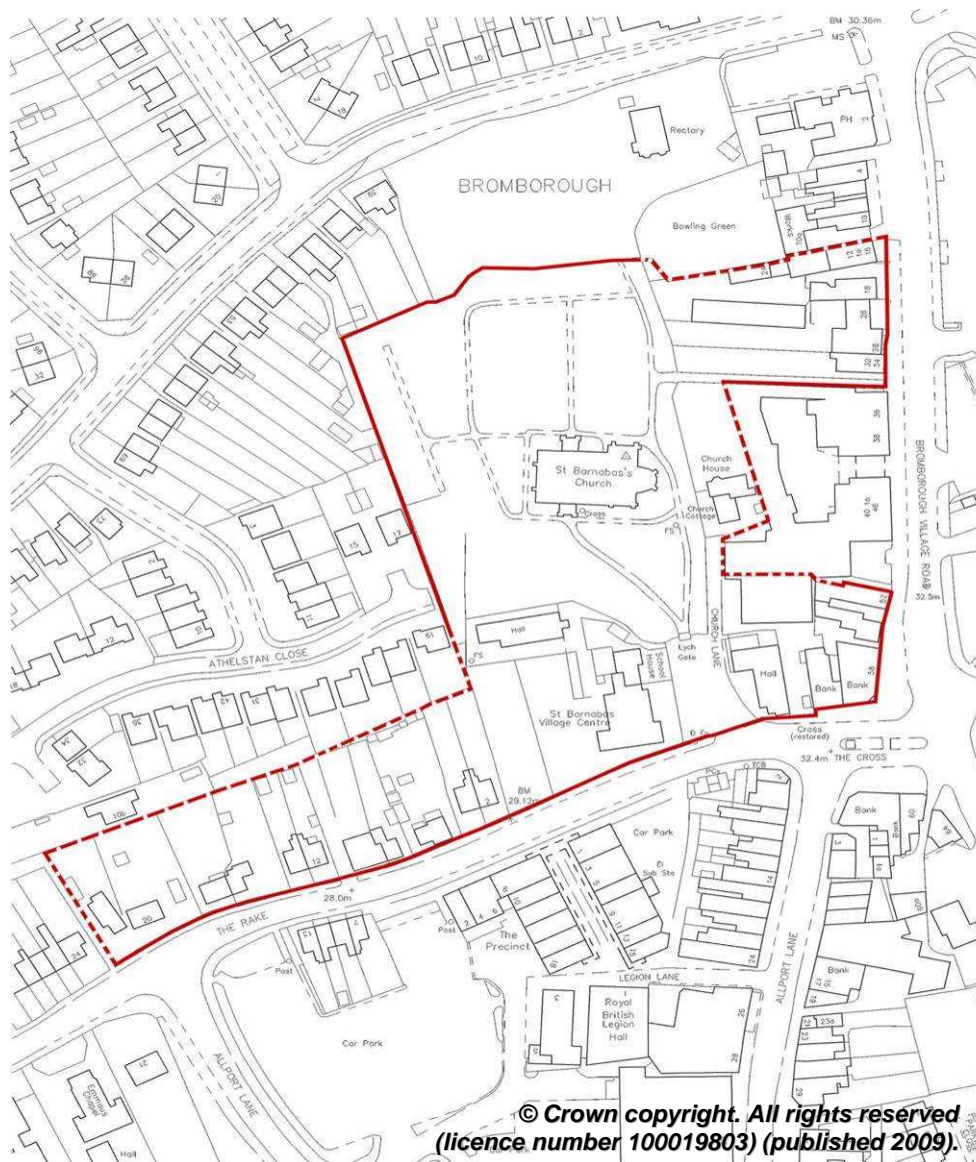
Map showing parts of conservation area where public access is restricted, denoted by a dashed red line

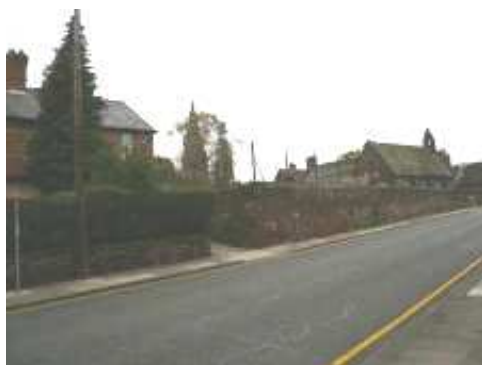
Eastern end of The Rake, viewed from the south-west, showing the change from residential use to community use, denoted by the long sandstone wall enclosing the village centre and car park

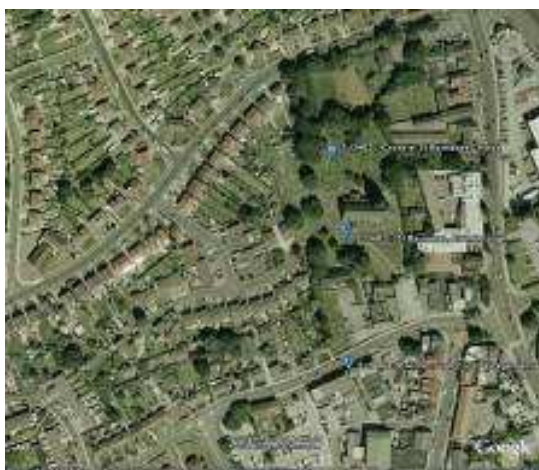
Google Earth image showing the green areas around the church

- 3.4.2 The extent and impact of the greenery around the church is particularly well illustrated by the aerial photograph below and shows that the church and its grounds occupy around half of the entire conservation area.

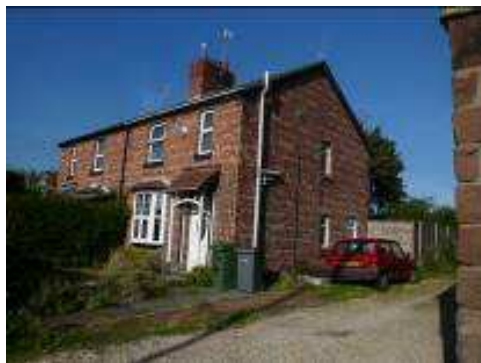
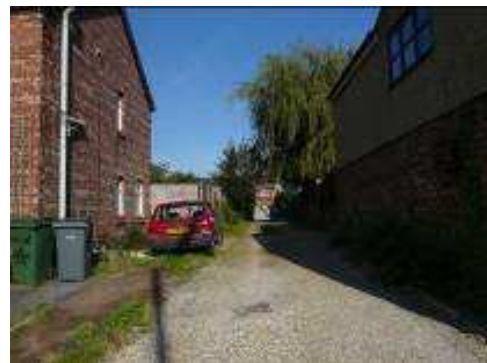
The C20th insertion of an access lane between No 10 and No 12 The Rake has created an unsightly gap in the streetscape and an interruption to the planted up gardens

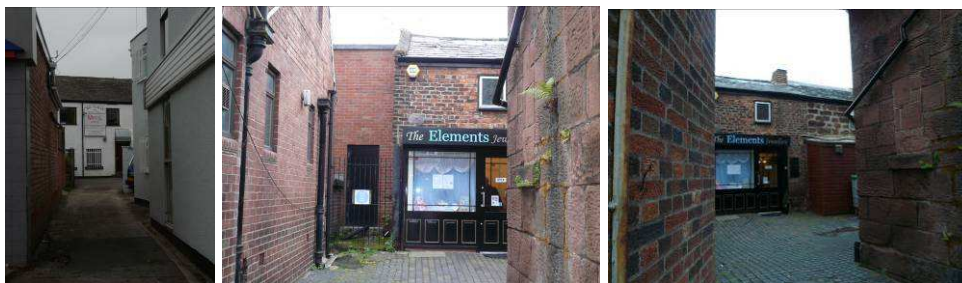
These buildings behind the NatWest bank and former Royal Oak public house may be remnants of the agricultural properties that stood on this site

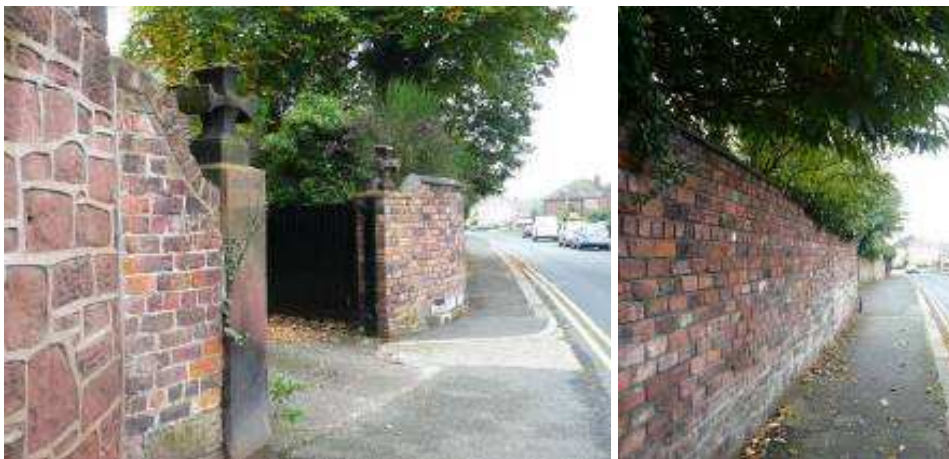
Entrance to the Rectory (left) and the long boundary wall beyond running westwards (right)

housing developments. The Rectory grounds are enclosed by a long brick and sandstone wall together with mature trees running along the south side of Mark Rake, complemented by the grade II listed Stanhope House at its eastern end.

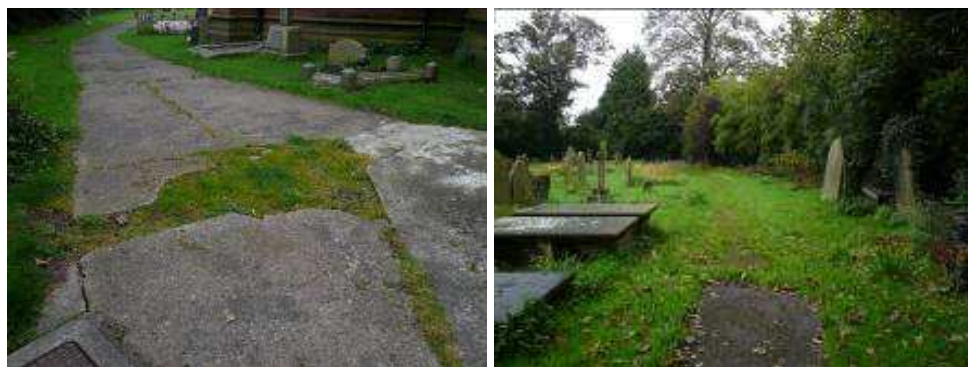
(left) The concrete pathways within the churchyard are in need of repair or replacement and do not enhance the setting of the church. The pathways turn to grass towards the northern end of the churchyard, making them uninviting and potentially dangerous in wet weather (right).

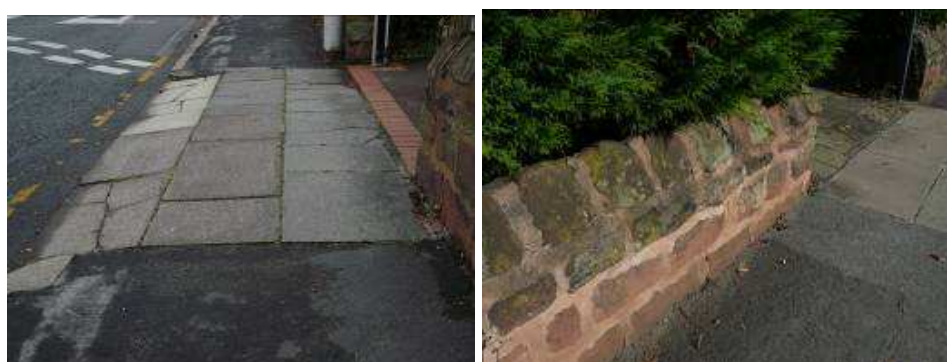
Poor quality surface treatments do little to enhance the setting of the conservation area

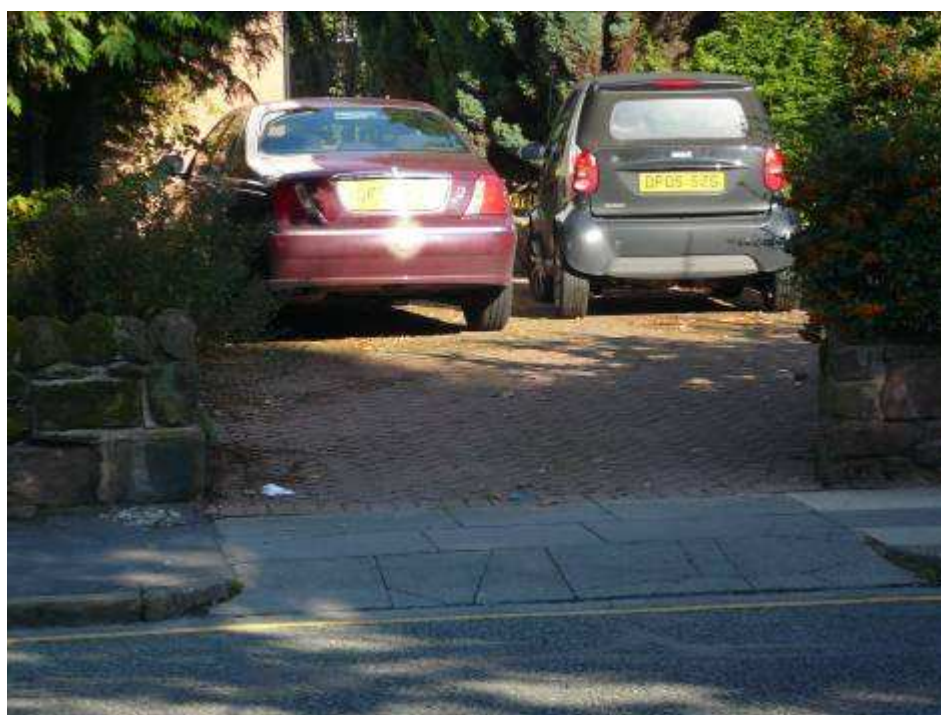
The block paved drive within the conservation area boundary contrasts with the broken flags at its entrance; to the left the pavement is surfaced with tarmacadam, to the right there are mixed paving slabs.

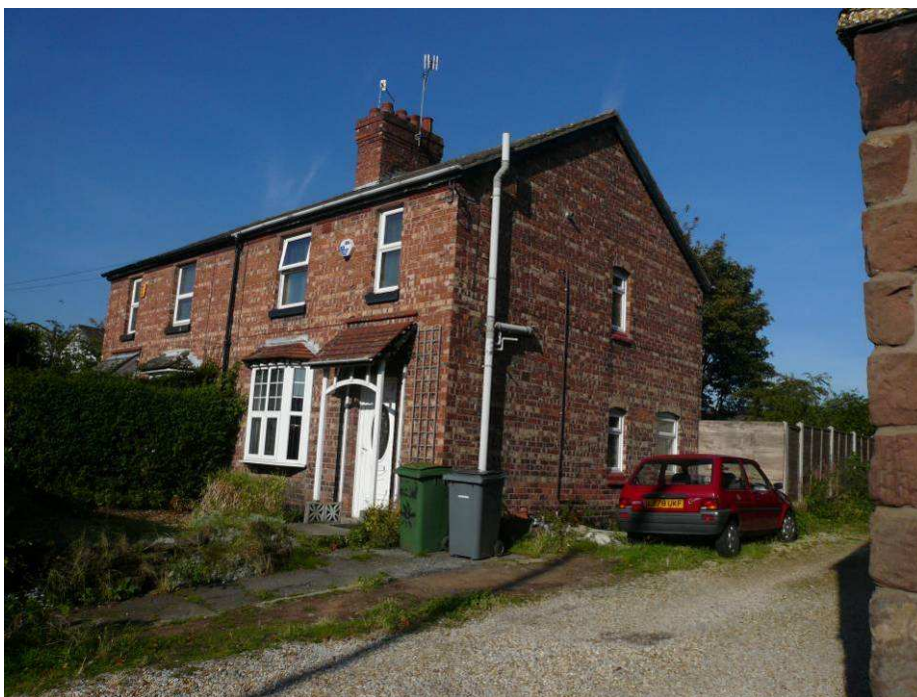
An early C20th inserted access lane between Nos 10 and 12 is surfaced with loose gravel but the border treatment does not enhance the setting of the adjacent dwellings

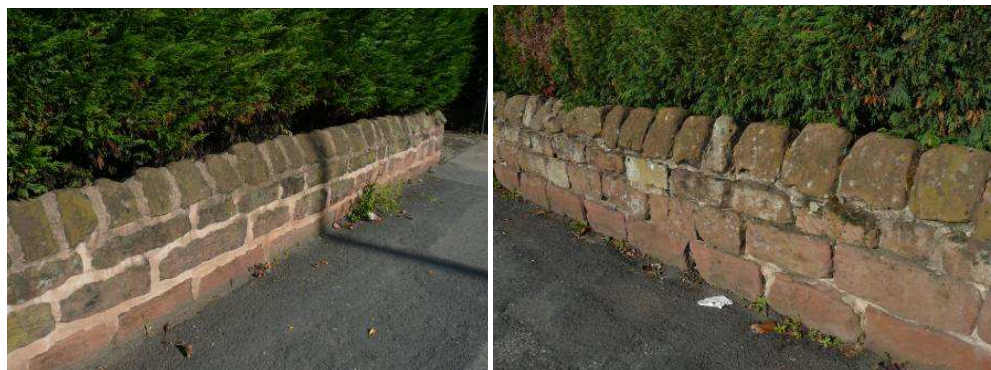
- 4.3.4 Private driveways within the conservation area are surfaced with a variety of materials including paviers, gravel, stone and tarmacadam. Whilst this adds variety to the area, the treatment of the pavements abutting them detracts from their appearance.
- 4.3.5 Most boundary walls are of the local red sandstone with triangular copings and are a defining feature of the conservation area. Boundary walls to the dwellings along The Rake are generally sandstone and some have a hedge planted immediately behind.
- 4.3.6 However, there are noticeable differences between properties in the quality of construction of boundary walls and particularly in their pointing.

Different treatments of sandstone walls to neighbouring properties

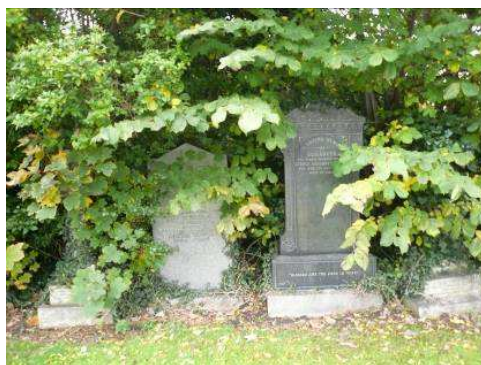
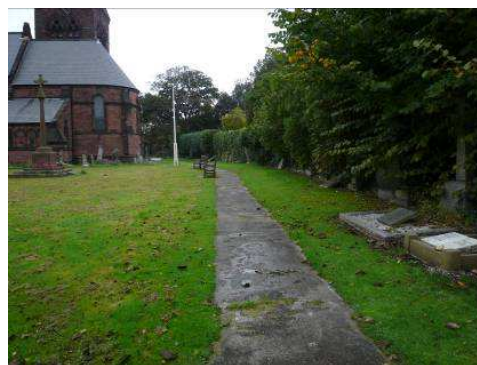
- 4.3.7 Around the church, there is a mix of boundary treatments. To the north, east and south the boundary walls are of sandstone although the walls are obscured in places by vegetation, mature trees and gravestones.

The eastern boundary of the churchyard is a mix of mature trees, overgrown vegetation and clipped hedges which mask a sandstone wall

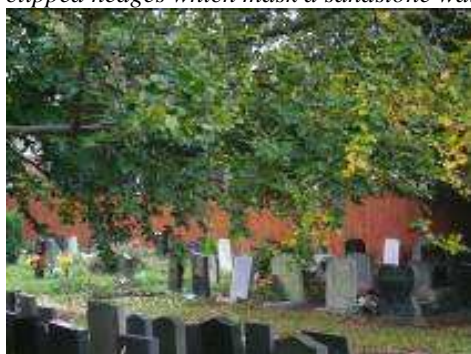
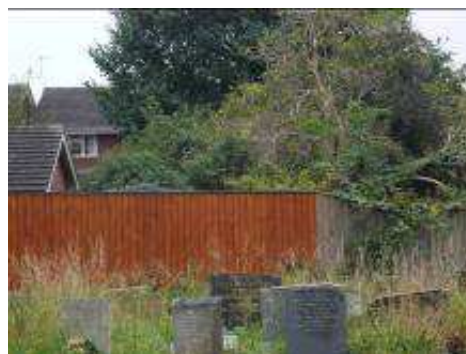
The panel fence that runs along the western side of the churchyard marking the conservation area boundary

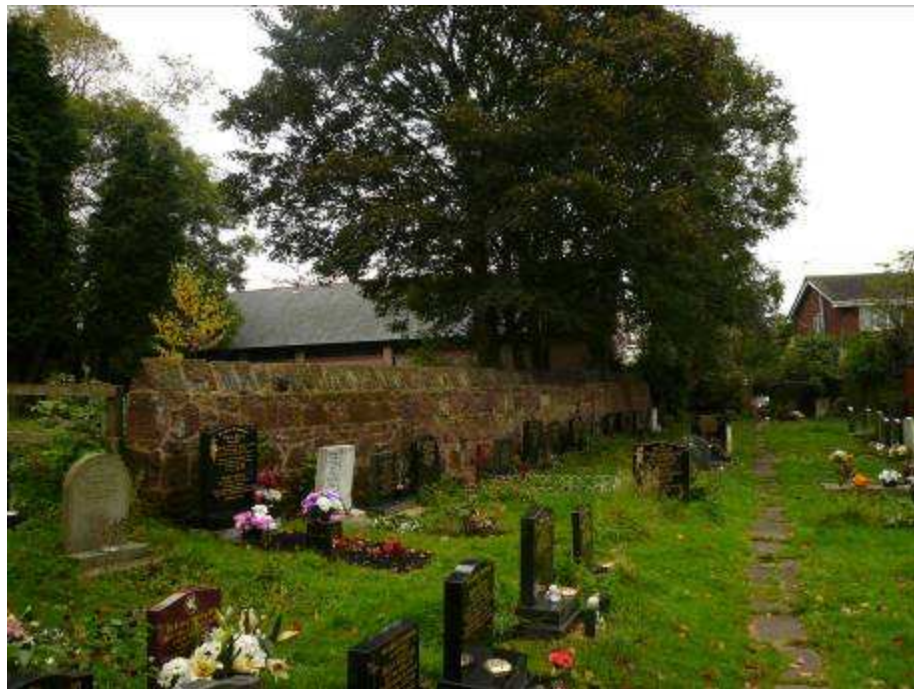
A mix of panel fencing, sandstone wall and post-and-rail fencing marks the southern boundary of the churchyard

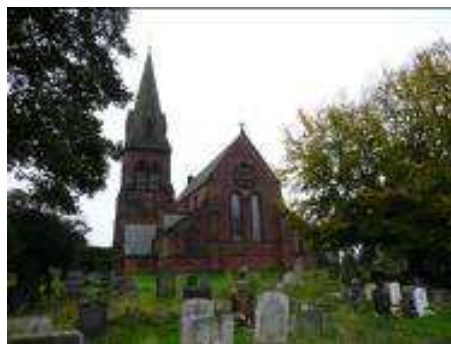
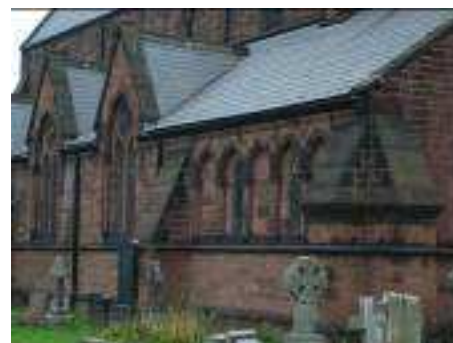
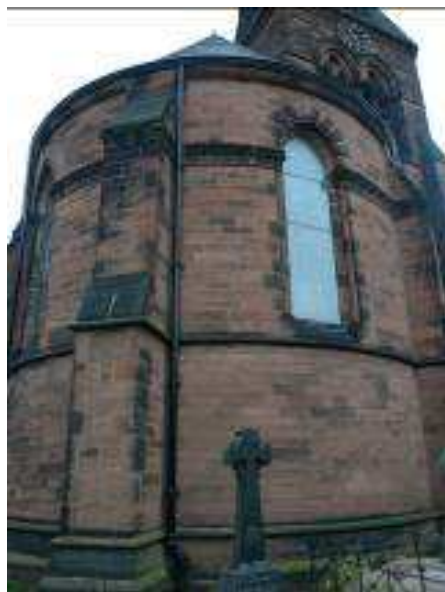
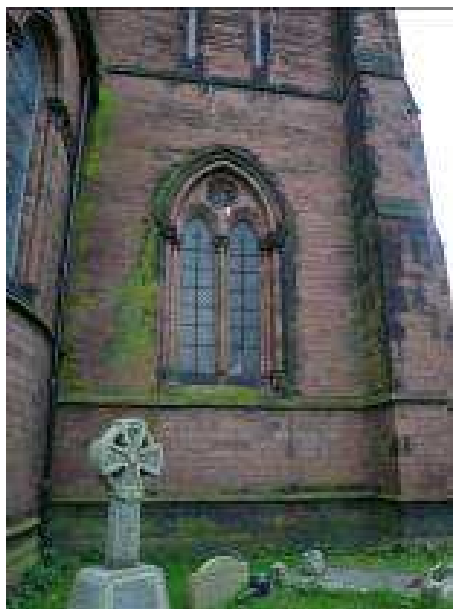
- 5.1.1 The houses within Bromborough Village Conservation Area are generally simply designed and detailed vernacular buildings with later alterations.
- 5.1.2 The public buildings are identifiable as late 19th-century Gothic and Tudor revival.
- 5.1.3 The church is in the 'Early English Style' which was much revived in the 19th century and is typified by the use of lancets (narrow pointed arches, often grouped in twos and threes), vaulted stone roofs, buttresses with plain, steeply pitched gablets, cusped arches to decorative arcades, circles enclosing trefoils/quatrefoils in the tracery, large rose windows, and decorative foliage. Many of these features were incorporated into the Church of St Barnabas.

Typical 'Early English' details: paired lancets beneath a large rose window (top left); blind arcading (top right); a buttress to the apsidal east end (bottom left); and a typical window with paired lancets, cusped plate tracery and clustered shafts (bottom right)

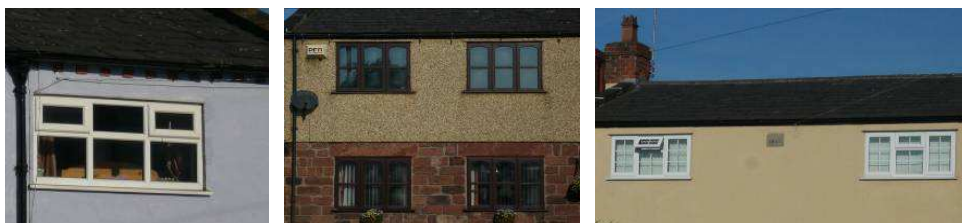
Small rectangular openings at Nos 8, 10 and 20 The Rake (unfortunately fitted with replacement windows)

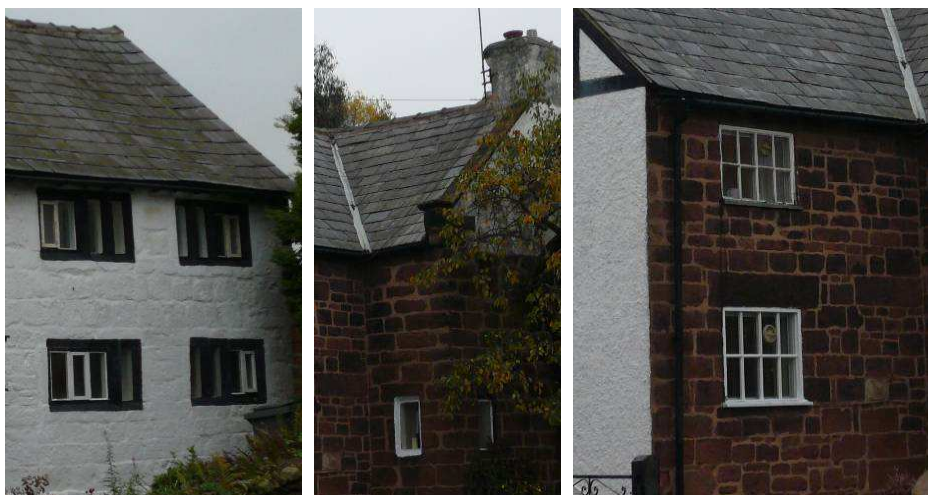
No 6 The Rake (listed grade II):- (left) to the east elevation of the original cottage are 4-light single chamfered mullioned windows (extended at some point), those to the west are single-lights (centre). The windows to the extension are later, being 8-light fixed windows (right). The upper window is probably contemporary with the extension but the lower window is a later replacement.

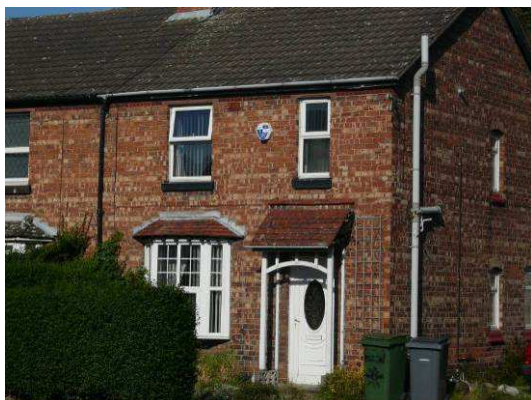
Larger, vertical openings at Nos 2, 4, 12 and 14 The Rake with canted bay windows on corbels to the ground floor, typical of the late C19th/early C20th. The original windows would have been two pane double-hung sashes with horns, though regrettably none remain.

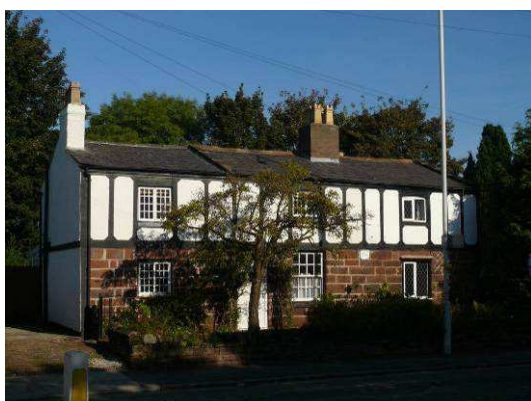
Nos 16 and 18 have been much altered and extended over their lifetimes, illustrated by the unusual variety of window types and openings (see examples below). Although each window is different, they are of an historic form and enhance the character of the cottage.

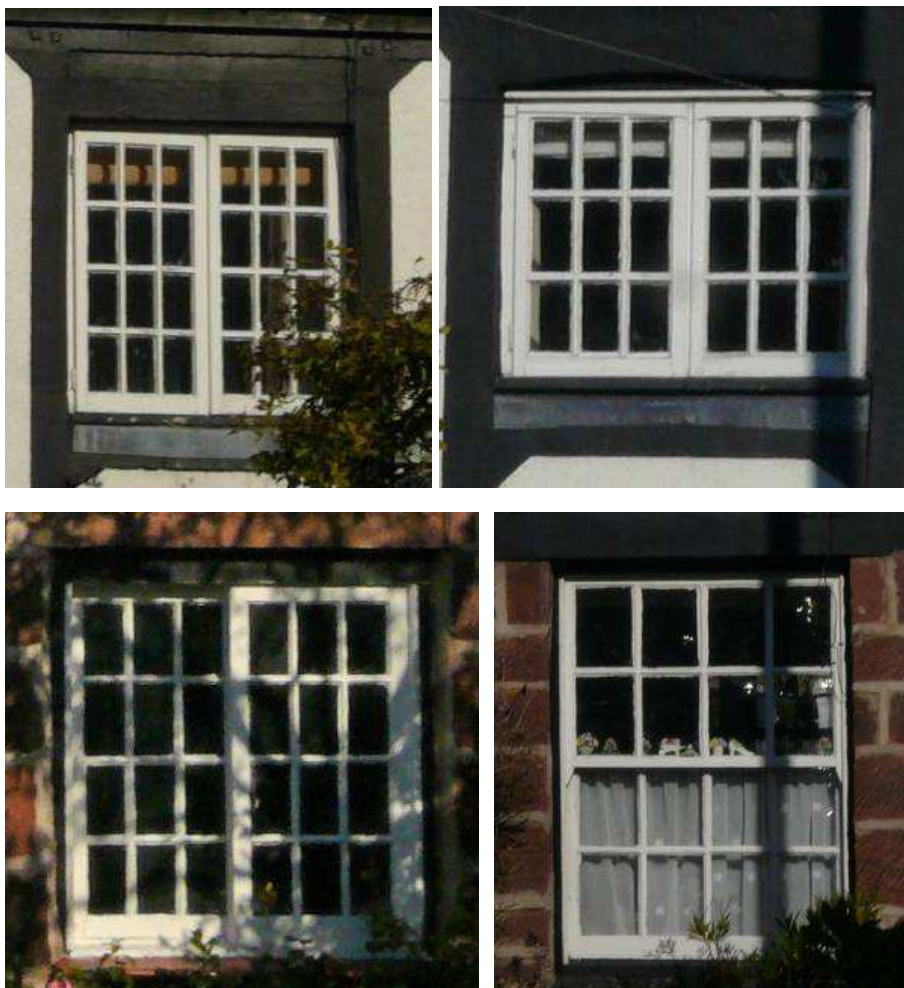
(top left) modern wooden-framed 12-pane casements in square opening; (top right) modern wooden-framed 9-pane casements; (bottom left) a Yorkshire (horizontal sliding) sash in a square opening; (bottom right) 16-pane double hung sash with horns, in an altered opening (possibly the original doorway and contemporary with the later C19th extension to the left)

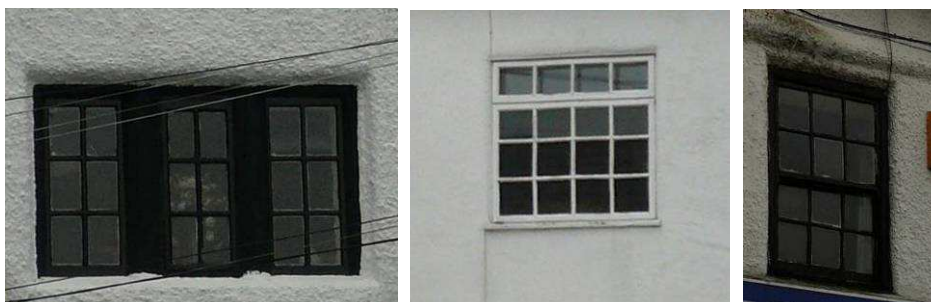
(left) Nos 54-56 Bromborough Village Road, C17th window to dormer; (centre) No 26, square mid-C18th window opening with modern toplight; (right) Nos 54-56, C19th 12-pane double hung sash

5.3.5 Along Bromborough Village Road, a great variety of window types can be seen. Although replacement uPVC windows are prevalent, a number of them are fitted to the original window openings which show the development from the small, horizontal windows of the 17th century and early 18th century to the larger, vertical windows of the later 18th century and 19th century (eg at Nos 54-56 and at Nos 26-28).

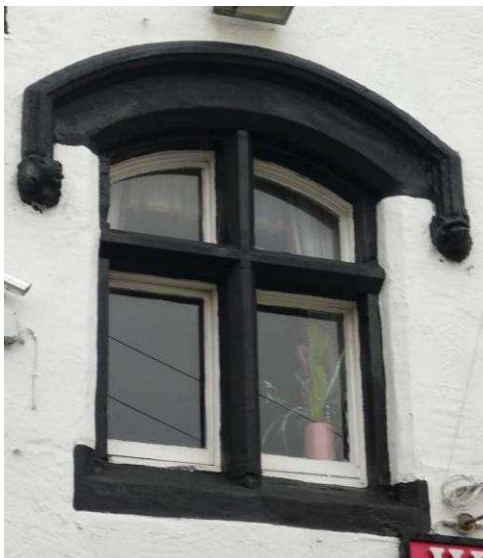
The distinctive 19th-century Gothic revival windows at 18 Bromborough Village Road have heavy, painted stone, chamfered mullions and transoms with a shallow arched head and carved finials to heavy hood moulds, set with wooden-framed lights.

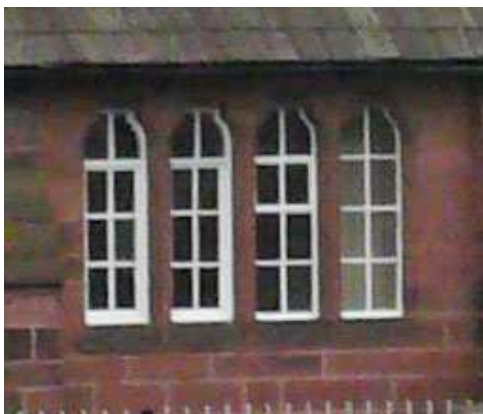
Village Centre windows have lancet openings with shouldered lintels, chamfered sandstone mullions with 8-light windows, and are arranged in groups of two, three or four.

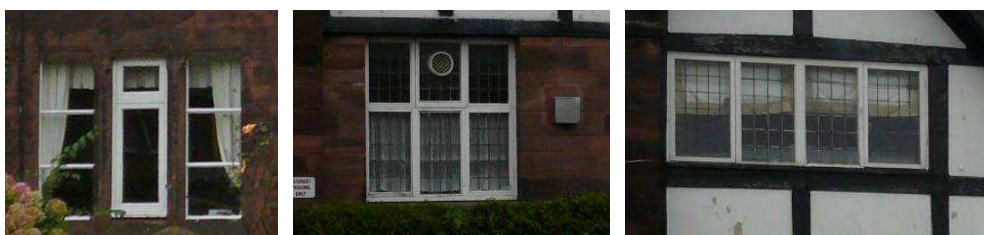
- 5.3.7 The windows to the Church Institute and Master’s House are typical later C19th Tudor revival windows designed to mimic the mullions and transoms of C16th windows.

(left) The Master’s House (centre, right) the Church Institute

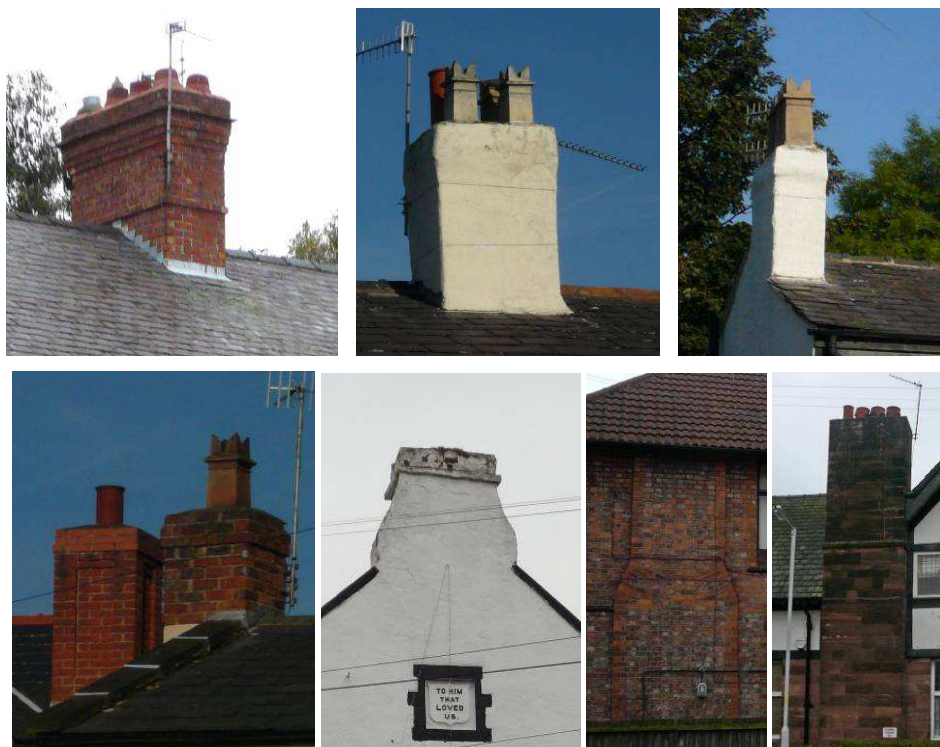
- 5.3.9 **Chimneys:** Most of the chimneys are of a plain, simple rectilinear design, although some have oversailing courses. They are generally built of brick (some rendered and painted) and surmounted with clay pots, but the style and colour of pots can vary within the same stack. Semi-detached dwellings share a central stack of up to eight flues, passing through the ridge. Detached dwellings have gable end stacks, either in the gable wall or projecting from it from ground floor level. One stack to the Church Institute, however, is of sandstone ashlar and is positioned at the junction of two roof slopes, in an ‘Arts and Crafts’ manner. The remains of the stack at 52 Bromborough Village Road show the use of tumbling-in brickwork in chimney construction. The gable end stack to 18 Bromborough Village Road is of an unusual shape although probably constructed using a similar technique.

Examples of different chimney types within the conservation area

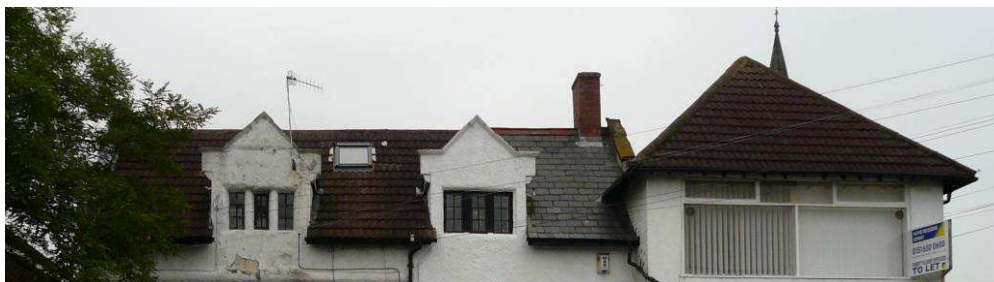
Nos 54-56 Bromborough Village Road

5.3.11 The roofs to the commercial premises have more varying pitches, from the flat roof of Barclays Bank (at Market Cross) to the more steeply pitched roof of Nos 54-56 Bromborough Village Road. Some buildings have the ridge at right angles to the street with the gable being presented to the street. The only Listed commercial building (Nos 54-56) has gabled dormers with stone copings and kneelers, together with overhanging eaves to the main roof slopes.

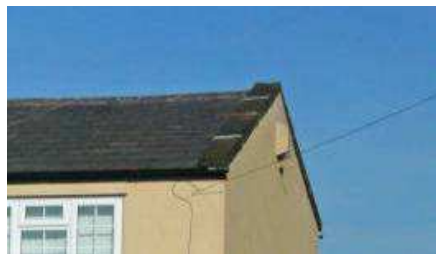
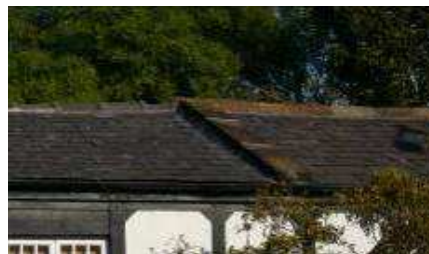
5.3.10 **Roof details:** buildings within the conservation area display more variety in roofs than in chimney types. The cottages tend to have fairly shallow-pitched roofs of slate or tile, although some may have been thatched originally as elsewhere in Wirral. Earlier cottages have stone copings to flush verges, whilst buildings of the late 19th/early 20th century sometimes have overhanging verges. Ridges generally run parallel to the front of the building and some have clay ridge tiles.

Roof details of dwellings along The Rake: earlier buildings (above) have stone coping to flush verges; later buildings (left) have overhanging verges and projecting purlins

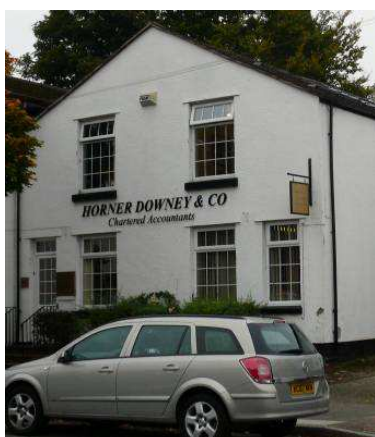
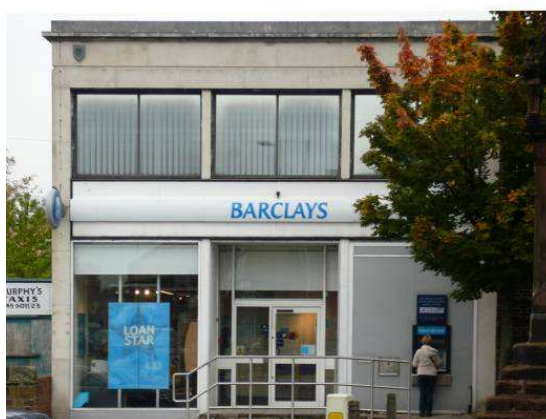
Gable end fronting the street at No 28 (left) and the flat-roof to Barclays Bank at Market Cross (right)

- 6.2.4 The Barclays Bank building at Market Cross is less sympathetic to the character of the conservation area, being clad in Portland stone and having a flat roof. However, this appears to be a remodelling and extension of the brick and slated gabled building (Roberts Garage) that it replaced as there is evidence of historic brickwork to the ground floor at the rear of the building.

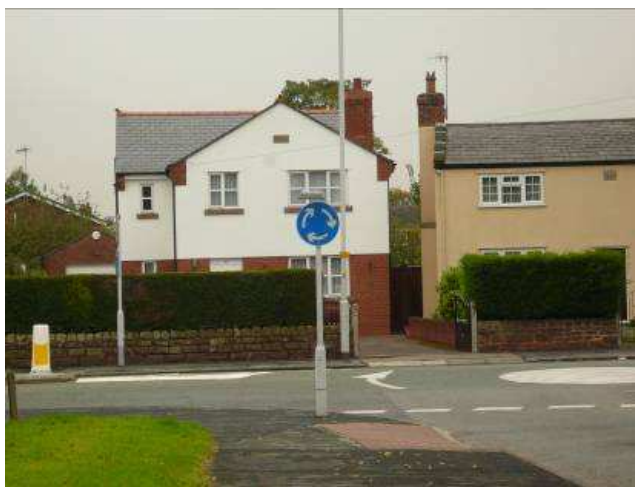
6.2.3 The single ‘new build’ along the north side of The Rake is clearly modern but has been designed with some vernacular details such as terracotta ridge tiles, slate roofs, a square chimney stack, corbelled eaves, sandstone cills and appropriately sized window openings. However, elsewhere in the

22 *The Rake*: a late C20th house generally sympathetic to the character of the conservation area

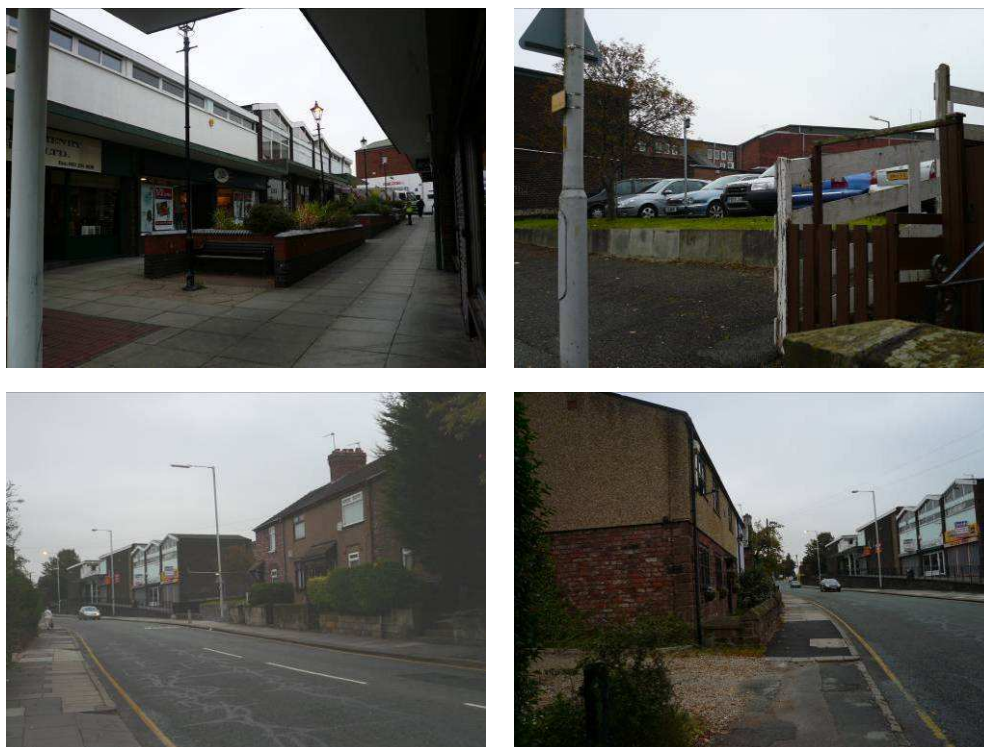
- 6.2.5 The biggest change to Bromborough Village has been brought about by development *outside* the conservation area, which immediately impacts upon its setting and restricts views out of the conservation area.
- 6.2.6 The south side of *The Rake* has seen the loss of dwellings and gardens, and now accommodates a shopping centre and associated car parking that directly affect the setting of the cottages on the north side of *The Rake*.

Views of the south side of The Rake: shopping centre (top left); car park (top right); the one remaining short terrace of cottages at Nos 7 to 13 (bottom left), and the proximity of the shopping centre to the conservation area (bottom right)

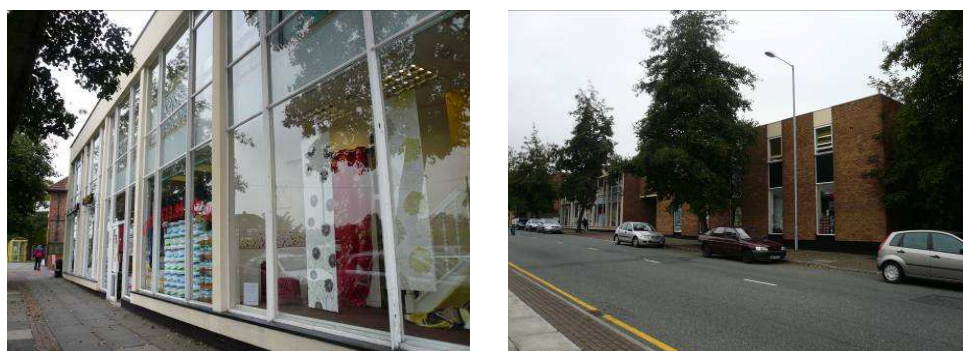
6.2.9 Along Bromborough Village Road, the immediate proximity of Nos 36 to 46 to the conservation area has an impact on its setting. The building is anonymous, brick-built, and flat-roofed with a large glass ‘shop front’ relieved by cream mosaic tiles and white painted timber window frames. It is disproportionately scaled in the context of the other buildings along Bromborough Village Road although its height is appropriate and it is obscured slightly by large trees.

Nos 36-46 Bromborough Village Road viewed from north east: the southern section (left) has a largely glass frontage and the northern section (right) is predominantly of brick

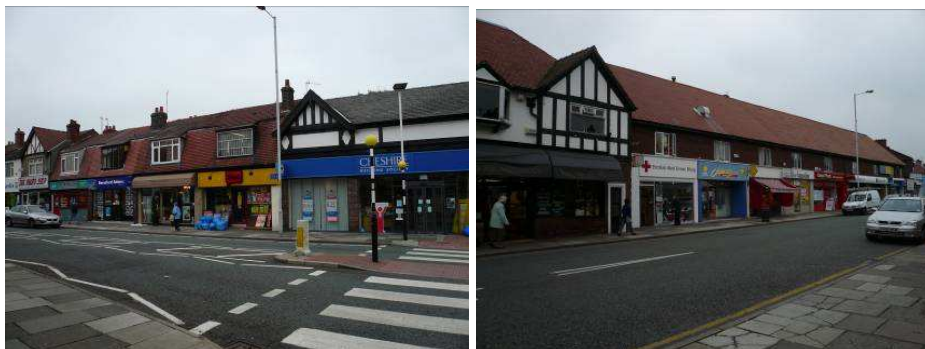
6.2.10 The setting of the conservation area is particularly affected by development around the area of the Market Cross. Manor House Farm on Allport Lane was demolished in 1928 and replaced by Irwin’s Grocery Shop. Other shops were built along Allport Lane, where previously there had been cottages and orchards. These buildings mark an important development for the setting of the market cross as the open square became increasingly built up.

Shops on the west side of Allport Lane (left) lie on the site of Manor House Farm; the shops on the east side (right) had interesting art deco elevations when built in the 1930s but have since been unified under a plain single roofline

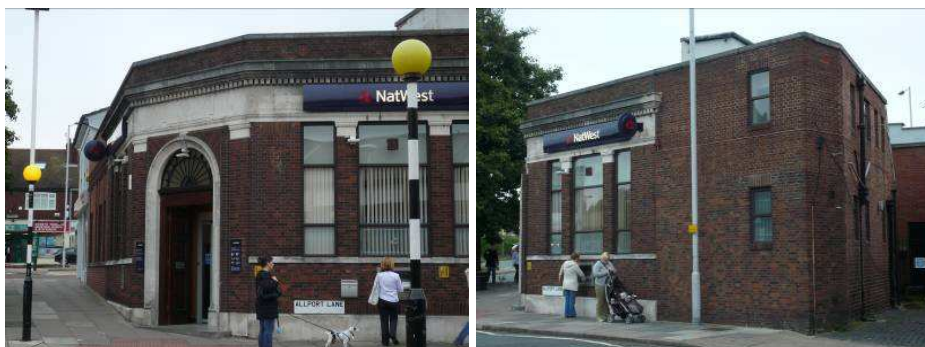
6.2.11 The design of the NatWest building at the junction of Market Cross and Allport Lane pays homage to the sweet shop, later bank, that formerly stood on the corner and has typical 1920s ‘stripped’ classical detailing. The later extension to the south has adversely affected its massing and it now appears slightly ungainly.

NatWest Bank on the corner of Market Cross and Allport Lane (left) with a further extension built to the south (right)

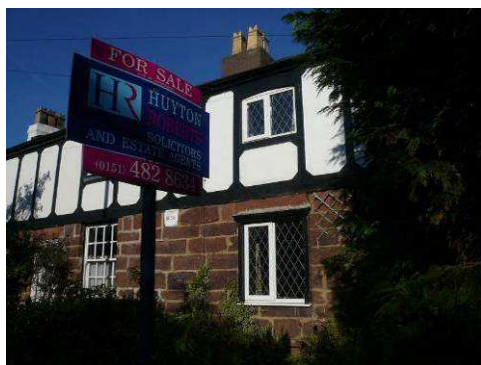
No 16 The Rake: Replacement uPVC two-light windows with single side-hung casements and imitation diamond-shaped leading. The upper window is almost flush with the wall face, instead of being recessed in the same way as the earlier windows to No 18 adjoining. The inserted timber reveal to the lower window stands proud of the wall face and is totally out of context.

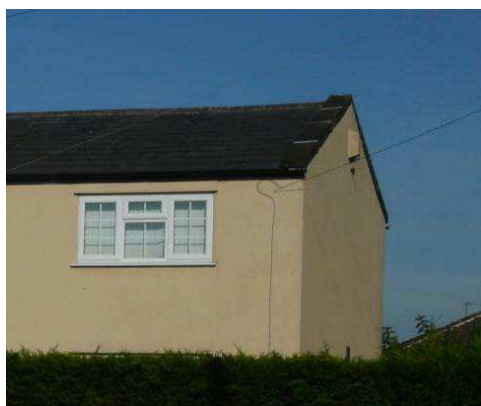
No 20 The Rake: The outer lights have side-hung casements and the central one a small top-hung casement, a feature alien to the original form of such cottage windows. Each light has imitation glazing bars sandwiched between the panes of glass. If the window openings are original, they would have most likely contained a three-light window with a central side-hung casement. The cluttered design of these windows does little to preserve or enhance the character of the building.

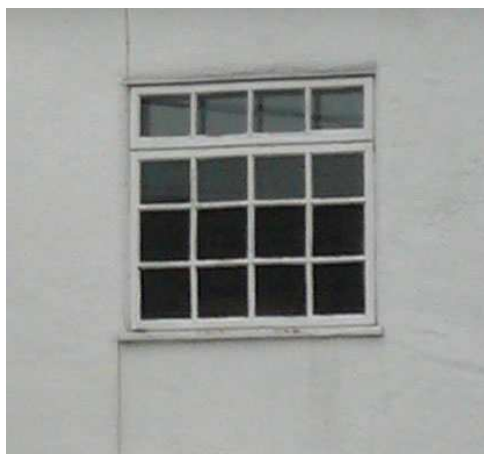
No 26 Bromborough Village Road: although the lights are appropriately sized, the square window openings now contain top hung casements, which are out of character

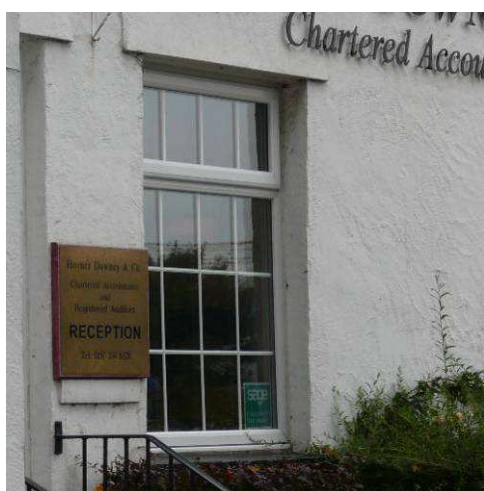
No 28 Bromborough Village Road: the openings originally would have been fitted with sliding sash windows, probably 8 panes over 8 and although an attempt has been made to emulate the historic glazing pattern, the use of uPVC top-hung casements has resulted in windows with ungainly proportions

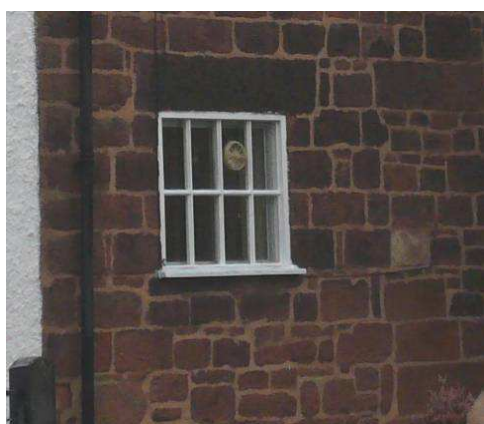
No 6 The Rake: A wooden replacement window in the spirit of the original but with a protruding cill and an extractor fan inappropriately placed. Its slightly awkward appearance suggests the original window may have had 12 panes rather than 8.

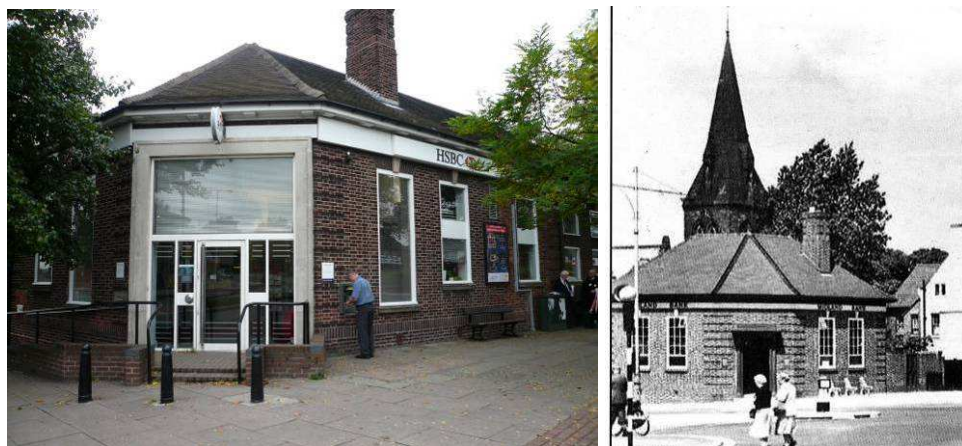
58 Bromborough Village Road: unsympathetic alterations are illustrated by comparison with a photograph from the 1950s

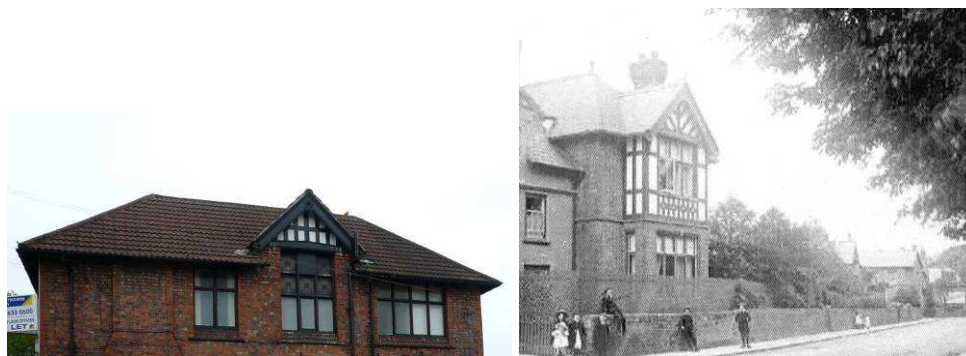
No 52 Bromborough Village Road: The north elevation (left) illustrates the loss of the east and west projecting gables and chimney shown in a 1920s photograph (right). (Note the open space beyond the building is the site of 36-46 Bromborough Village Road)

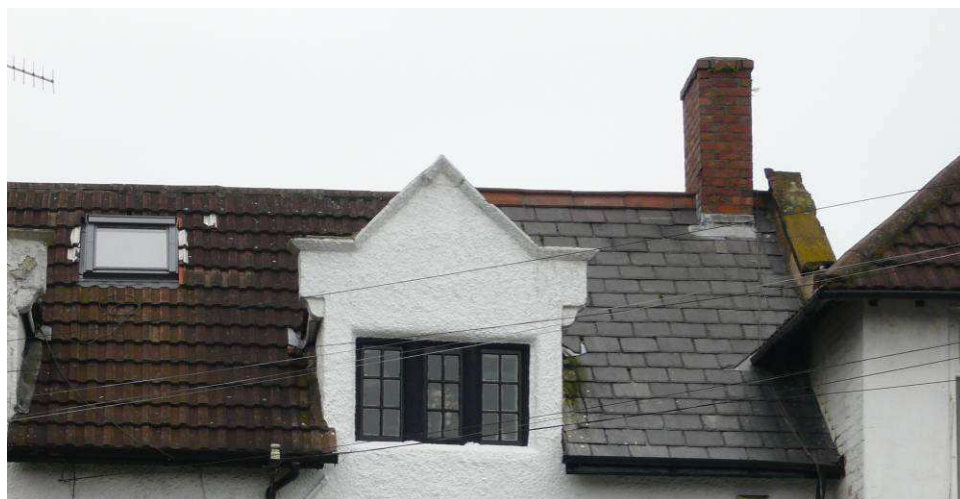
Nos 54/54a Bromborough Village Road demonstrates the difference in appearance between a slate roof (right) and modern interlocking profiled tiles (left)

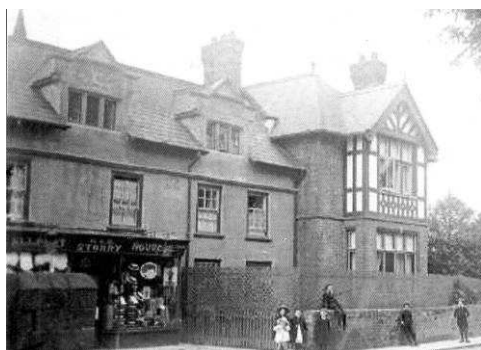
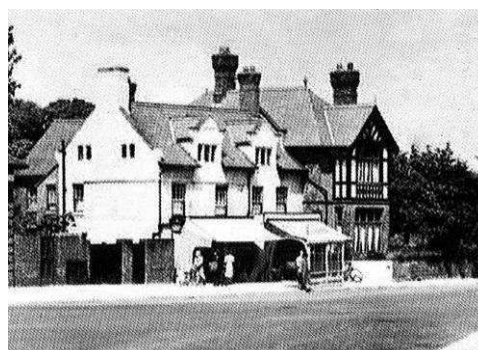
6.3.8 The conversion of the former Tellet's farm house to shops in the first half of the 20th century appears to have been carried out without much radical alteration to the original fabric. However, subsequent alterations have been more intrusive and the building's legibility as a former, fairly substantial, farmhouse has been considerably diluted. Similarly, the conversion to a laundrette of the neighbouring building, once a handsome Tudor revival house, has been less than successful and unsympathetic to the character of the original building.

Nos 52-56 Bromborough Village Road: the early C20th conversion of the former Tellet's Farmhouse to a chandler's shop was sympathetic to the character of the building (top left), as was its division into two by the 1950s (top right).

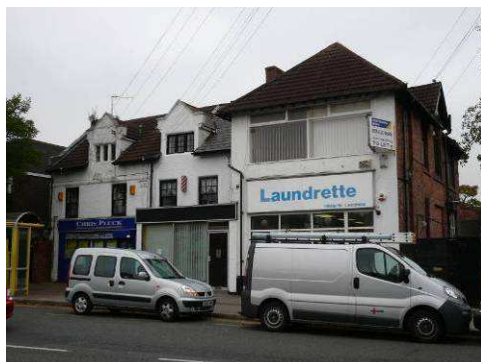
Subsequent alterations to Tellet's farm, the adjacent No 52 (now Laundrette) and to the public realm have had a more significant impact (left)

- 6.5.2 Similarly, buildings such as Tellet's Farmhouse (Nos 56-56 Bromborough Village Road) are in need of repair and maintenance works, as well as a considered approach to how best to secure their future and preserve or enhance their character.

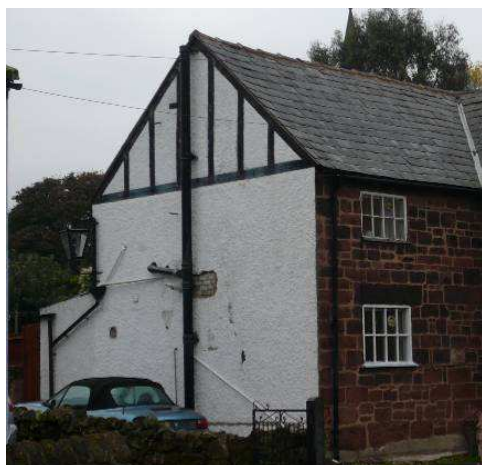
Intrusive waste pipes and rainwater goods

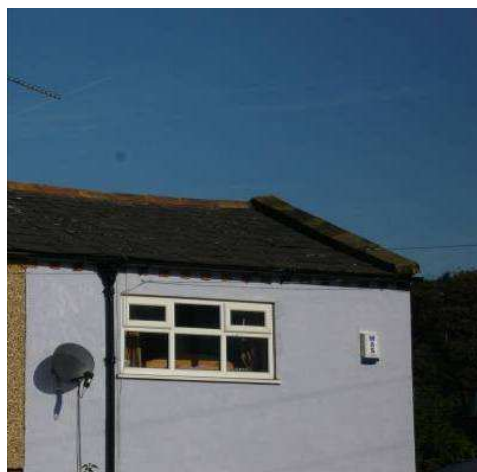
More considered placement of the rainwater downpipe, satellite dish and burglar alarm would improve the aesthetic appeal of this cottage

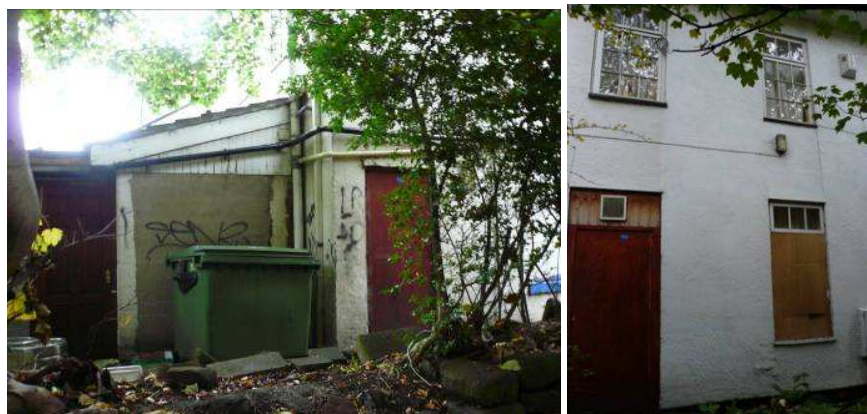
The rear of Nos 32-34 Bromborough Village Road sits alongside the pathway to the church and is in need of some improvement
