BROMBOROUGH VILLAGE CONSERVATION AREA APPRAISAL AND MANAGEMENT PLAN

PART 1 – CONSERVATION AREA APPRAISAL

Prepared for Wirral Council by Donald Insall Associates Ltd, 2007 – Wirral Council 2009

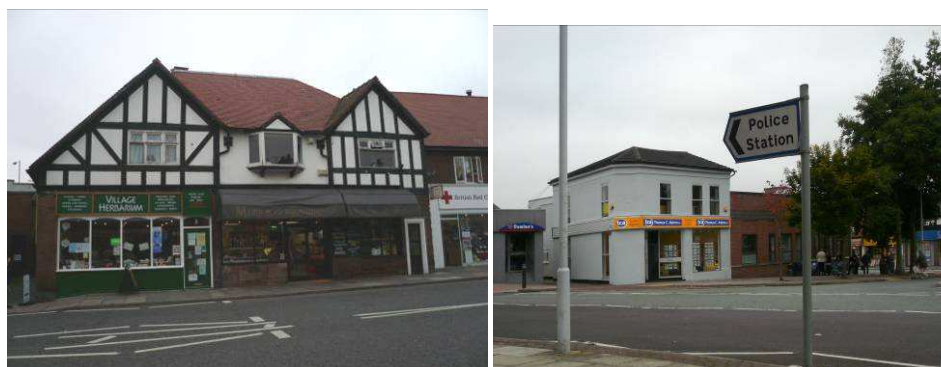
Subtle signage can enhance the setting of the conservation area. Along Allport Road, Nos 3 to 5 (left) for example have pleasantly designed shop fronts and appropriate signage, whereas the illuminated signage to the former Royal Oak (No 60 Bromborough Village Road, (right) is insistently bright and overly conspicuous.

- 6.6.4 Signage on some buildings within the conservation area is inappropriate and detracts from its character. This is most noticeable along Bromborough Village Road.
- 6.6.5 The setting of the conservation area, particularly around the market cross, is also affected by signage on nearby shops particularly where it is illuminated. A notable example is the illuminated signage to the former Royal Oak public house, now housing an estate agent, near the Market Cross.

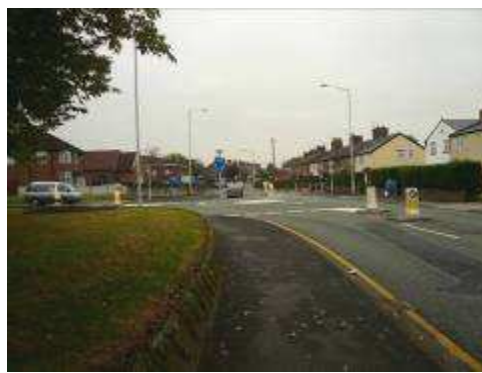
View looking west along The Rake near its junction with Allport Lane (western end)

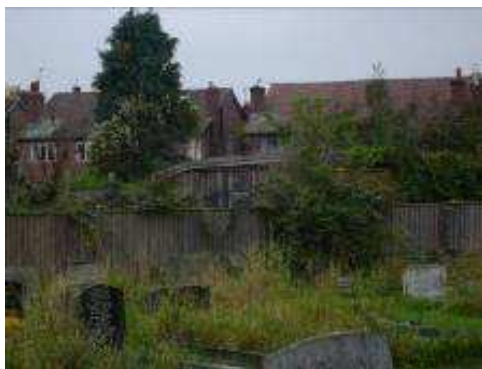
View from the churchyard to the houses on Athelstan Close built on former open fields

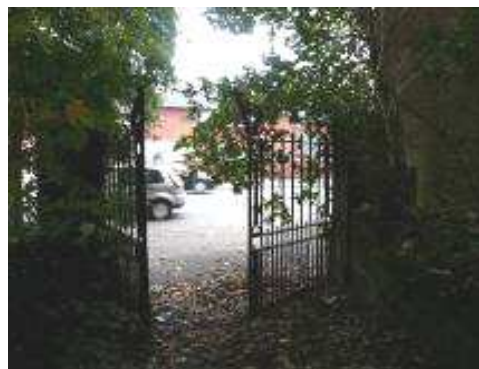
View from the pathway leading from the churchyard onto Bromborough Village Road showing proximity of busy thoroughfare and modern commercial premises, where formerly the sandstone boundary wall of the Bromborough Hall estate stood

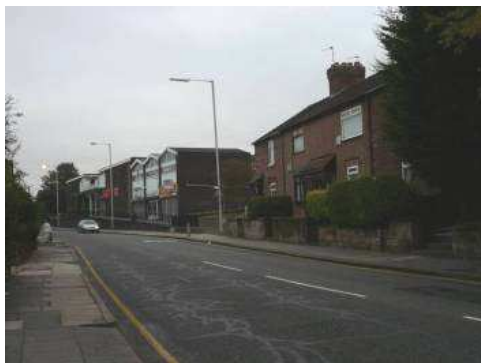
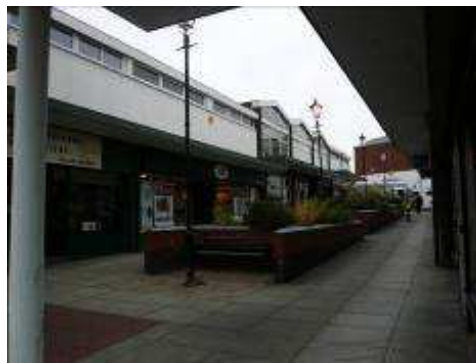
The setting of the southern section of the conservation area is affected by a large shopping centre

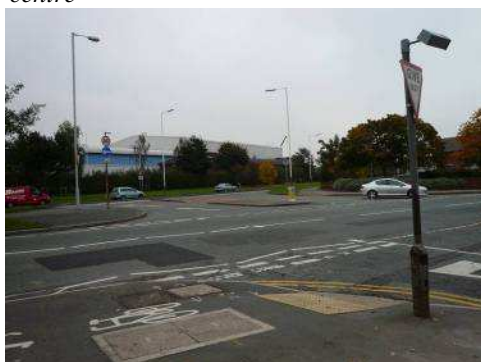
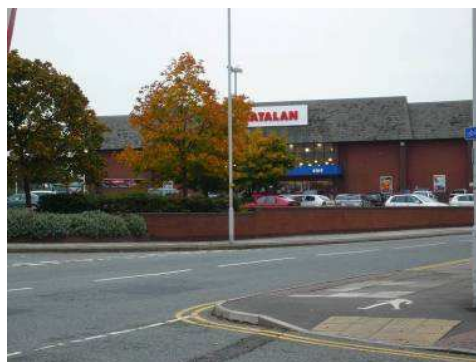
The setting to the east of the conservation area has changed considerably following the demolition of Bromborough Hall and the development of the estate grounds for commercial/residential use.

(left) northern junction of Bromborough Village Road with New Chester Road (A41), viewed from north west
