A Report to Birkenhead School

A Report into the Proposed Pitch Improvement Works at Old Parkonians Rugby Union Football Club

23 March 2023

Document Title **A Report into the Proposed Pitch Construction at Old Parkonians RUFC**

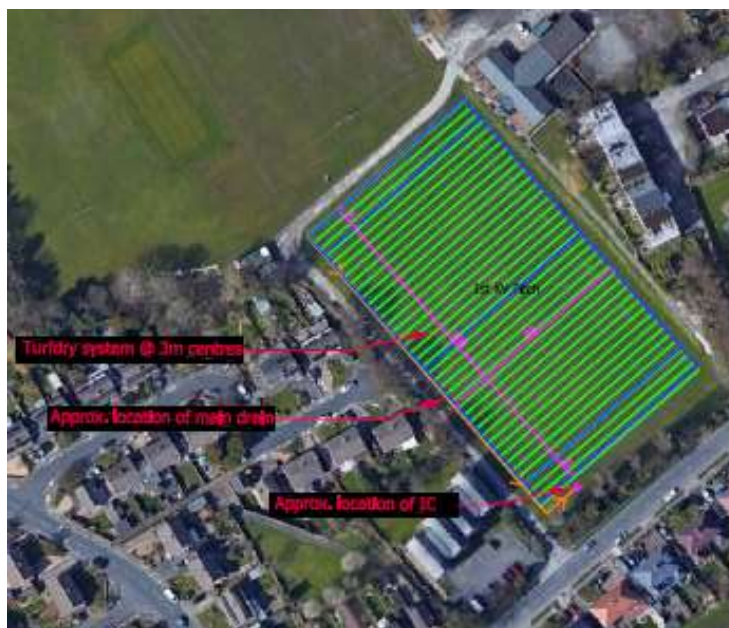
Plate 1: Existing Site Layout

The existing layout comprises of the 1st XV rugby pitch to the south of the site and 1 cricket square and outfield to the north of the site which accommodates the 2nd XV rugby pitch. The layout can be seen on the aerial image below with both pitches being in a similar orientation to generally a northwest to south east direction.

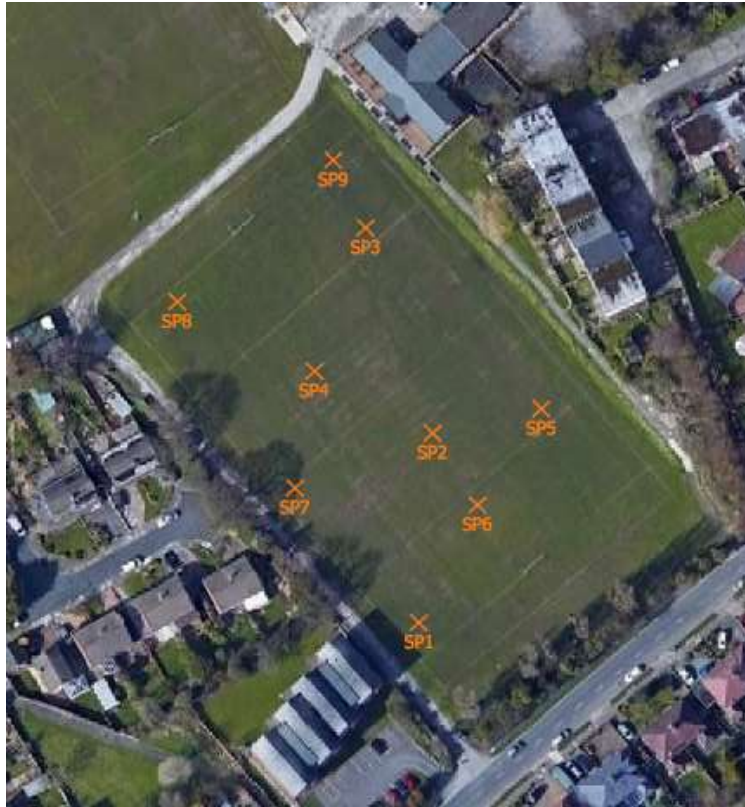
Plate 2: Approximate soil pit locations

Excavations were carried out with a spade and hand-held auger and together with laboratory analysis of the topsoil the following comments are made:

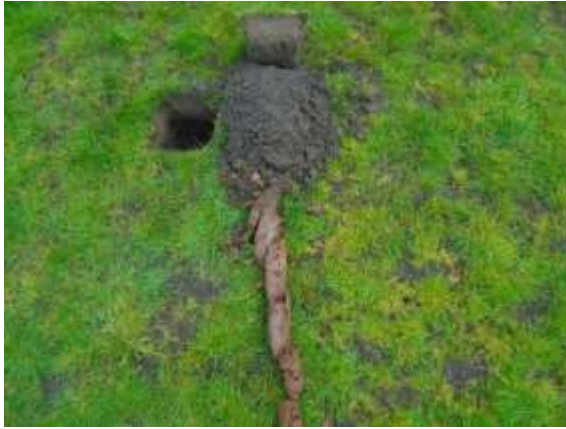
- The topsoil depth range was between 130mm and 180mm. The topsoil was well structured and appeared to be of a sandy loam texture and crumbled on touch. Some areas were contaminated with stone.
- The upper 20mm was compact.
- There were differences present over the site with the northeast wing containing an ash/clinker layer below the topsoil and this was also slightly higher than the rest of the pitch.
- Laboratory analysis (see Appendix 1) classified the topsoil as a sandy loam which after the removal of 5.6% gravel contained 61.9% sand, 28.5% silt and 9.6% clay.

Plate 3 Typical topsoil profile and condition away from the north wing

To improve soil texture, sand dressing will be required during the works which will make improvements to the upper profile of topsoil. Further sand dressings are recommended on an annual basis to ensure that continual improvements are made to the upper profile by controlling thatch along with ensuring that the surface to drainage connection remains positive and functional.

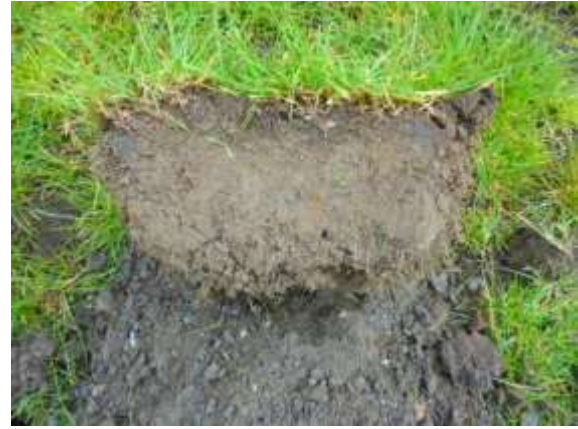
The subsoil material varied over the pitch with some areas containing clay dominant material which was of a dark colour with some sand present. The clay material present was dense and not productive to natural drainage. The northeast wing contained clinker along its entirety which was up to 100mm in thickness below the topsoil which varied in depth between 130mm and 150mm. Below the clinker material was a dense clay to 1m.

Plate 4: An example of the ash/clinker layer present below the topsoil on the north wing

- There is an existing drainage outlet present on site. Confirmation of its continued use should be gained from the relevant Authorities.
- Any ash/clinker contained within drainage spoil may require a Waste Acceptance License if disposed off site. On-site disposal within a bund would be preferable.

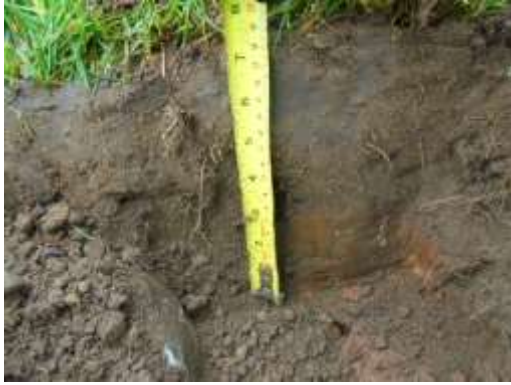
In 1993-94 a further system was installed which consisted of the Turfdry system which consists of narrow diameter pipes wrapped in geotextile connecting to a 125mm plastic pipe which runs along the southwest touchline. This scheme also connects into the existing manhole which outlets into Holm Lane.

Site investigations found lytag type gravel which was used as a backfill for the 1993/4 system. This gravel was topped with topsoil and was heavily contaminated soil which will significantly reduce the effectiveness of the system.

Plate 5: Example of the 1994 system capped by topsoil and the backfill heavily contaminated

Due to the condition of the existing system and allowing for the climatic factors present and predicted usage levels, a new system should be installed to improve drainage of the pitch. All factors dictate that the main primary system should be supplemented by excavated slit drains which will intensify the system providing a quick method for water removal from the surface and into the drainage system.

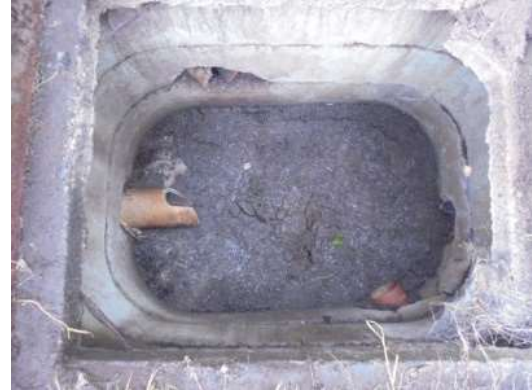
The inspection chamber is in a poor condition, and it is recommended to replace it during the improvement works making good the existing connections. The chamber also contains a significant amount of silt which needs to be removed, this should be monitored on a regular basis. The outfall pipe and its connection to the surface water system to and beyond the club boundary should be checked for its condition and ultimately determine its path.

Plate 6: Inside the existing inspection chamber which requires replacement due to its condition. Note the build up of silt in the base of the chamber

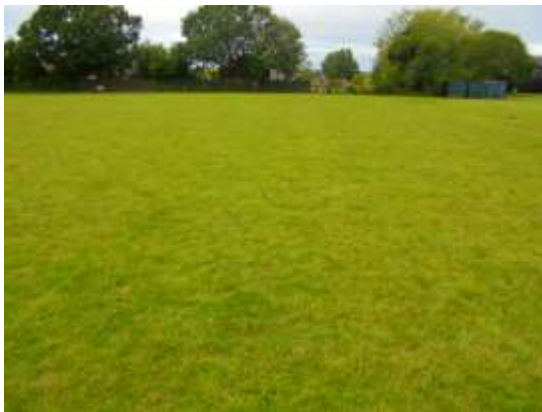
The 2019 assessment recorded the existing vegetation was of reasonable length being approximately 40mm in height. The sward was an established surface consisting of perennial ryegrass and annual meadow grass with weed species and broadleaved weeds present.

Plate 7: General view of the existing vegetation (2019)

The Club had carried out some chain harrowing prior to the visit and this practice was recommended to continue to remove some of the thatch/stalky growth which has developed over time. This work will help to improve the growing habit of the grass and provide a better appearance.

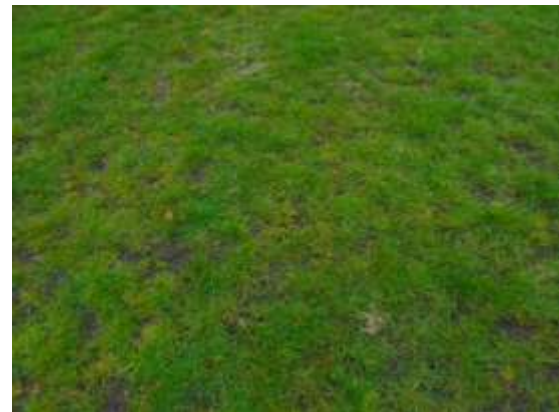
On the northern side along with high wear areas, the sward was patchy in appearance and a reflection of the time of visit following the end of the season and the level of compaction present. Away from these areas, the grass was longer but of a coarse nature and works to improve sward composition and condition are required.

Plate 8: Close up of the sward, in areas there is a patchy appearance which is a reflection of the amount of compaction present (2019)

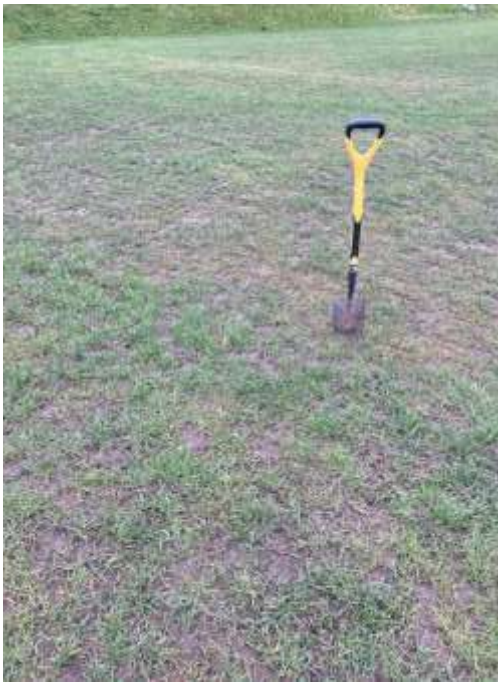
The March 2023 visit coincided with the lead up to the end of the season. The pitch was characterised by variable wear with the northern half exhibiting more wear than the southern half. Grass cover was in the range 10 – 60% and comprised mainly of a mixture of perennial ryegrass and meadow grass.

The immediate surface was compact and visually appeared slightly undulating. The Club reported rootzone had been used to fill some of the hollows in 2020 (lockdown period) and had achieved improvements but gradual deterioration has since been observed mainly in terms of inadequate drainage.

Plate 9 : Worn surface and consolidated surface (2023)

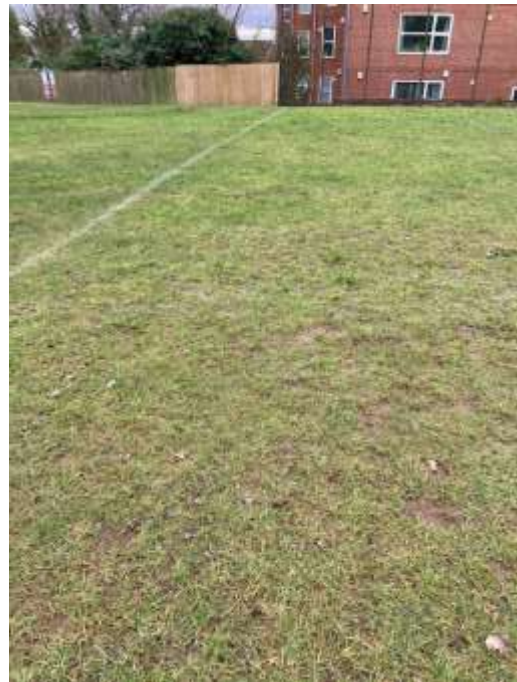
It was reported heavy rain the previous day had caused significant water ponding over the pitch, but the majority had dissipated on the day of the visit apart from a number of localised areas still characterised by surface water.

Plate 10 : Localised depression at southern end; flattened sward and surface water (2023)

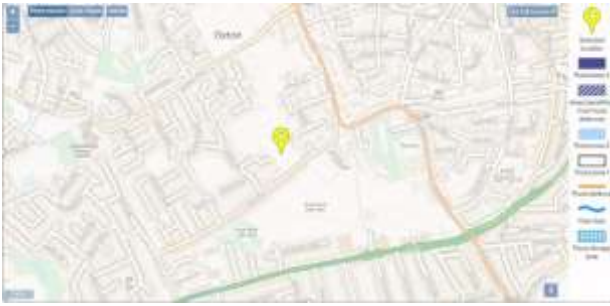
- Based on current Local Authority data, the site is within Flood Zone 1 which does not represent a high risk of flooding.
- Irrigation might be required to ensure that the sward establishes effectively following the works.

Fig. 4: Flood map showing the site falls in Zone 1

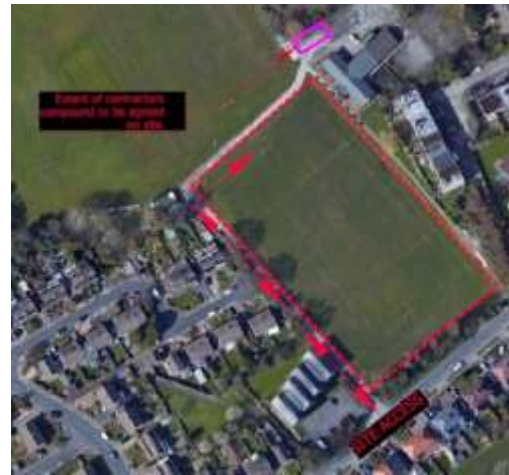
Plate 11: Work area, site access & materials storage
