CLIFTON PARK CONSERVATION AREA APPRAISAL

A Report for Metropolitan Borough of Wirral by Donald Insall Associates Ltd

June 2004

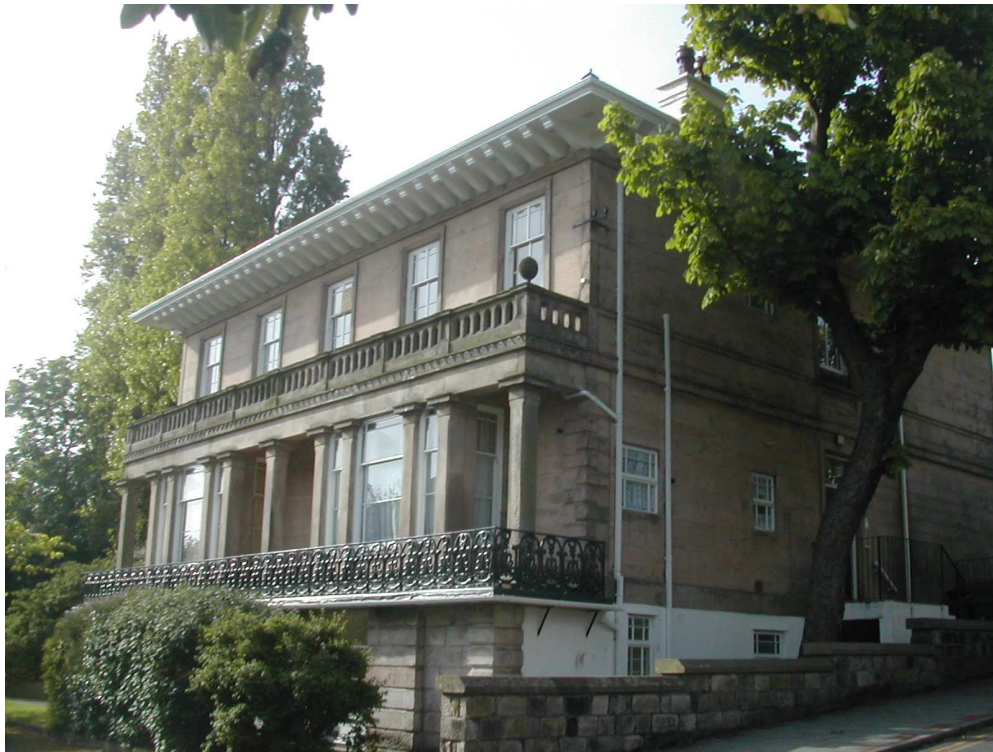
Number 47, Clifton Road, an original house in the development, by Walter Scott

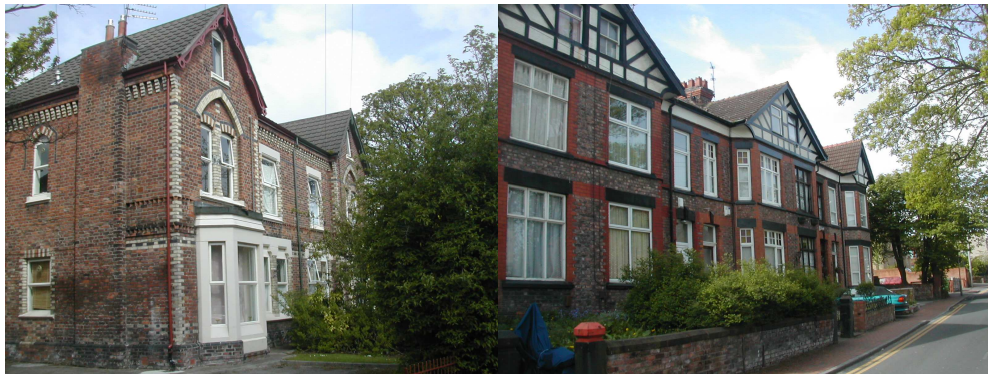
Number 11 Circular Road (c 1880) and 46-50 Woodlands (c. 1890)

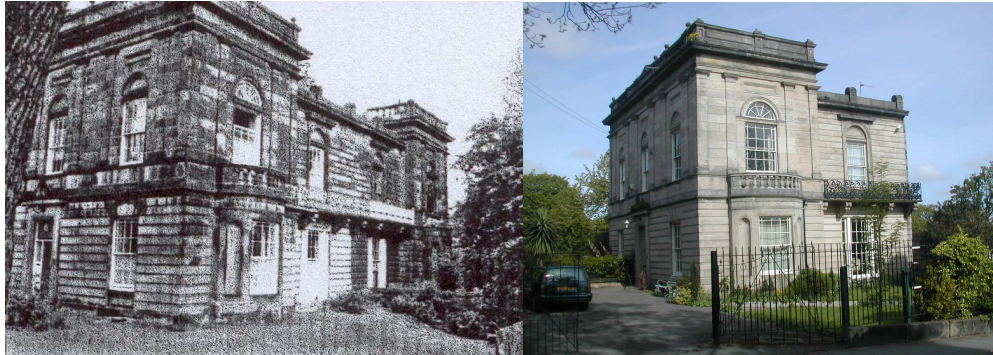
(Left) Photograph of numbers 38 & 40 Clifton Road, taken in 1982. (Right) Present day photograph of number 40, since demolition of number 38.

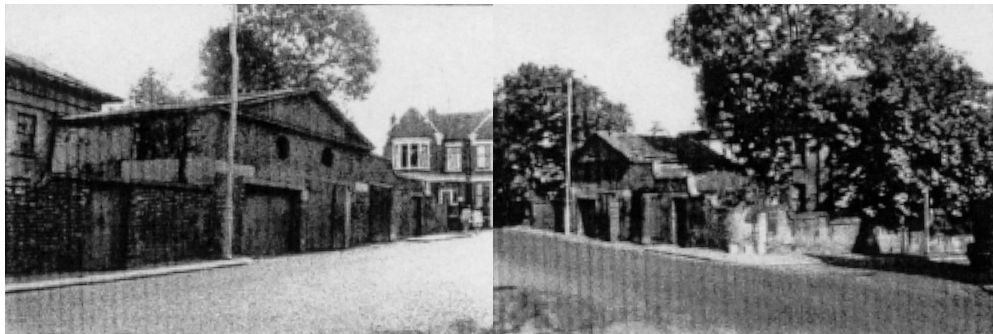
Photographs of coach house on Whetstone Lane, prior to demolition.

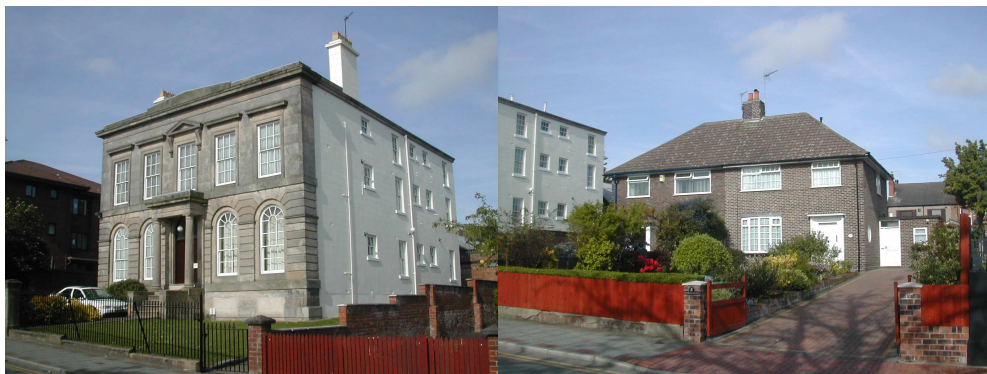
An example of the variety of scale and character, seen particularly towards the lower end of Clifton Road. Adjacent house, numbers 20,22 and 24 Clifton Road.

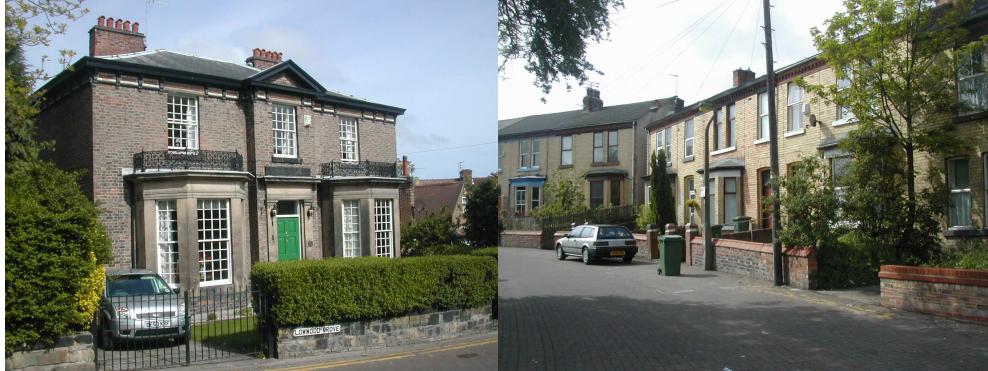
Villa c. 1850 (number 8 Lowwood Grove) and terrace on Circular Road (c.1890)

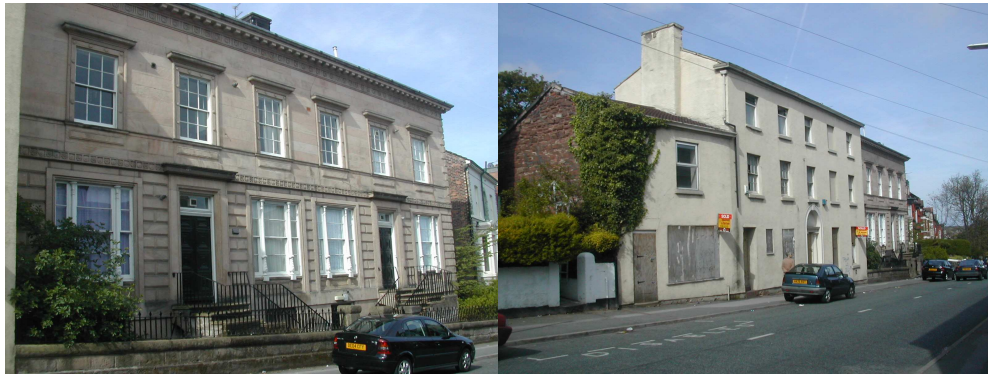
Numbers 140/142 and 144 Whetstone Lane. Although of a similar date and both listed, they are of stark contrast in terms of condition.

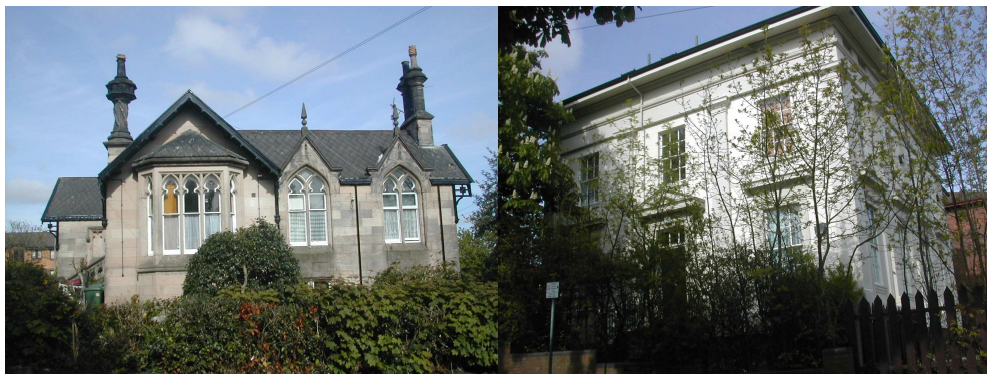
Number 42 and 44 Clifton, both designed by Scott and built between 1840 and 1850, are contrasting in style.

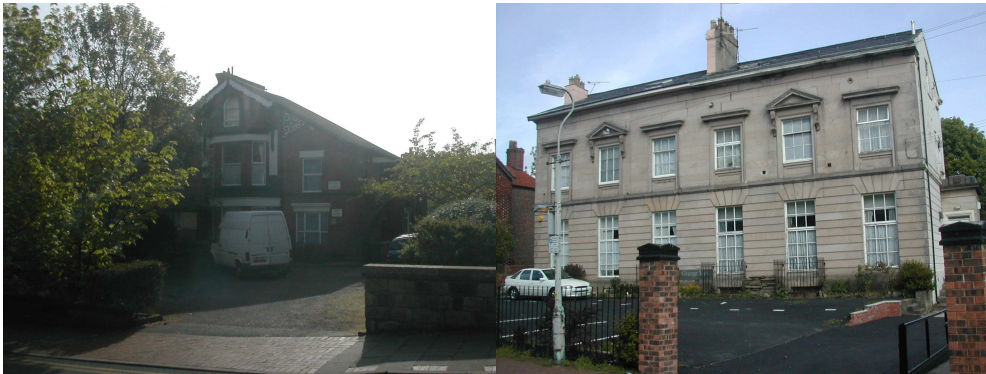
Number 45 Clifton Road (left) and 53 / 55 Woodlands (right). Both examples of larger properties being subdivided into flats. 45 Clifton Road is dominated by parking in front of the building, ugly signage and an external fire escape. 53 / 55 Woodlands has a tarmac parking area taking up virtually all the front area. Its stonework is dotted with extract vents and its roof littered with television aerials.

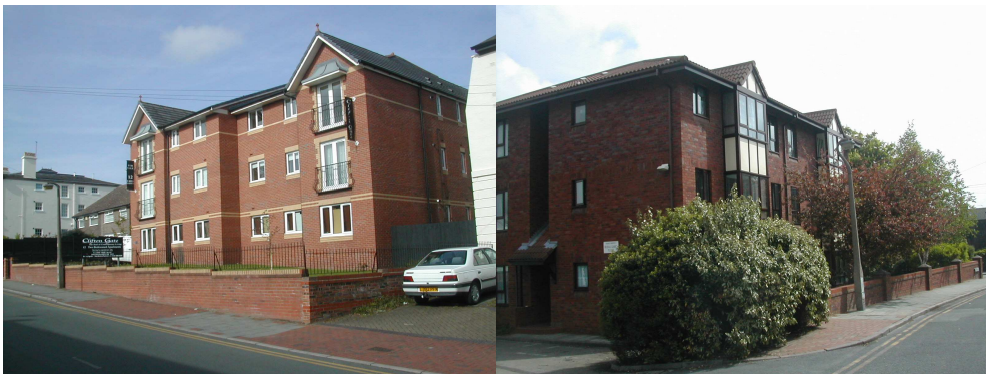
Clifton Gate (left) and Field House (right). Both recent developments on Clifton Road, of a similar size and quality. Neither building makes a positive architectural contribution to the area nor is sufficiently set back

from the road to be unobtrusive. It should be noted, however, that a good landscaping scheme can have a considerable impact on the site. Field House is well screened behind mature and semi-mature trees and hedges. Clifton Gate, on the other hand, has only a small area of lawn, a few small shrubs and a couple of scrawny, barely distinguishable trees. Although only newly planted, this scheme will never mature into an attractive garden. The building is further blighted by a large area of tarmac, without even a border of planting, on the left hand side for car parking.

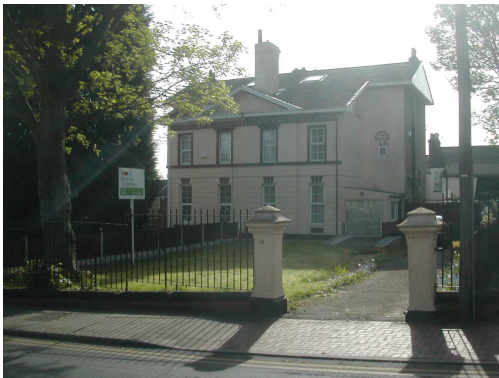
No. 31 & 33 Clifton Road. Although small in scale, an unsympathetic porch with large patio doors is stylistically out of keeping with the rest of the building and upsets the symmetry of the building as a whole.

The materials, form and positioning of any extension must also be carefully considered if the building's character is not to be lost. Materials should be of a quality that matches the existing building and should not detract from it. Traditional materials would generally be preferable to man-made ones, however, there may be instances where a 'sleeker' more modern alternative (e.g. lightweight materials such as glass) may actually detract less. The form of any extension should consider the scale, proportion and massing of the original as well as roof pitch. A new extension should generally be positioned in an unobtrusive position as possible, with the rear elevation being preferred to the front and sides.

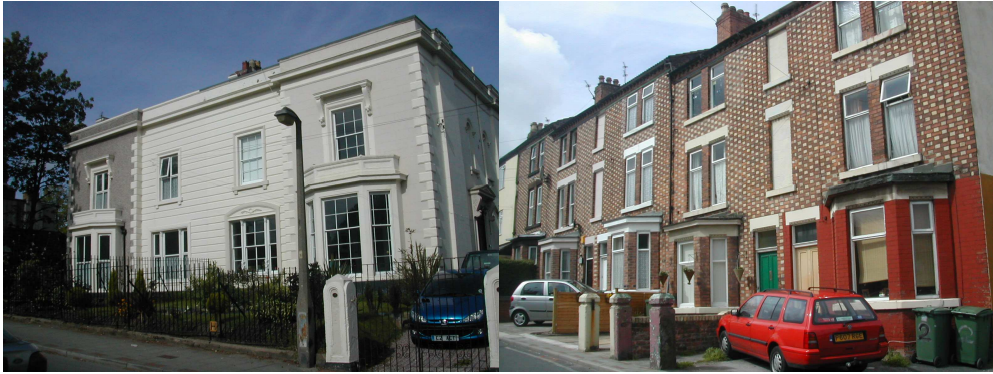
(Left) Grade II listed 34 & 36 Clifton Road. Although generally in a good state of repair, the symmetry of the pair is partly lost due to the unmatching render types and the insertion of top UPVC casement windows into the openings of the left hand house. (Right) Terrace on Brookland Road. The attractiveness of the polychromatic brick is marred by the muddle of different windows, painted brick and cars parked in gardens.
