**Donald Insall Associates**  
Chartered Architects and Historic Building Consultants

The King's Gap Gazetteer

## Introduction

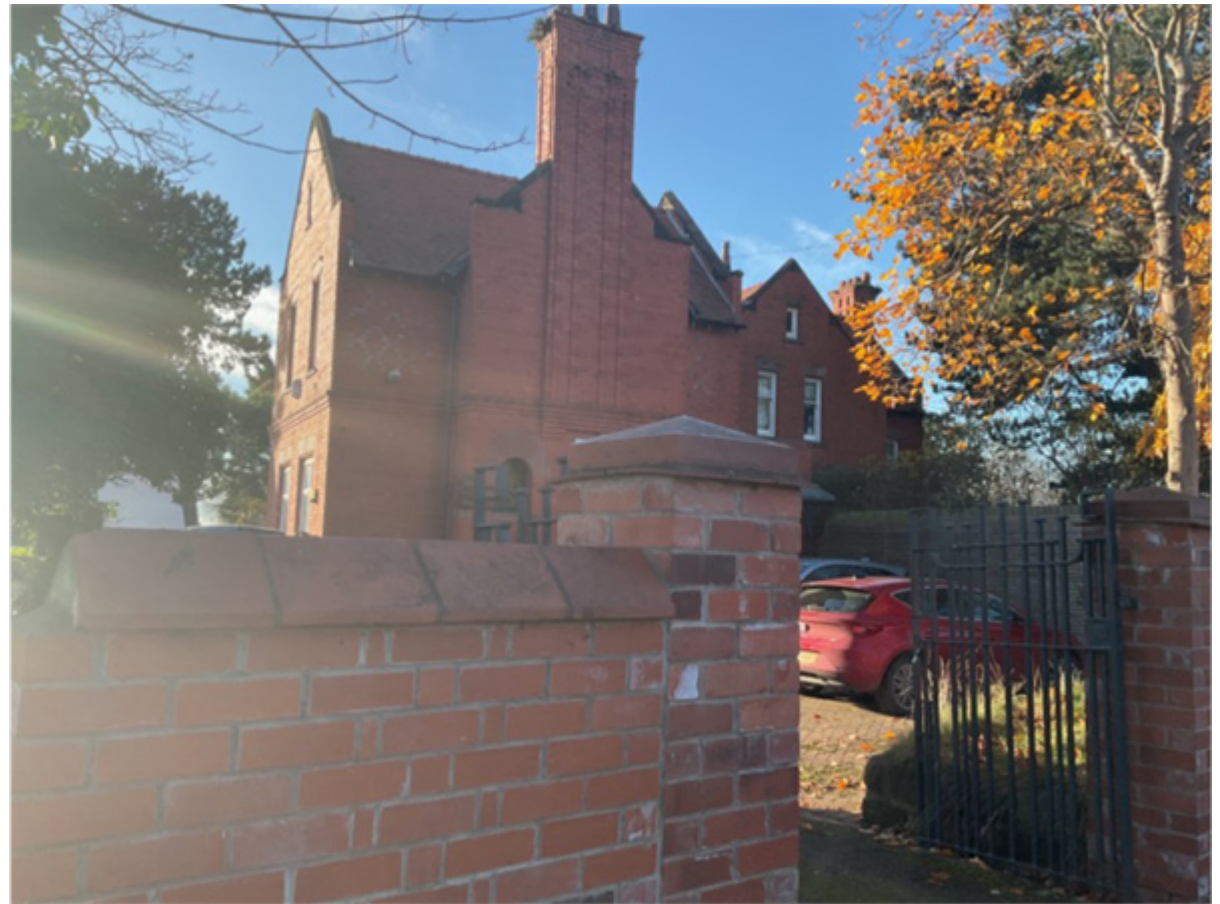
### Detrimental Elements:

Timber side boundary wall, front garden predominantly hard standing. Some uPVC windows.

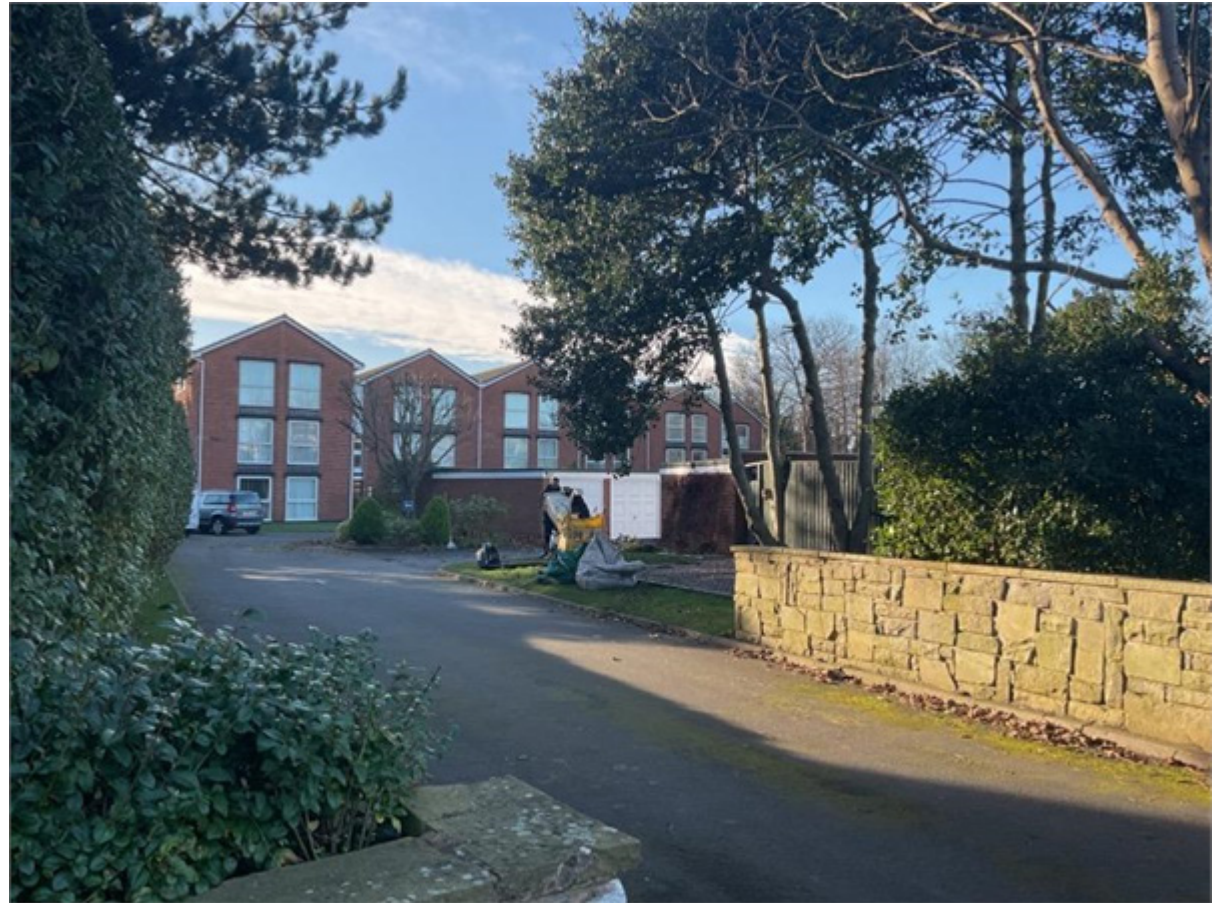
### Rear / Side Elevation Overlooks Key Space:

Golf Course, with a poor visual impact given its scale.

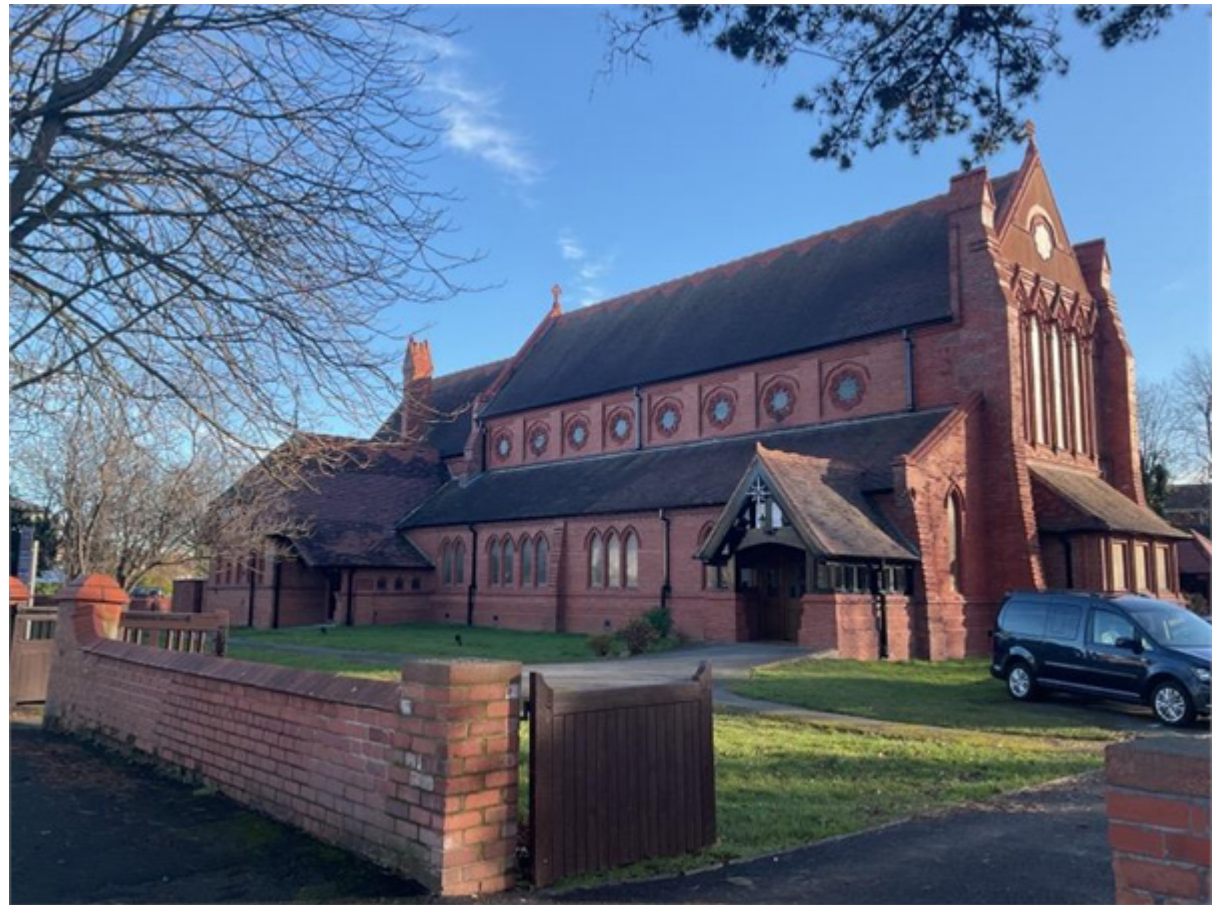
## St Hildeburgh's Parish Church, 1 Stanley Road

Hall to the rear is modern and architecturally bland. Prominent hardstanding for car park.

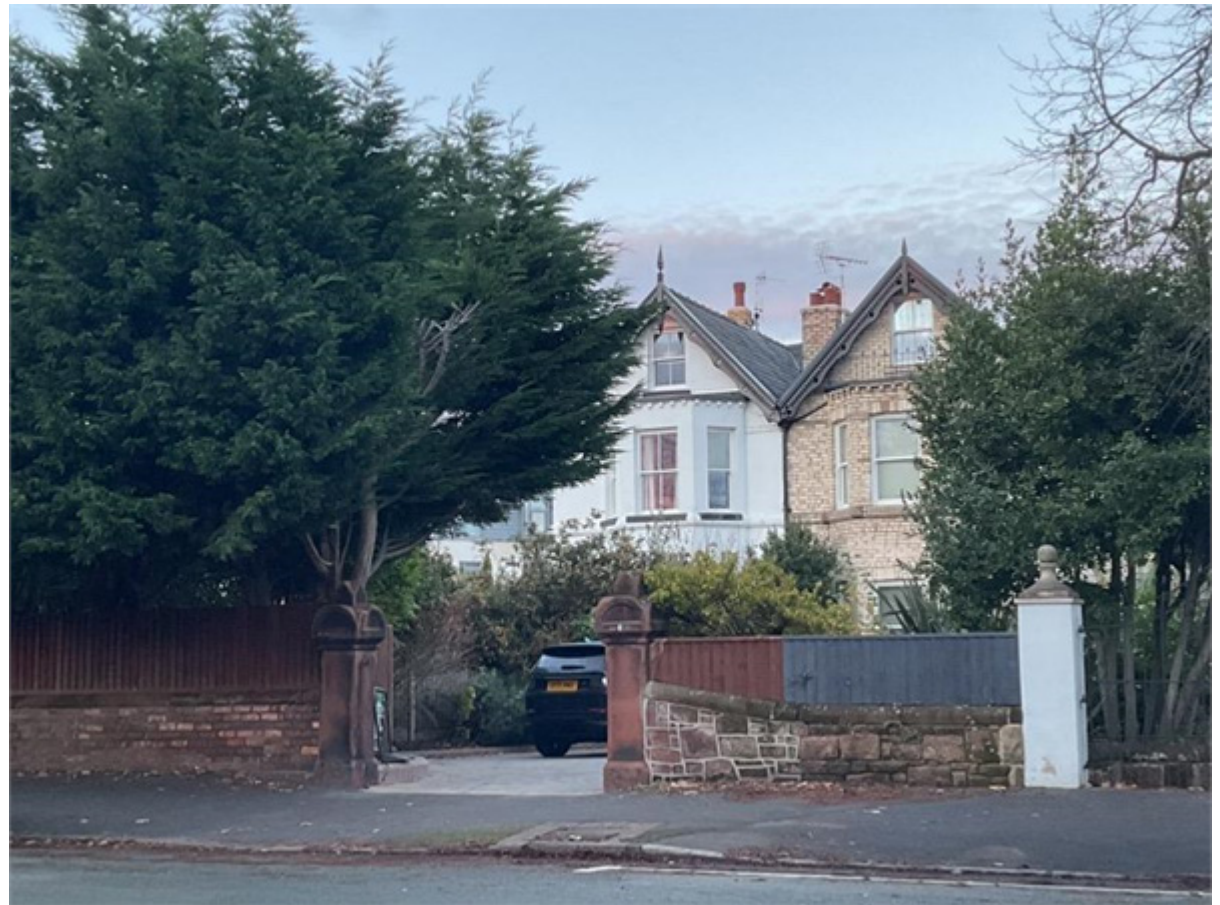
### Detrimental Elements:

Symmetry impacted as one half is rendered, the other brick. Significant extensions, and addition of large flat-roofed dormers to rear. R/h has concrete roof tiles. Close board fencing added to boundary wall and in the r/h a higher level of hardstanding to front garden.

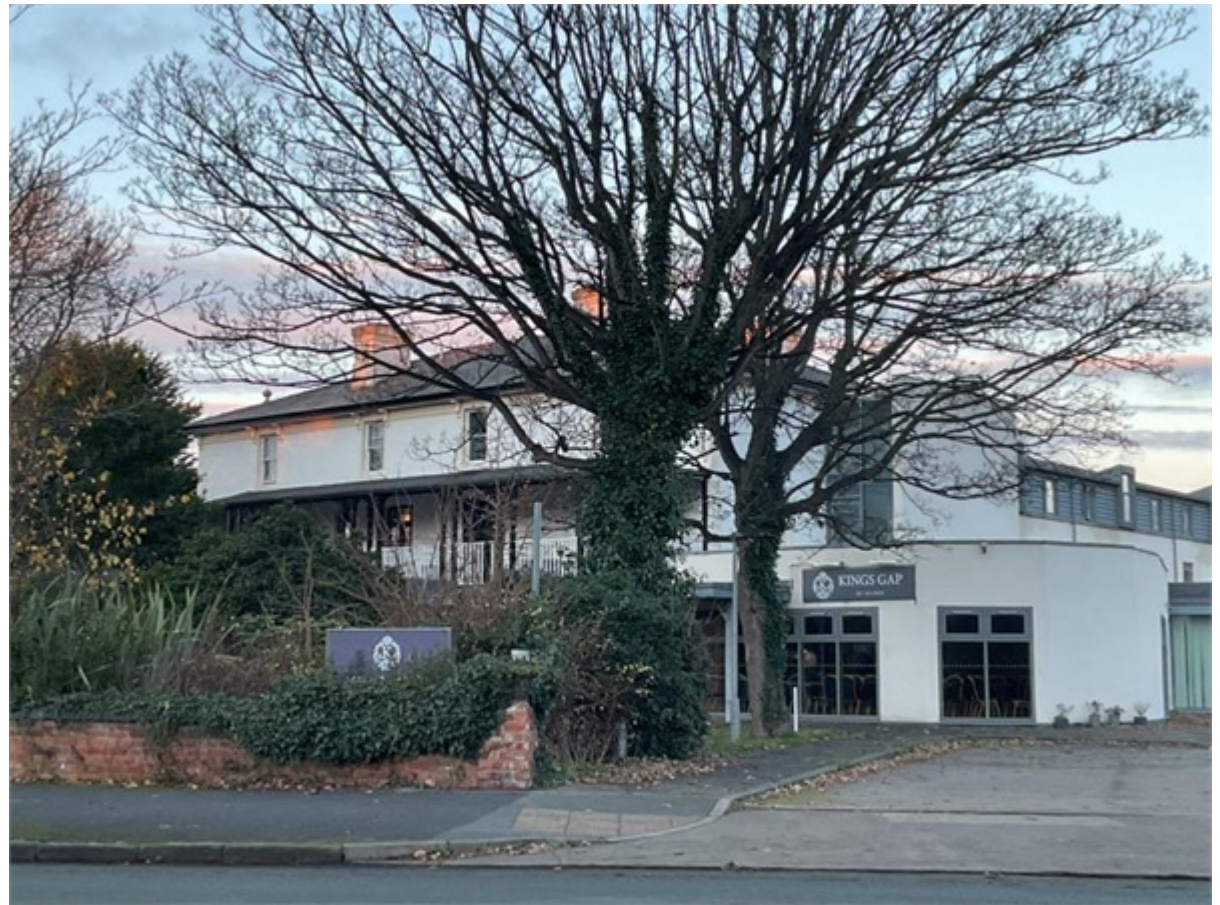
## Holiday Inn, The King's Gap

Render likely later, and in need of attention. Modern extensions for hotel use are unsympathetic. Mature landscaping has been lost for car park (also see 6b). Bin stores are prominent to Valentia Road.

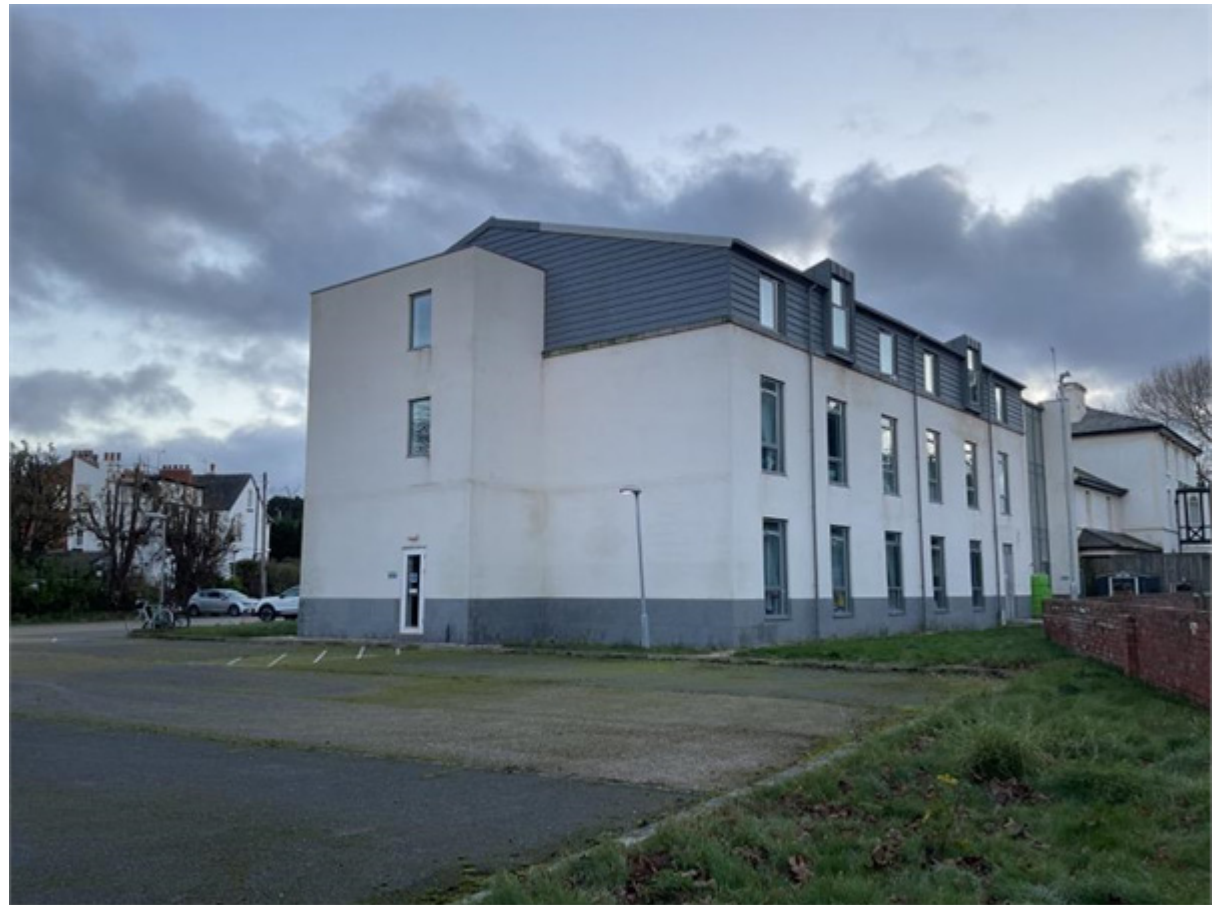
## Holiday Inn, The King's Gap

Large and architecturally monolithic, out of scale with the area and has a large swathe of hard standing to car park.

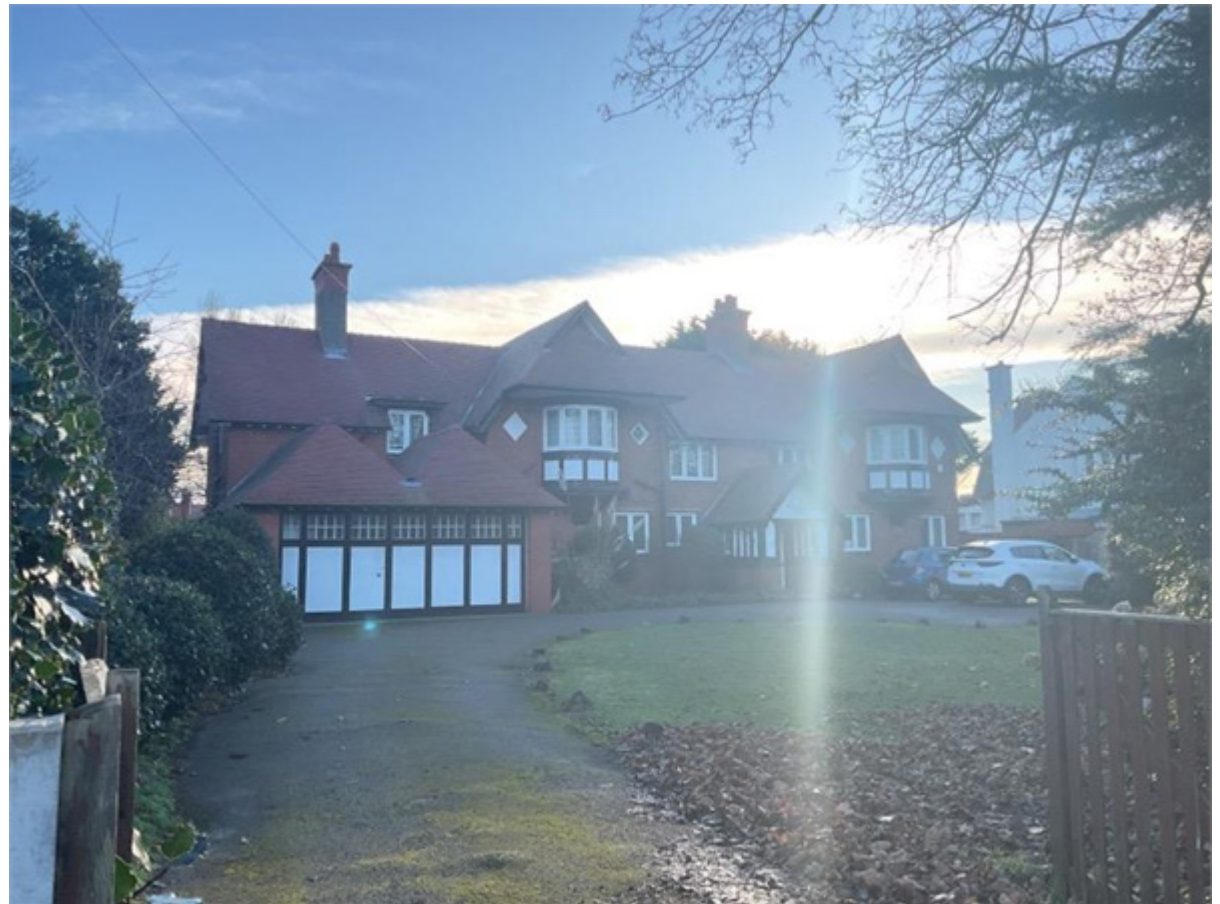
Front boundary wall replaced with close board fencing, itself in poor condition.

### Rear / Side Elevation Overlooks Key Space:

Golf Course, generally screened by trees with filtered views. Close board fencing.

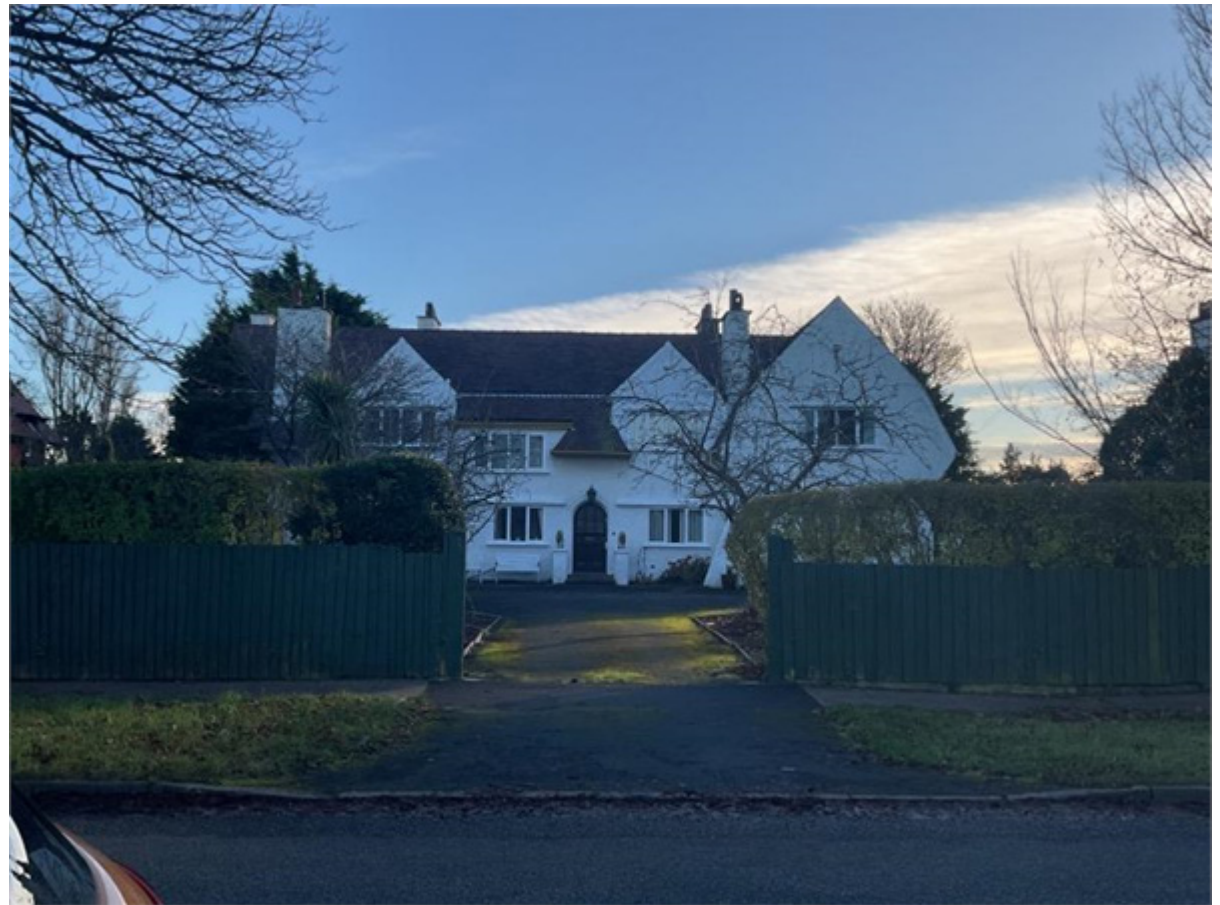
Front boundary wall replaced with close board fencing, itself in poor condition, and visually prominent hard standing. Flat roofed garages.

### Rear / Side Elevation Overlooks Key Space:

Golf Course, generally screened by trees.  
Close board fencing.

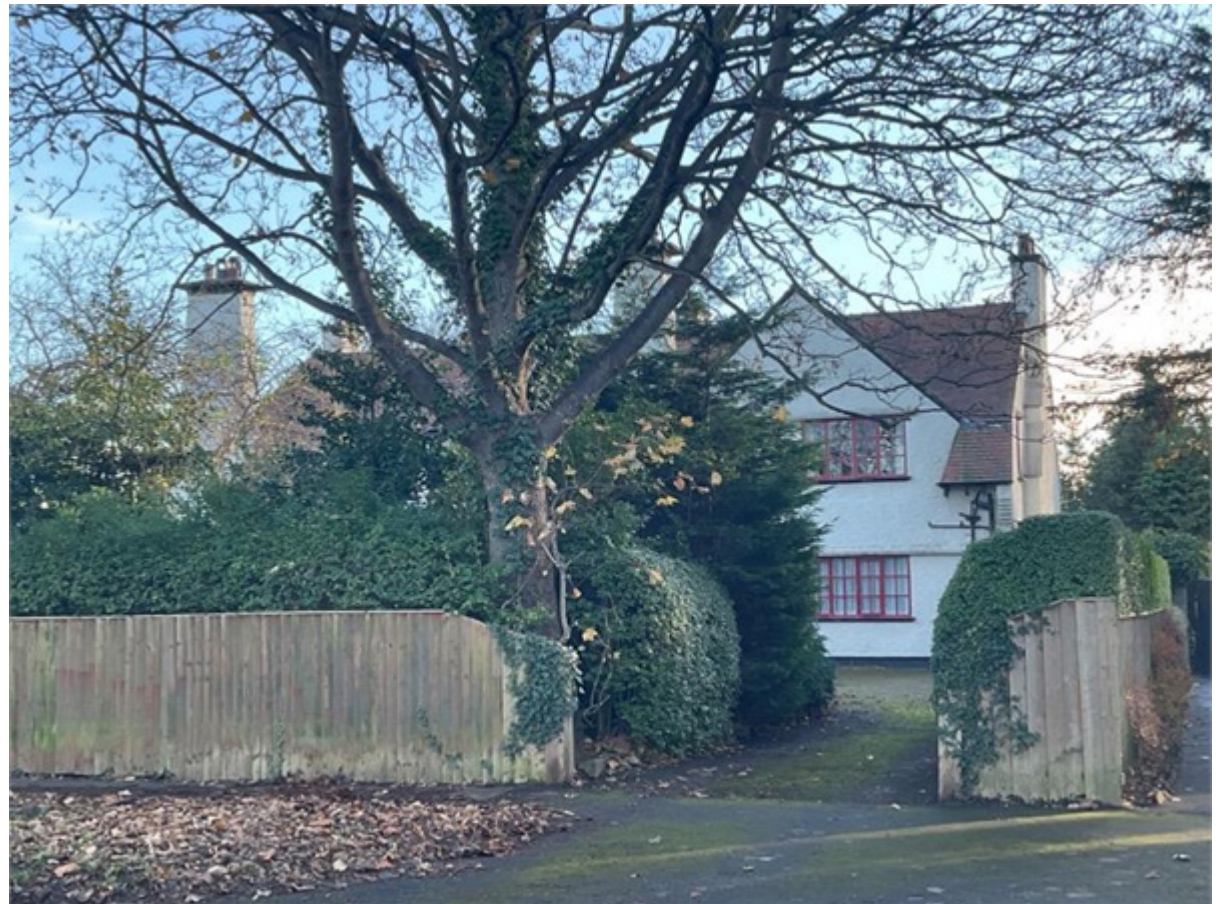
Hard standing to front. Flat-roofed garage. Close board fencing to front, in poor condition.

### Rear / Side Elevation Overlooks Key Space:

Golf Course, generally screened by trees.  
Close board fencing.

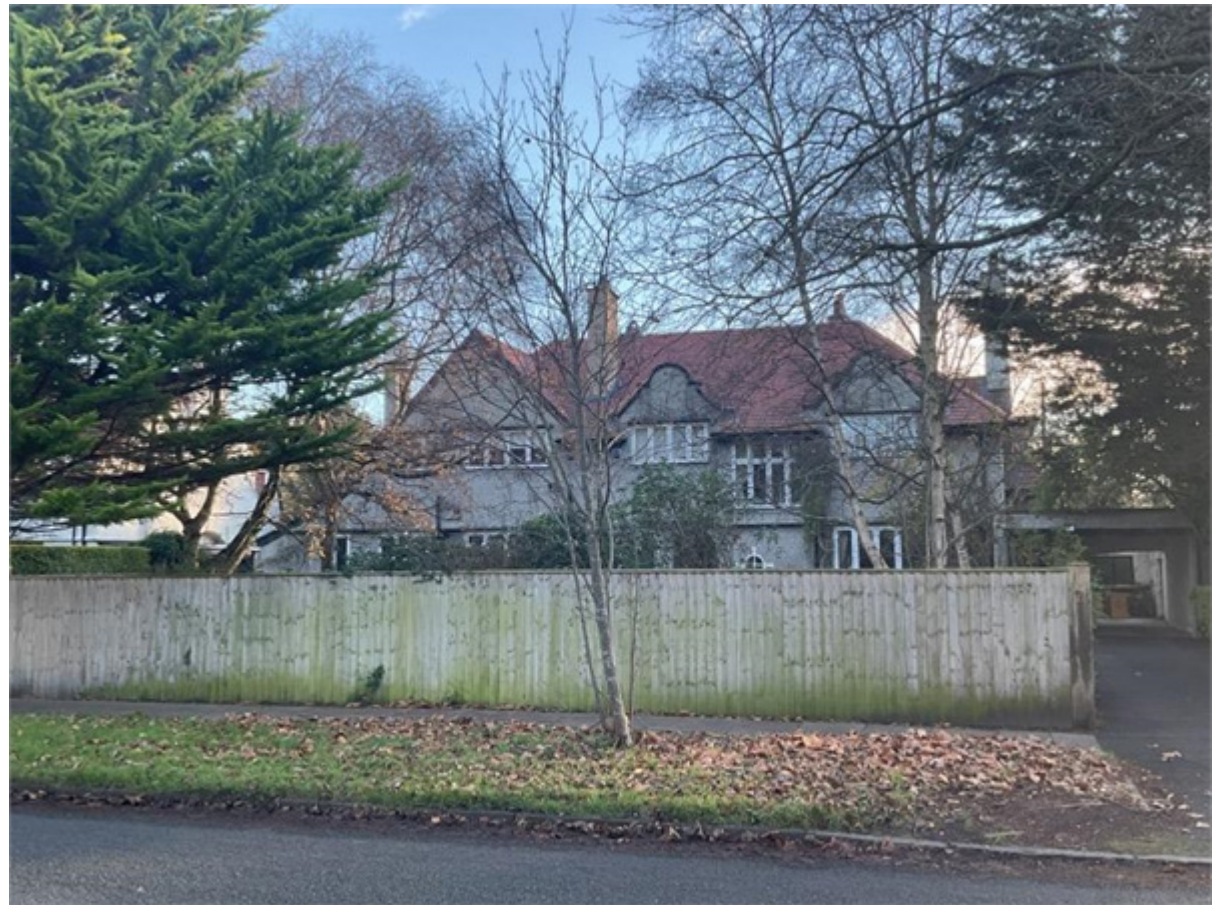
Replacement interlocking tiled roof. Close board fencing to front boundary, prominent drive and flat-roofed garage.

### Rear / Side Elevation Overlooks Key Space:

Golf Course, generally screened by trees.  
Close board fencing.

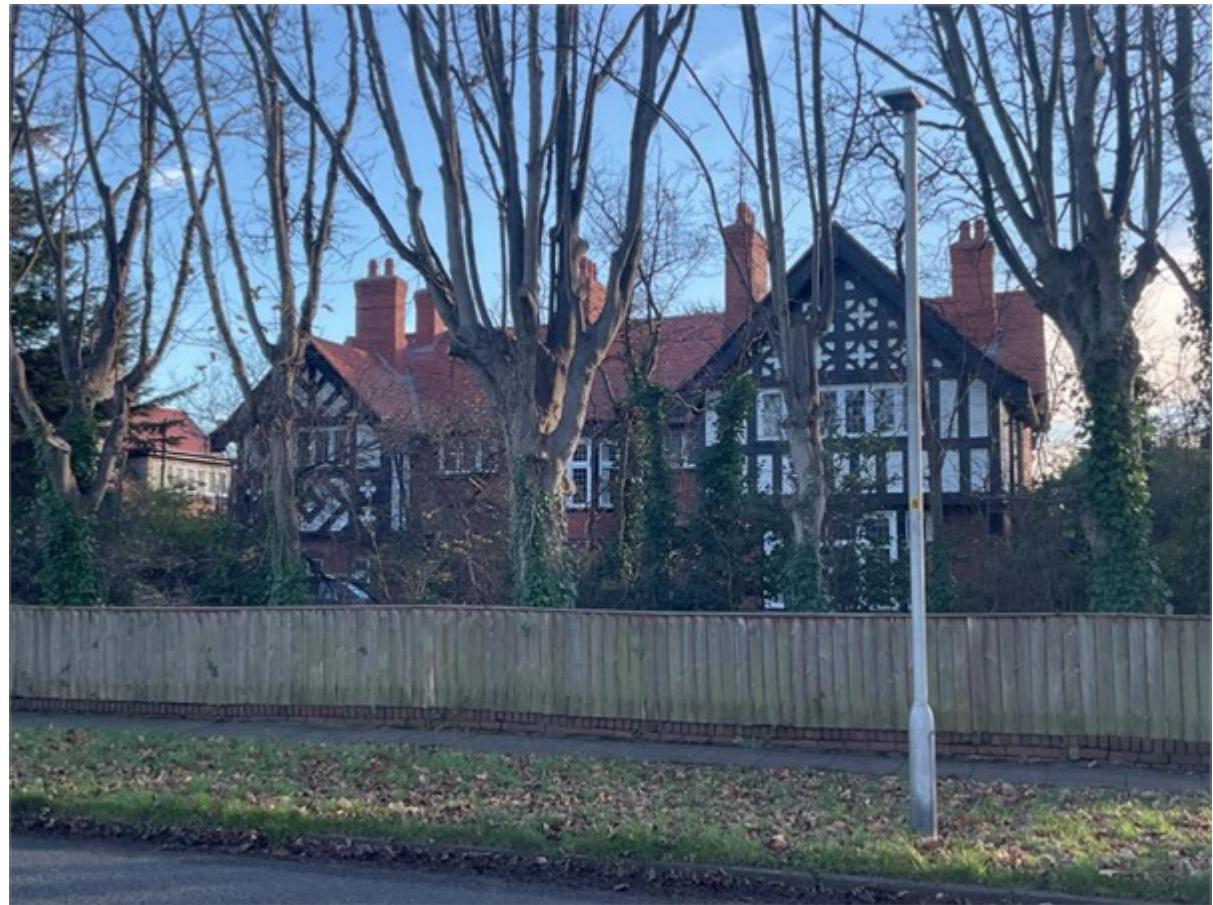
### Rear / Side Elevation Overlooks Key Space:

Golf Course, generally screened by trees.  
Close board fencing.

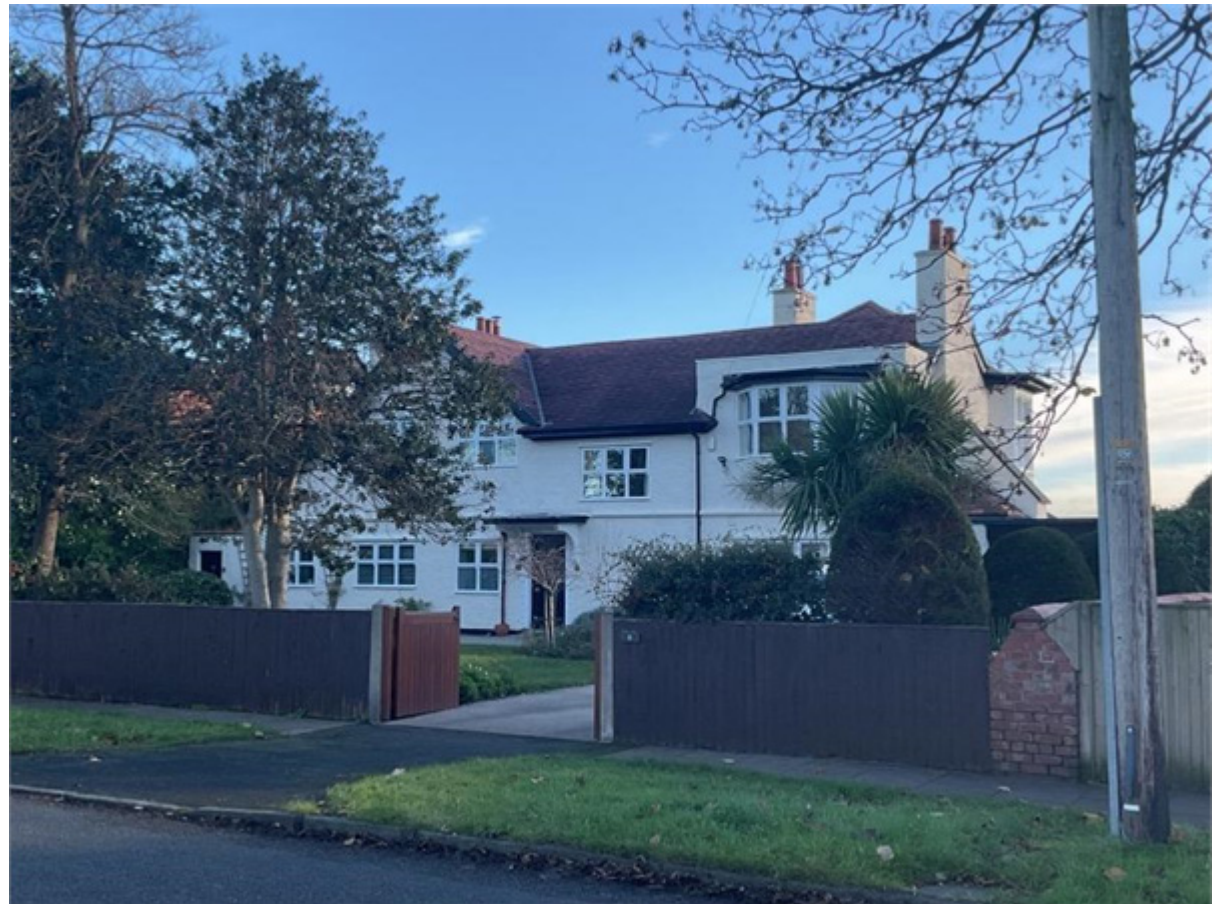
Replacement windows. Replacement interlocking tiled roof. Close board fencing to front boundary, some loss of landscaping for driveway. Flat-roofed extension to rear. Flat-roofed garage.

### Rear / Side Elevation Overlooks Key Space:

Golf Course, generally screened by trees.  
Close board fencing.

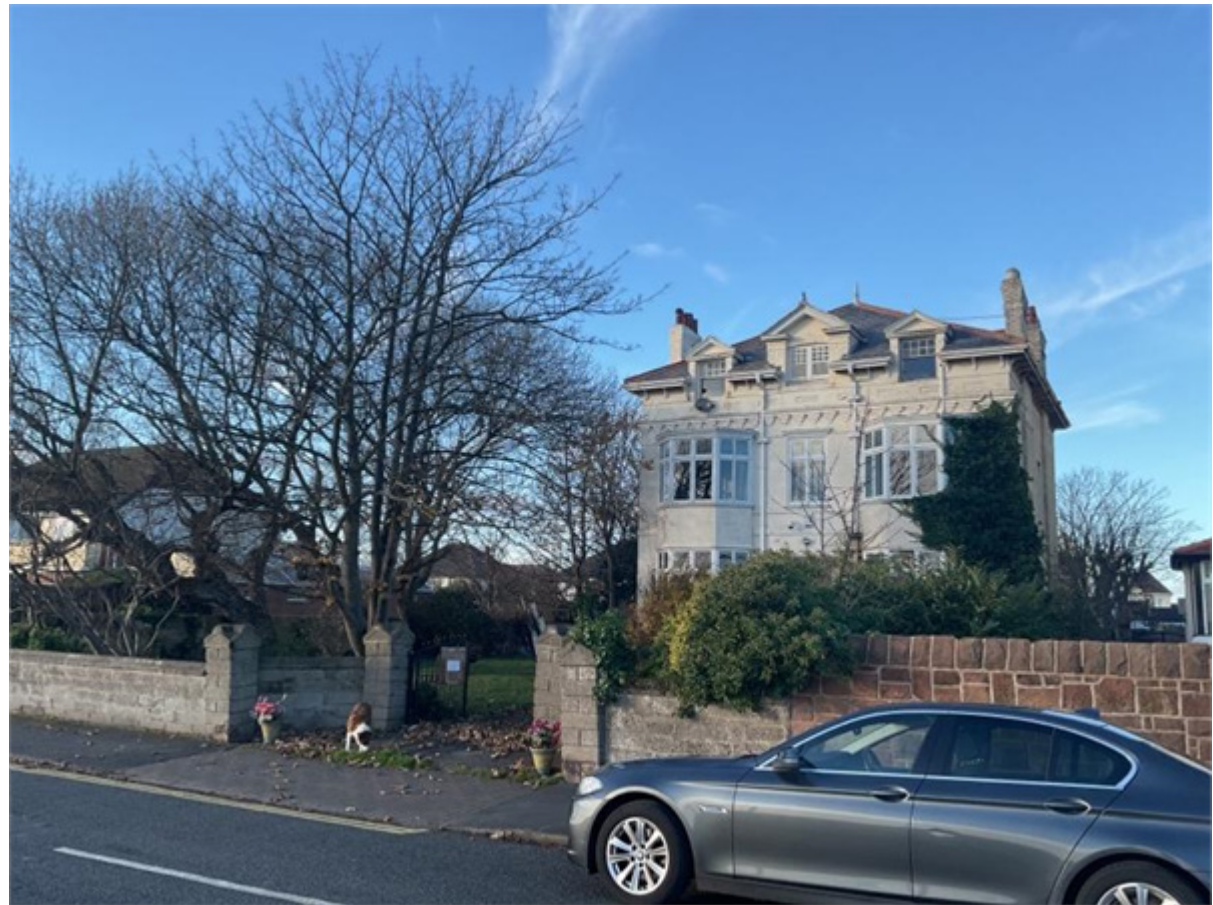
In poor condition overall, and items have been dumped in the front garden. Side boundary to rear has close board fencing. Outbuilding in poor condition.

### Rear / Side Elevation Overlooks Key Space:

Part of a group with Buildings 15 and 16, a prominent entry into the conservation area and overlooking the golf course. Side boundary prominent on Beach Road, with part stone effect concrete block wall leading to brick the rear on Barton Close. Rear elevation prominent on Barton Close.

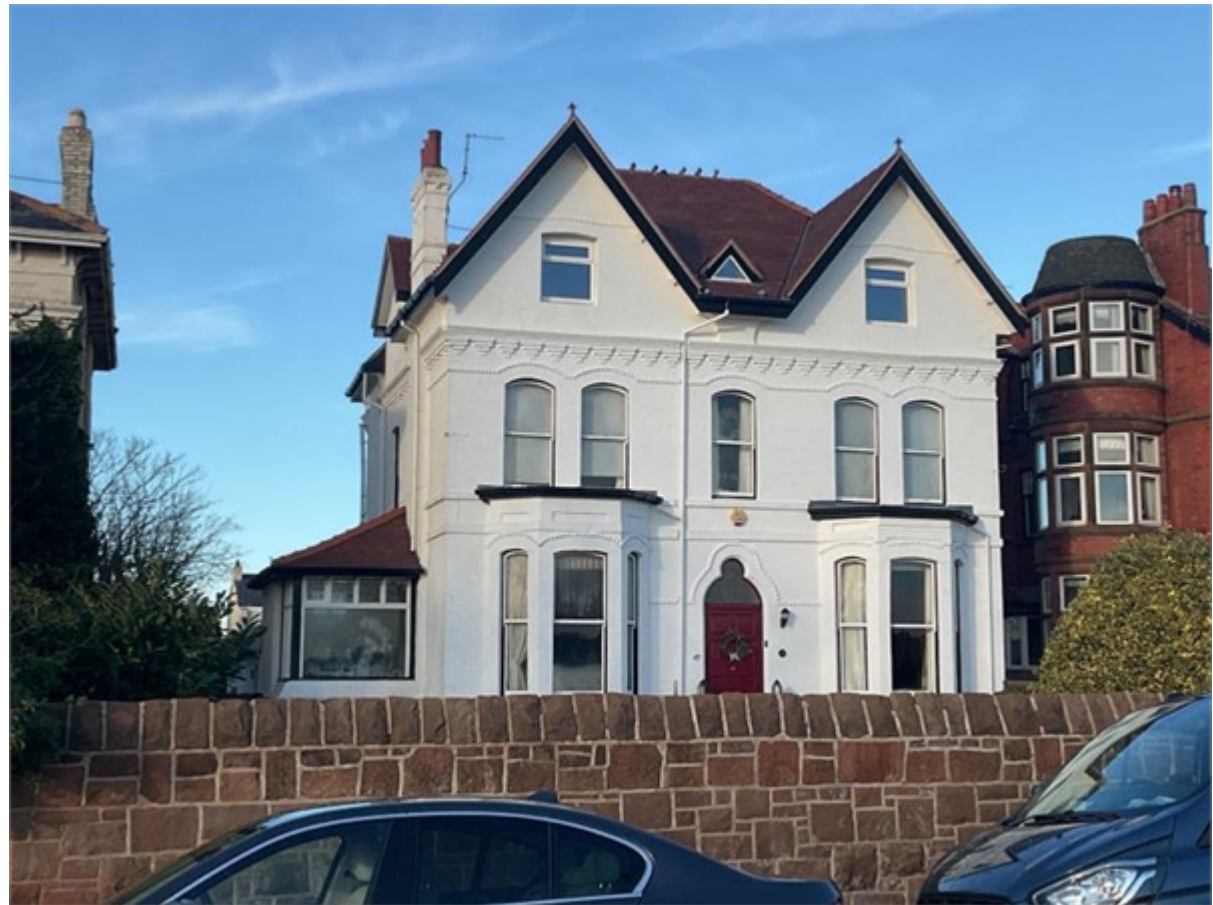
### Detrimental Elements:

Poor quality hardstanding to front drive. Some visual detritus such as satellite dish, and upper windows are uPVC. Flat-roofed extension to rear visible, particularly to Barton Close. Close board fencing behind stone boundary wall to rear, and modern gates.

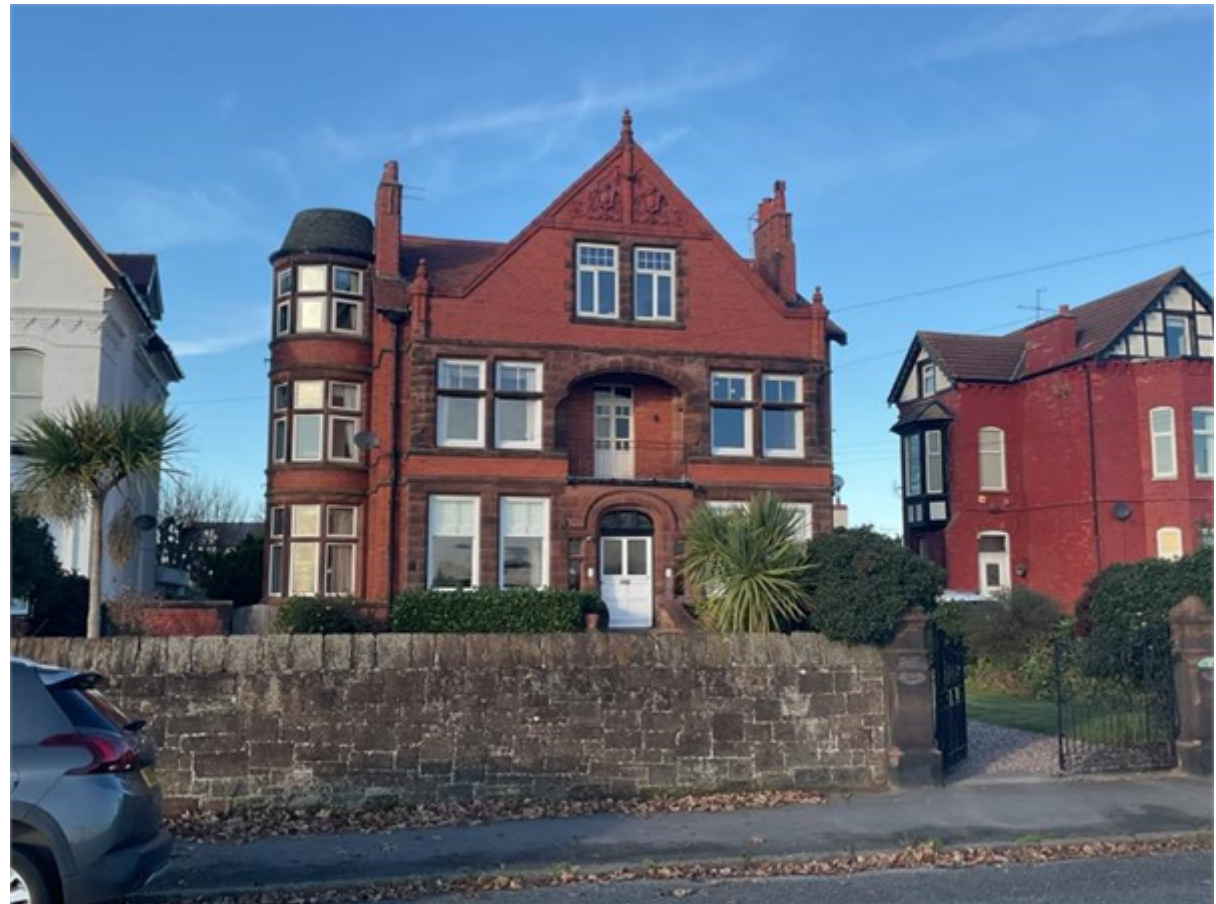
Some visual detritus to frontage such as satellite dishes and some windows appear replaced with uPVC. To the rear on Barton Road, a poor modern detached garage block.

### Rear / Side Elevation Overlooks Key Space:

Rear visible from Barton Road. Part of group with Buildings 14 and 15, forming a prominent entry into the conservation area and overlooking the golf course.

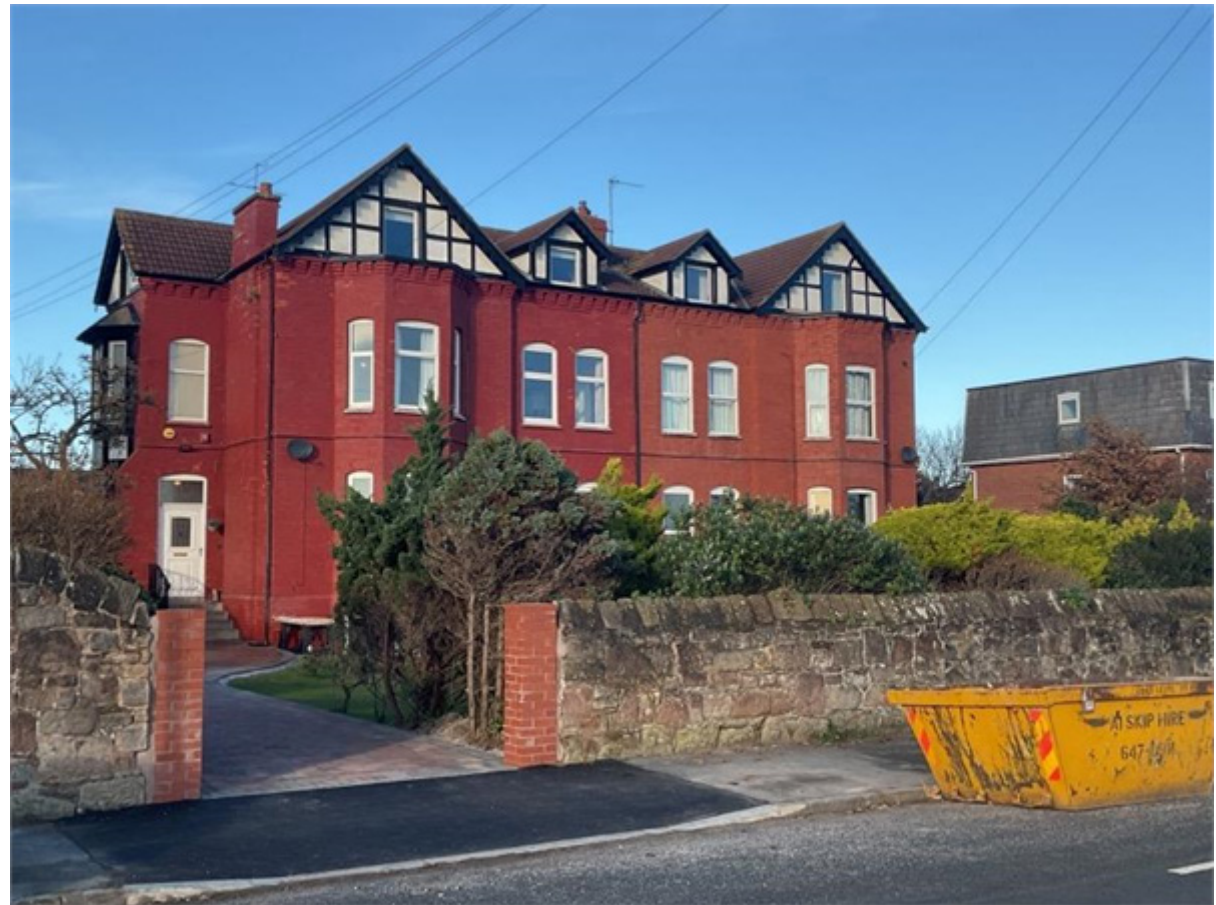
R/h has been painted and roof tiles replaced with profiled concrete. UPVC windows. Crude brick gate piers.

### Rear / Side Elevation Overlooks Key Space:

Rear prominent from Barton Close, where gable detailing varies, and modern extensions are more visible.

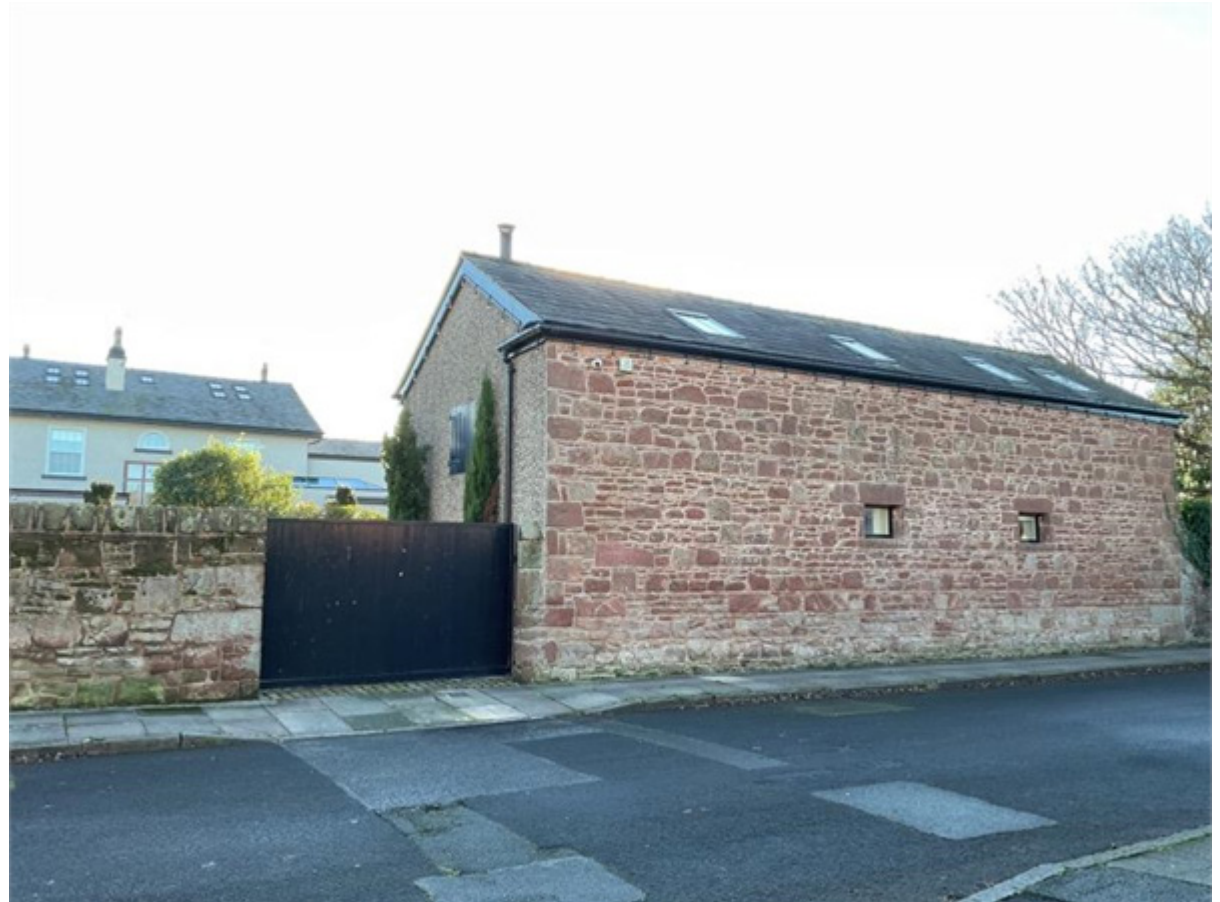
### Detrimental Elements:

Side elevation is rendered. A separate detached garage has been constructed but is reasonably well detailed and uses good materials.

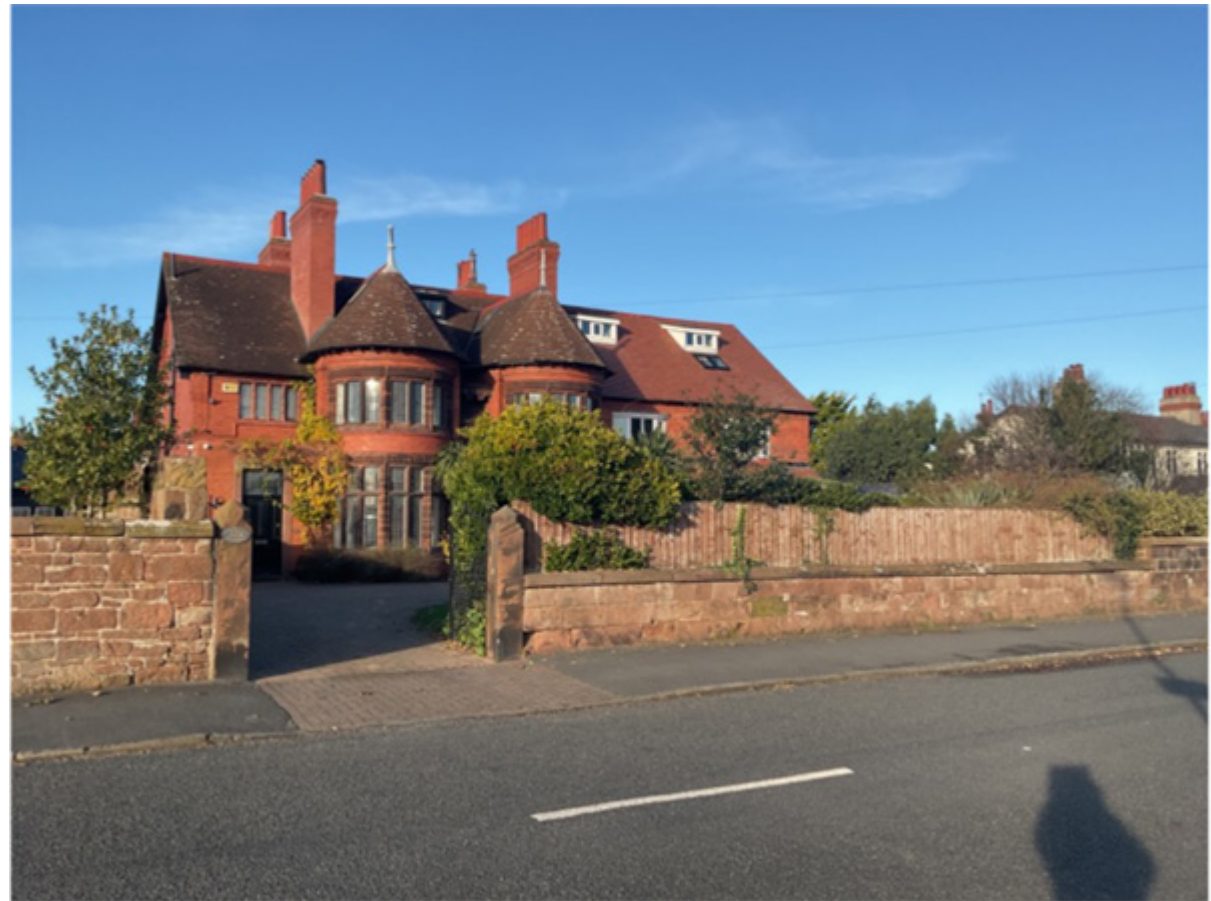
### Detrimental Elements:

Close board fencing added atop stone boundary wall to l/h.

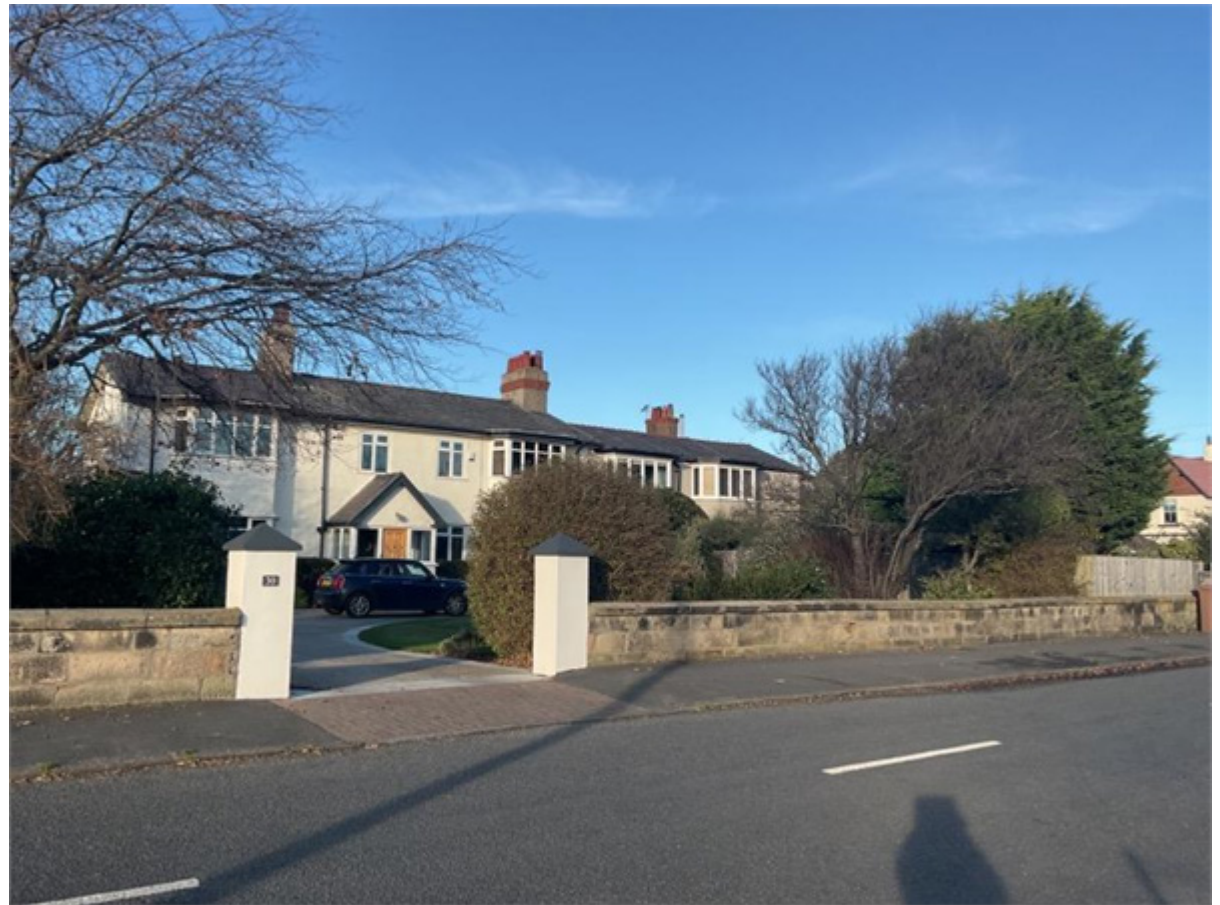
### Detrimental Elements:

UPVC windows to l/h. Close boarded fencing atop wall to r/h.

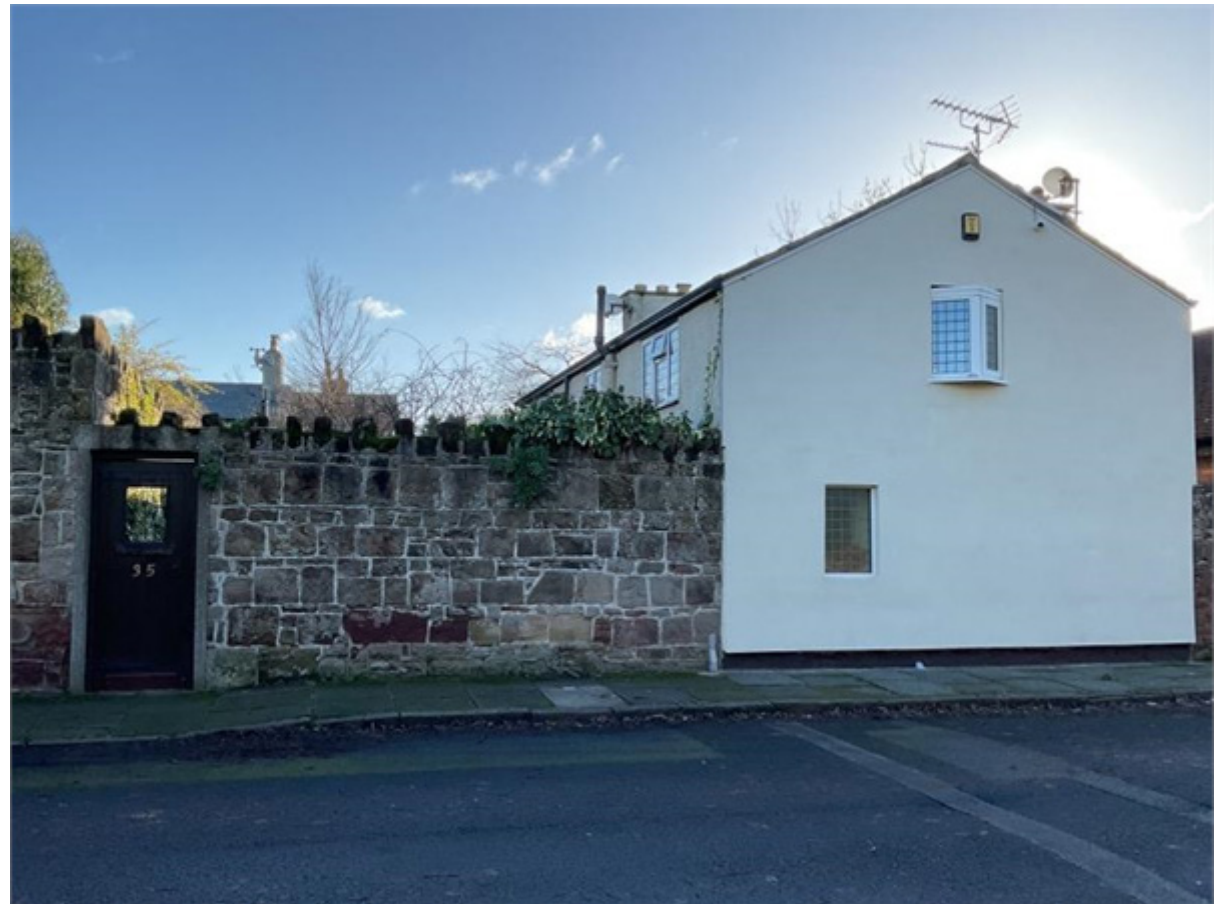
### Detrimental Elements:

UPVC windows. Prominent satellite dishes.
