**Donald Insall Associates**  
Chartered Architects and Historic Building Consultants

The King's Gap Gazetteer

## Introduction

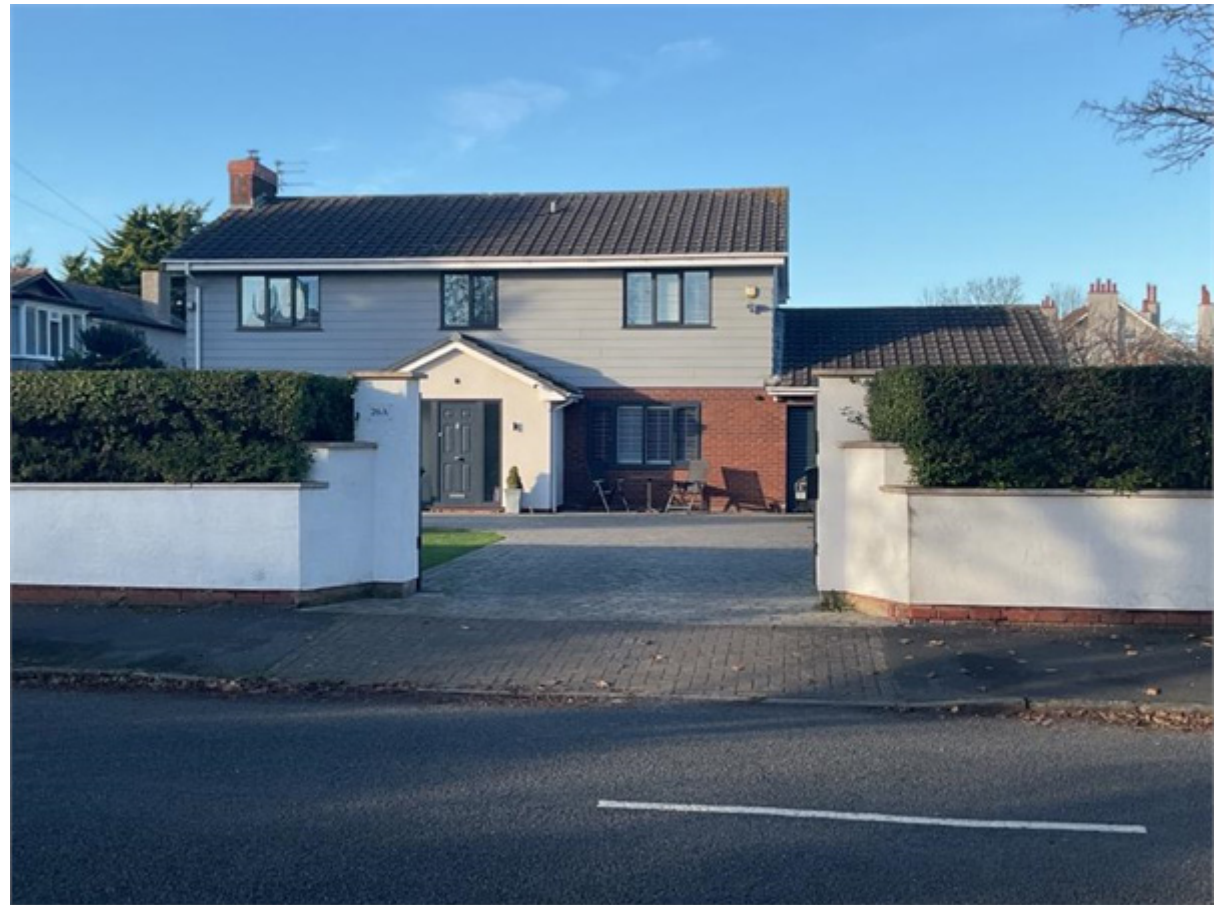
### Detrimental Elements:

Modern and utilitarian form and materials. Plot has been split in two, at rear. Extensive hard standing.

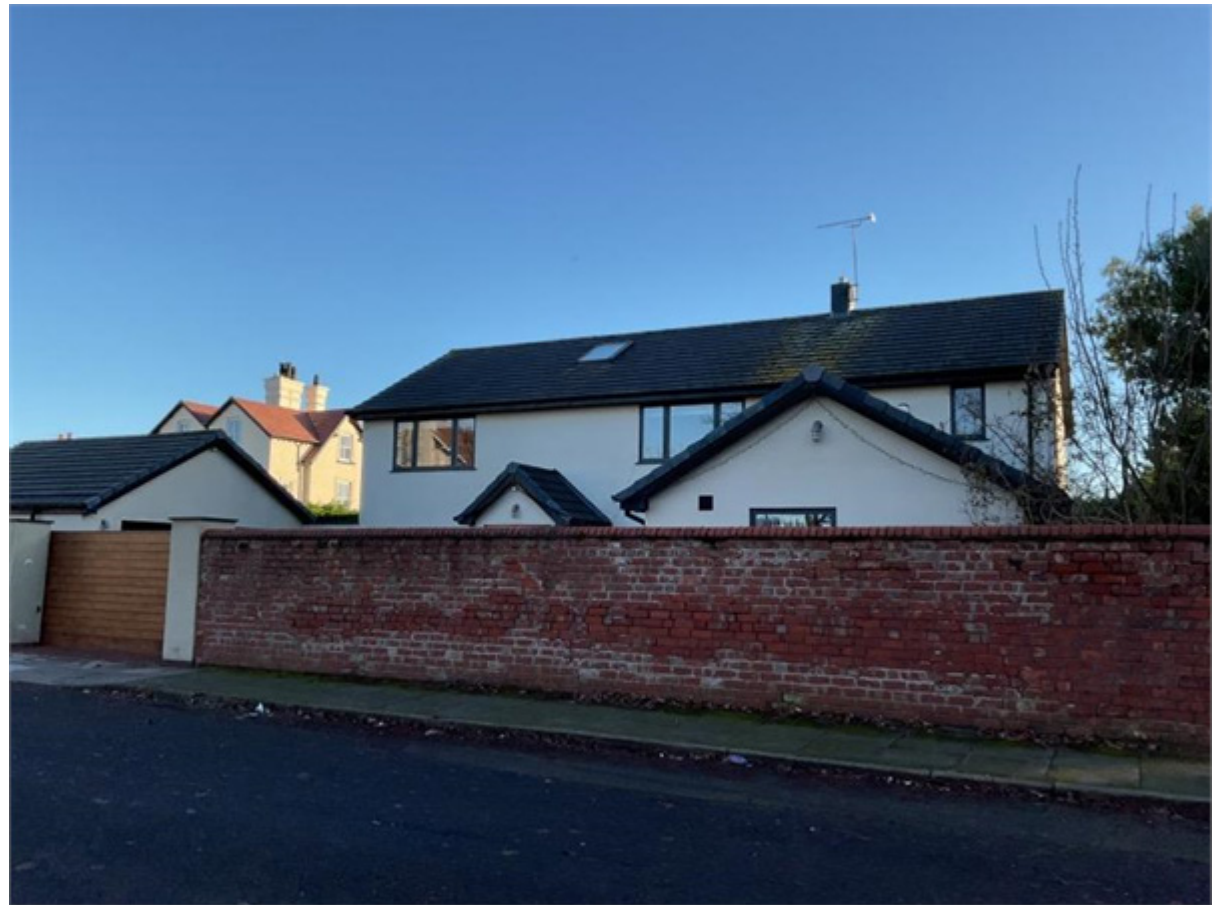
### Detrimental Elements:

Modern and utilitarian form. Extensions occupy the width of the plot, which has also been separated to the front (Building 22).

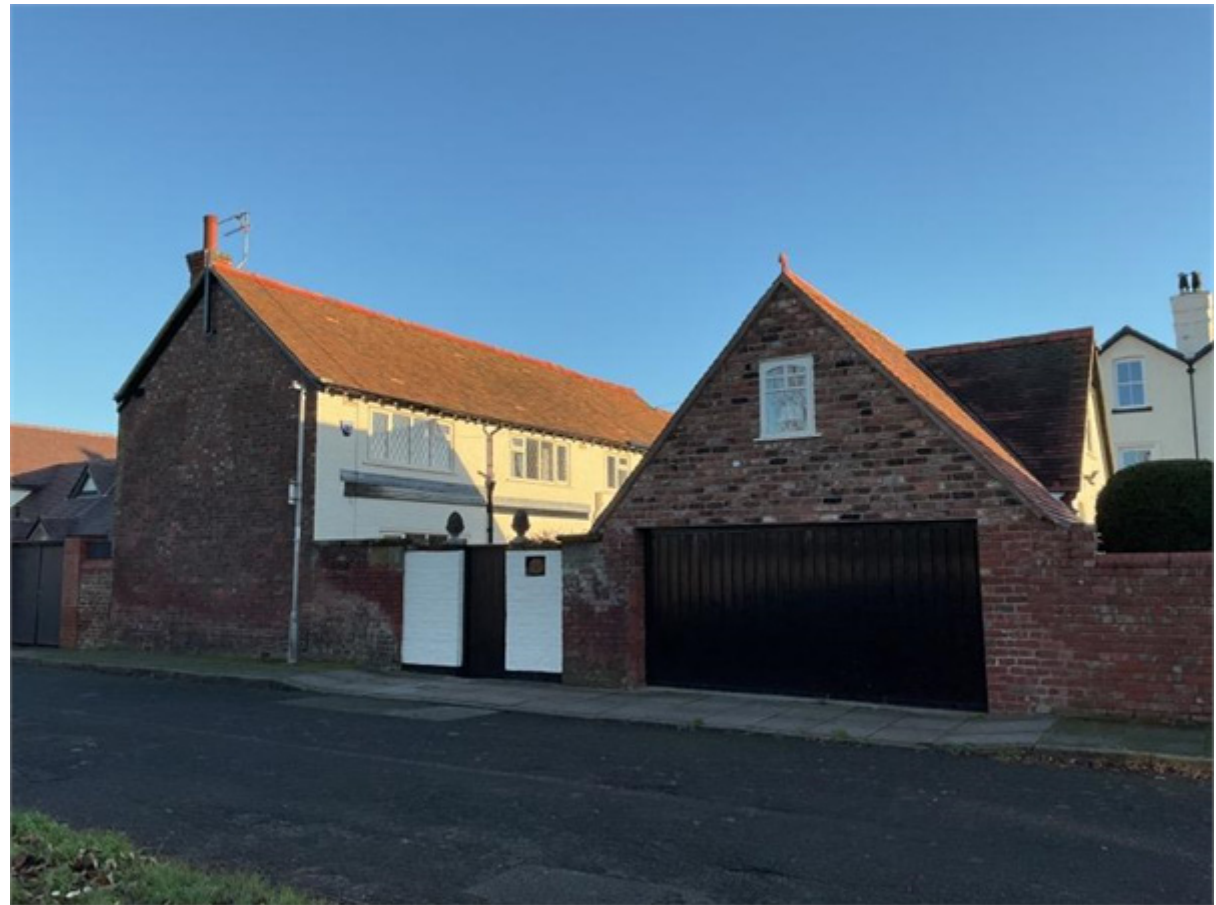
### Detrimental Elements:

Conversion has added cosmetic elements including extensive windows and chimneys. Large conservatory extension.

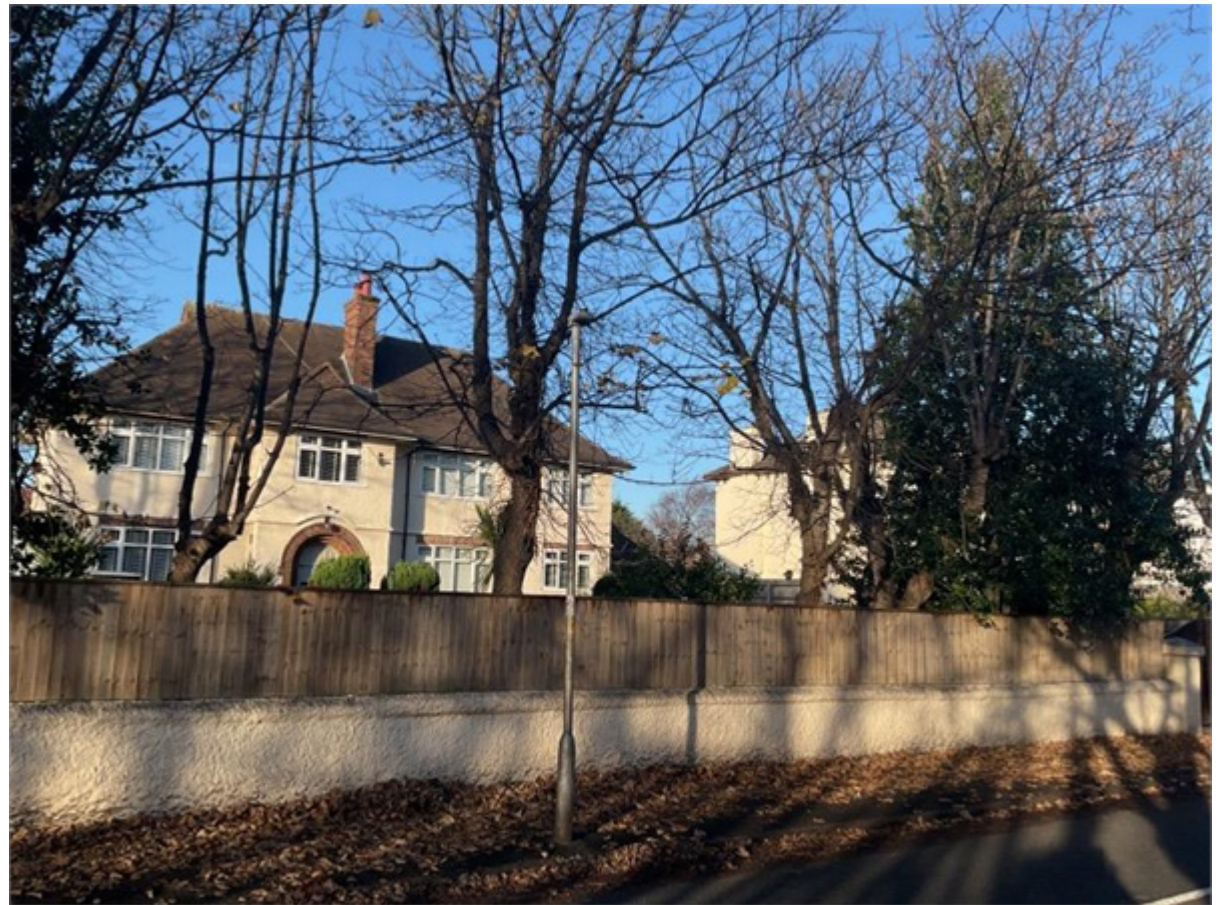
### Detrimental Elements:

UPVC windows, close board fence on wall.

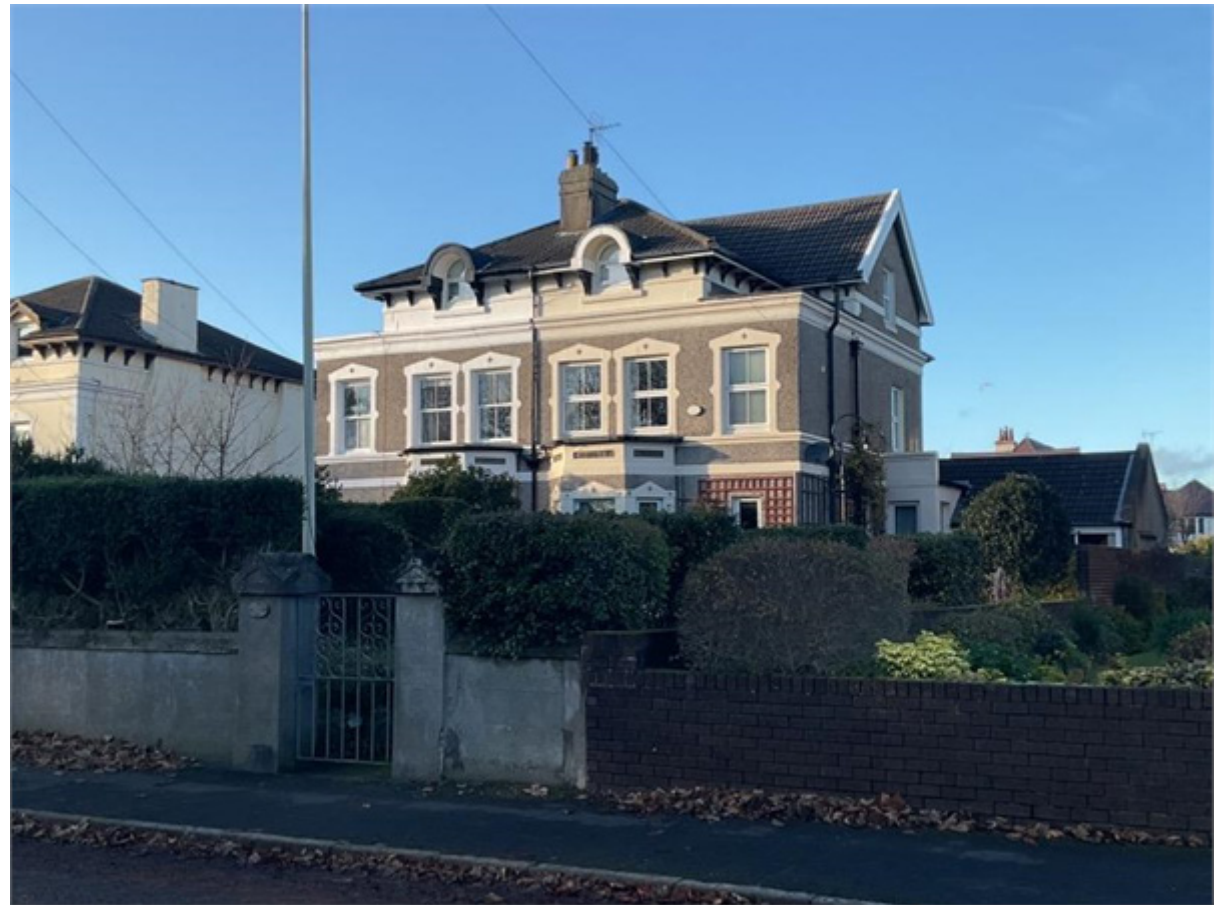
### Detrimental Elements:

Key detailing lost including roof tiles (concrete) and windows (uPVC). Boundary wall has been cement rendered.

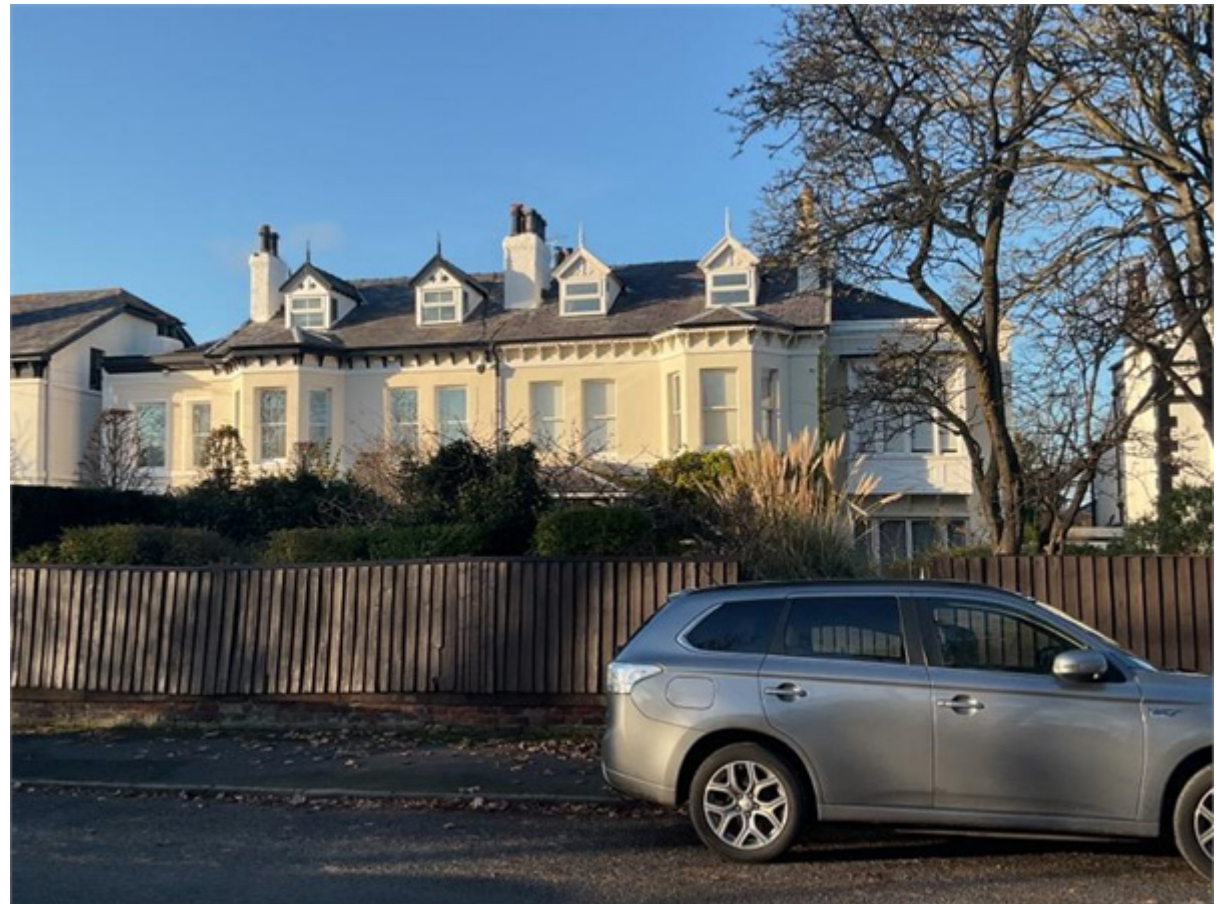
### Detrimental Elements:

R/h has added fence to wall.

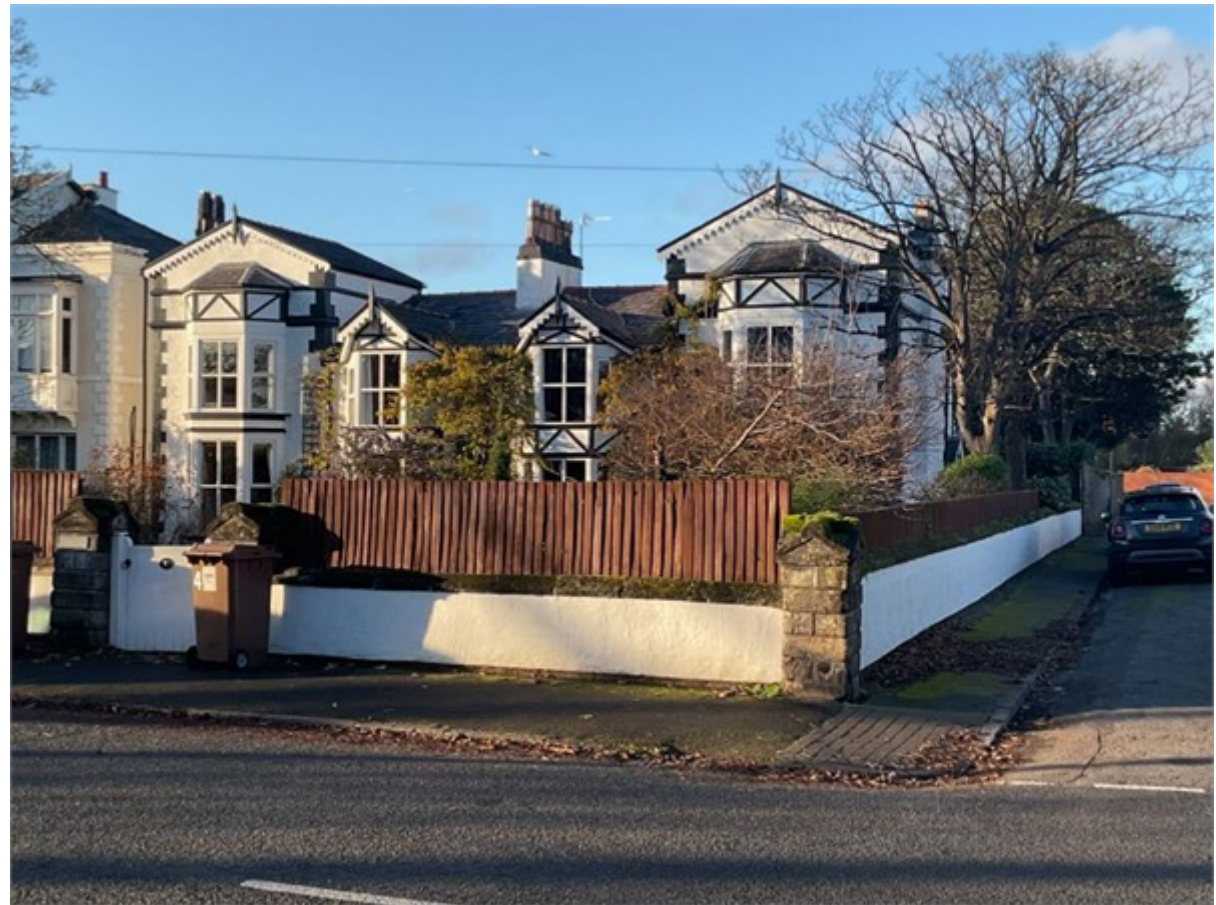
### Detrimental Elements:

Fence added atop low boundary wall.

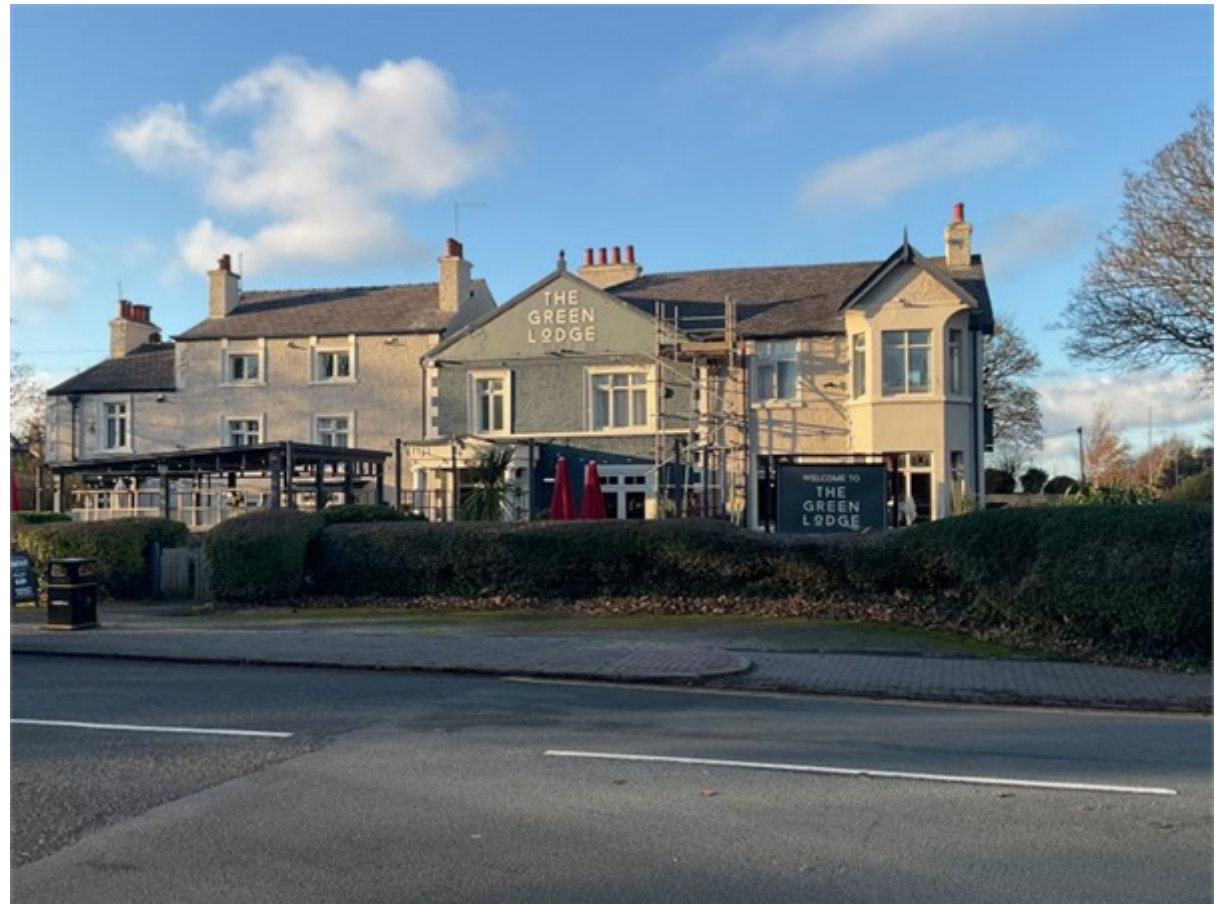
### Detrimental Elements:

Large flat-roofed extension to rear. A lot of hardstanding for car parking to the rear (prominent from the street). Covered seating structure to frontage.

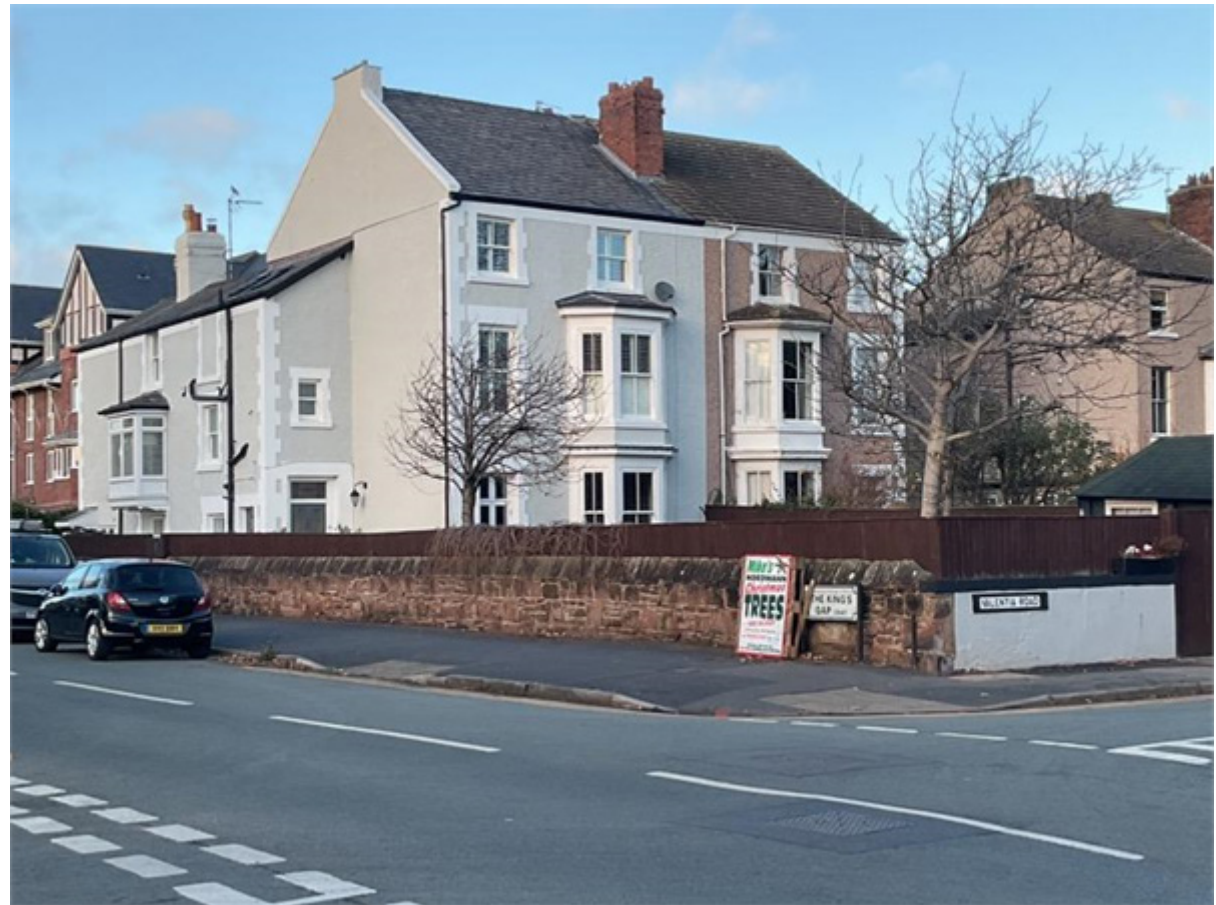
### Detrimental Elements:

Some details lost including roof tiles (concrete to l/h) and capped off chimneys. Difference in render colour and texture. Parts of boundary wall rendered, fence added. Detached sheds to front. Hard landscaping.

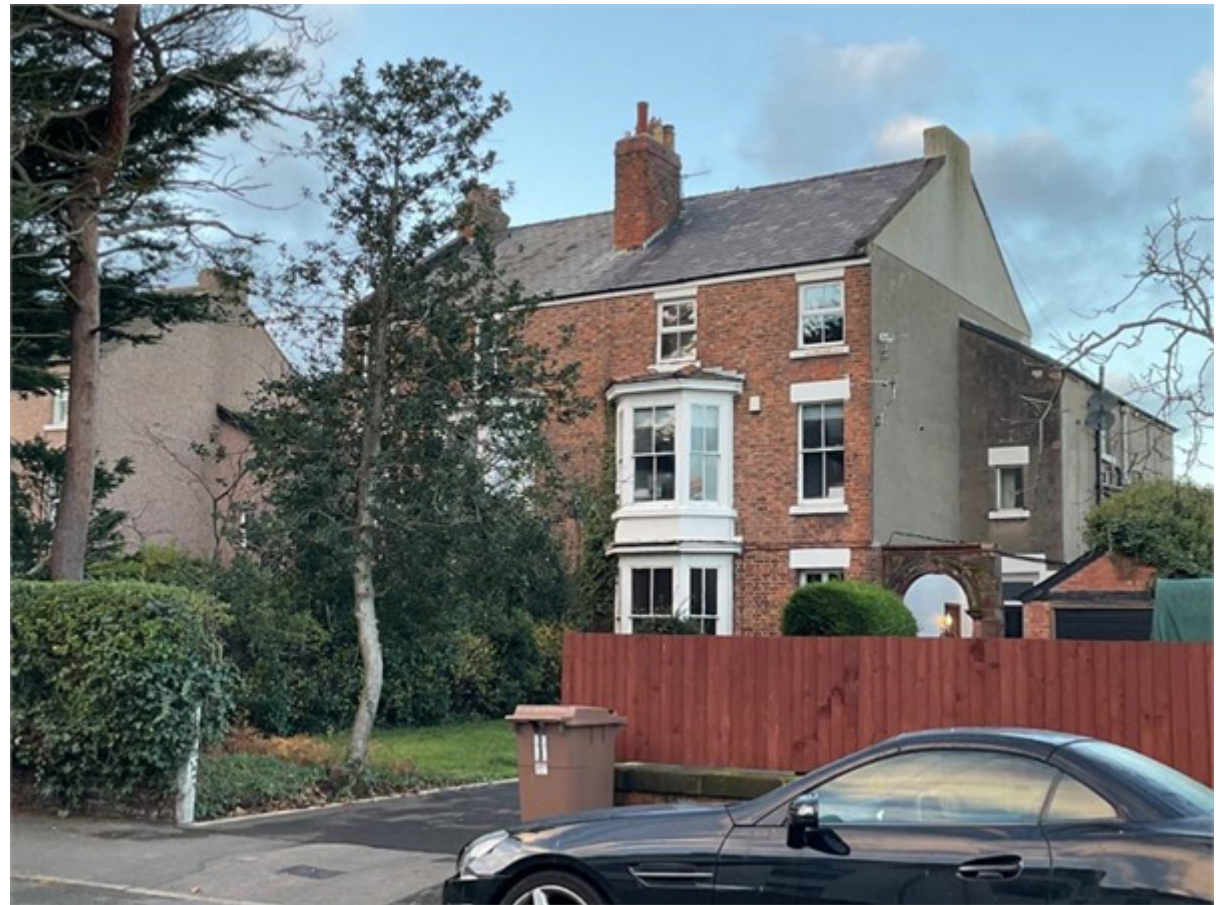
### Detrimental Elements:

Side elevation rendered to r/h. Large amounts of hard landscaping to front, and fence added atop wall.

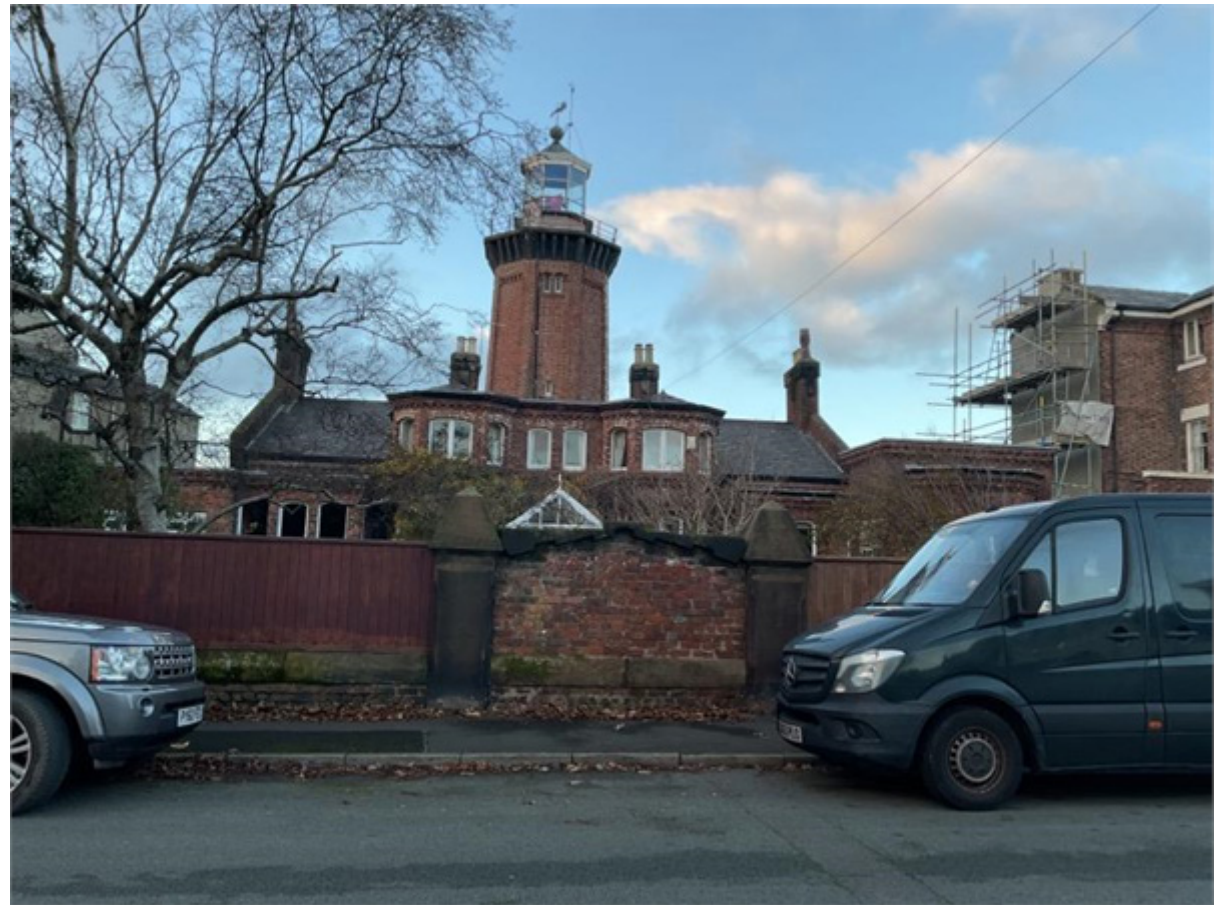
### Detrimental Elements:

Fence added atop boundary wall. Brick infill between the stone gate piers.

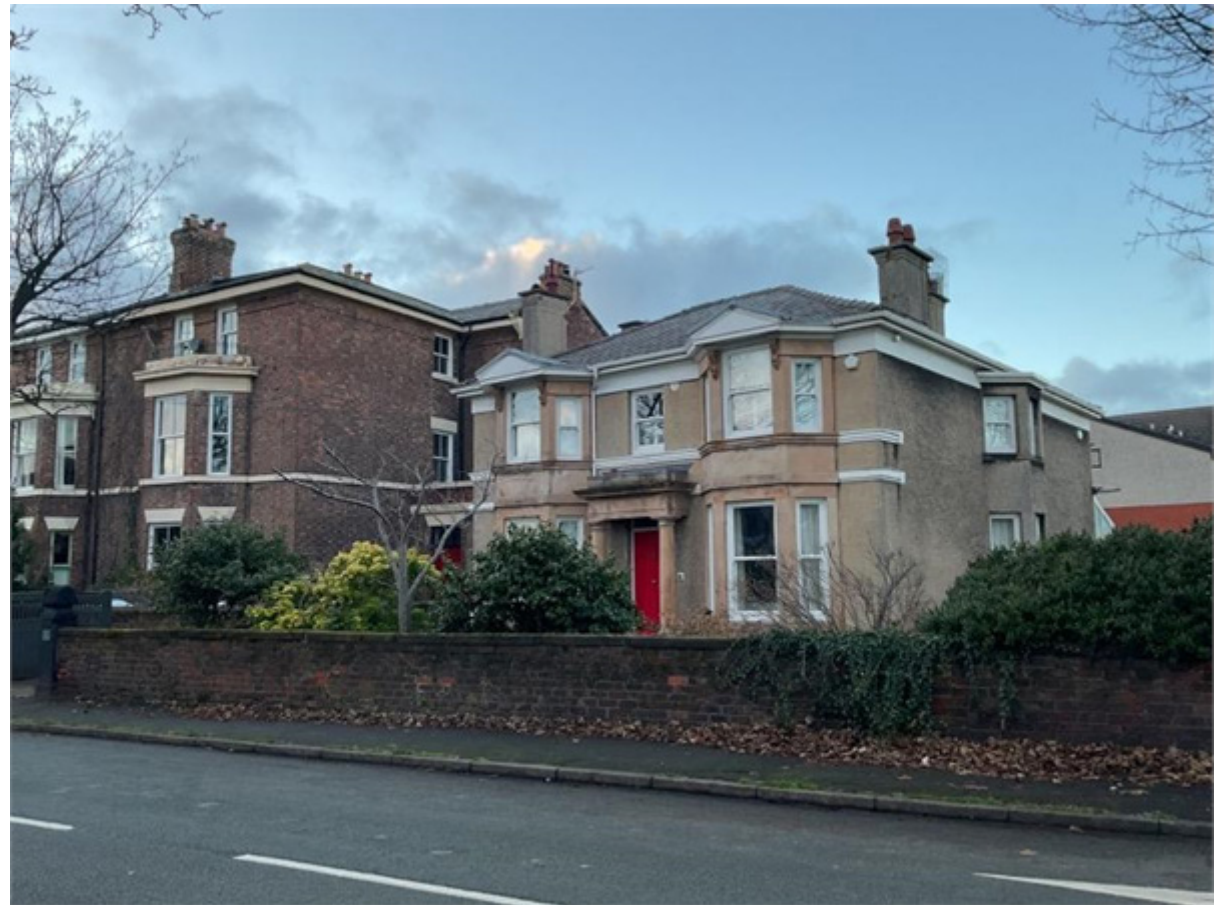
### Detrimental Elements:

Replacement sash windows are chunkier than historic examples. Render, later, in poor condition. Adjoining garage.

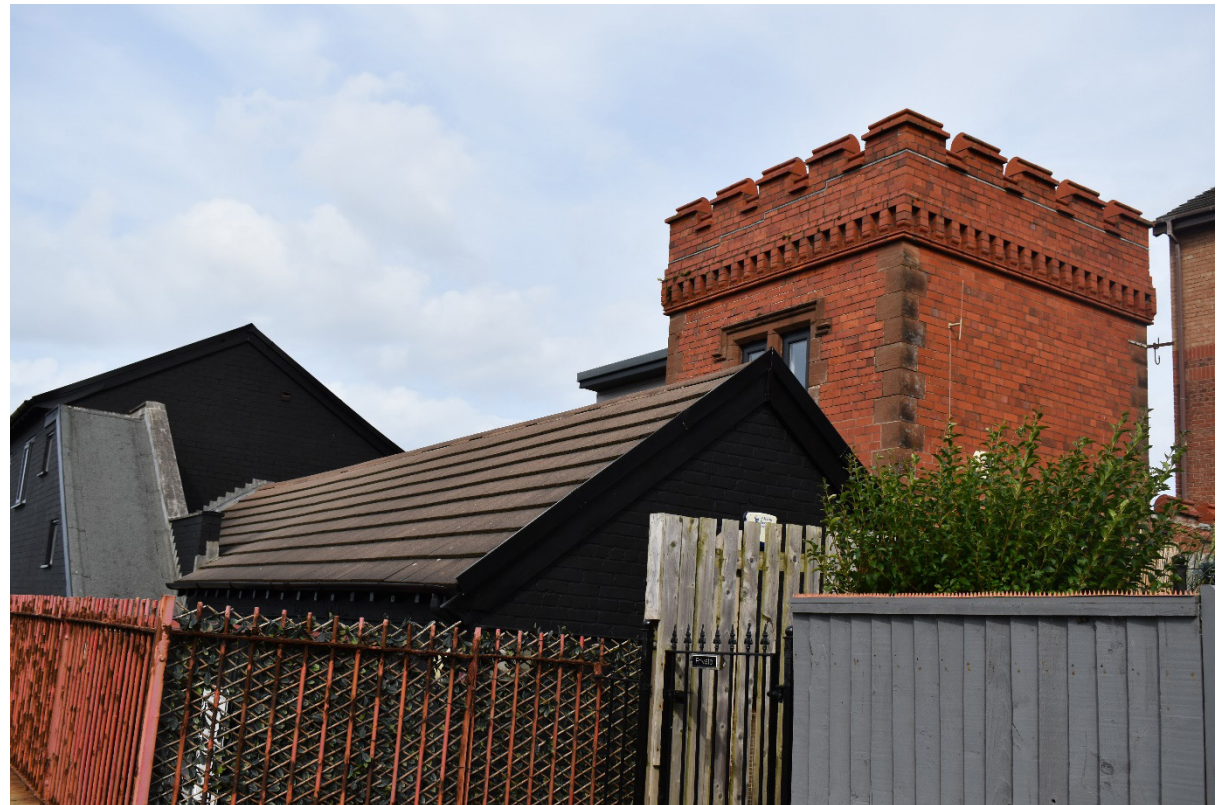
## The Old Lifeboat Station Hoylake, 15 North Parade

Altered, including loss of original crenelated roof to frontage. Large modern extension, but conversion has muted the poor brickwork.

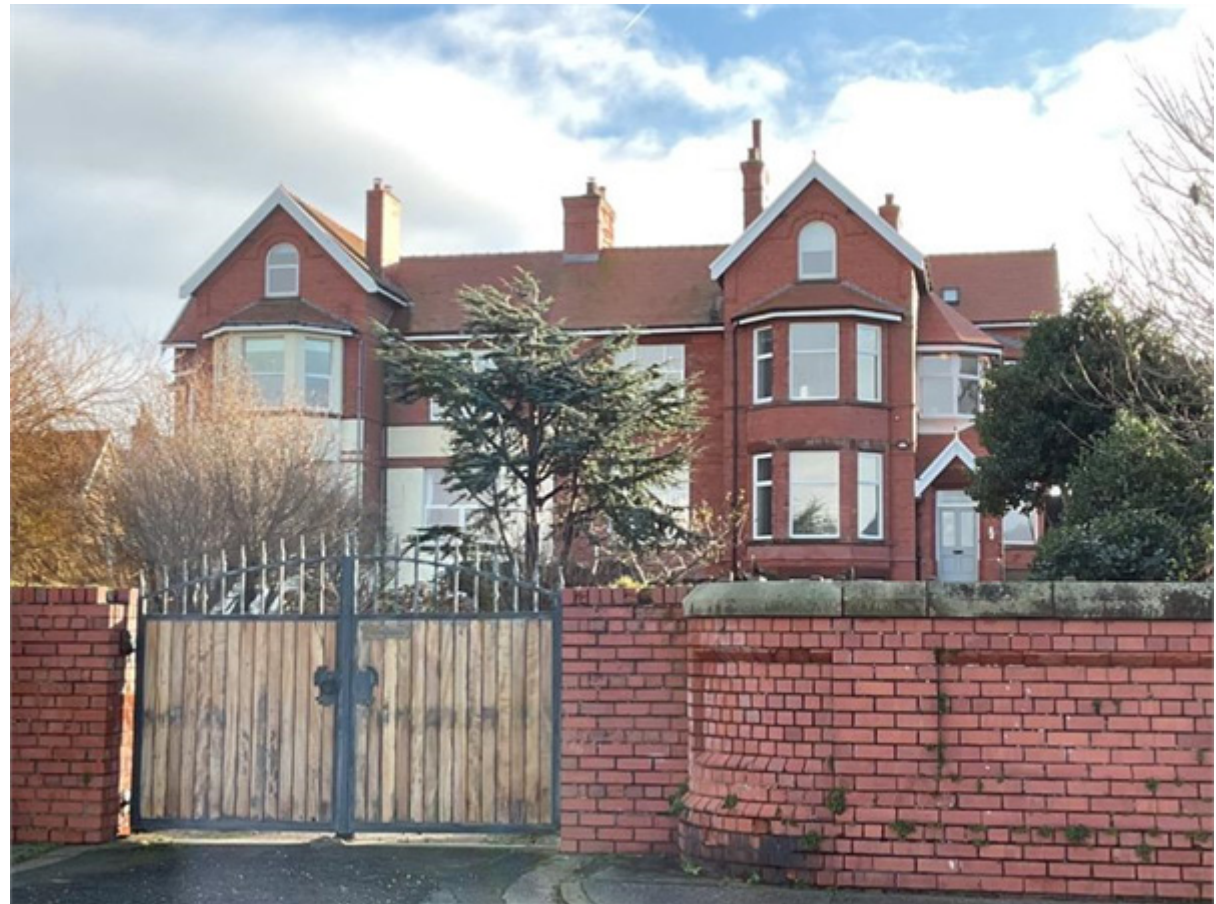
### Detrimental Elements:

Converted to apartments. Symmetry impacted by façade painting, loss of windows (uPVC) and ad hoc extensions. R/h has poor area of fenced hard-standing, prominent to road. Large and monolithic car parking block to rear (on Marine Road).

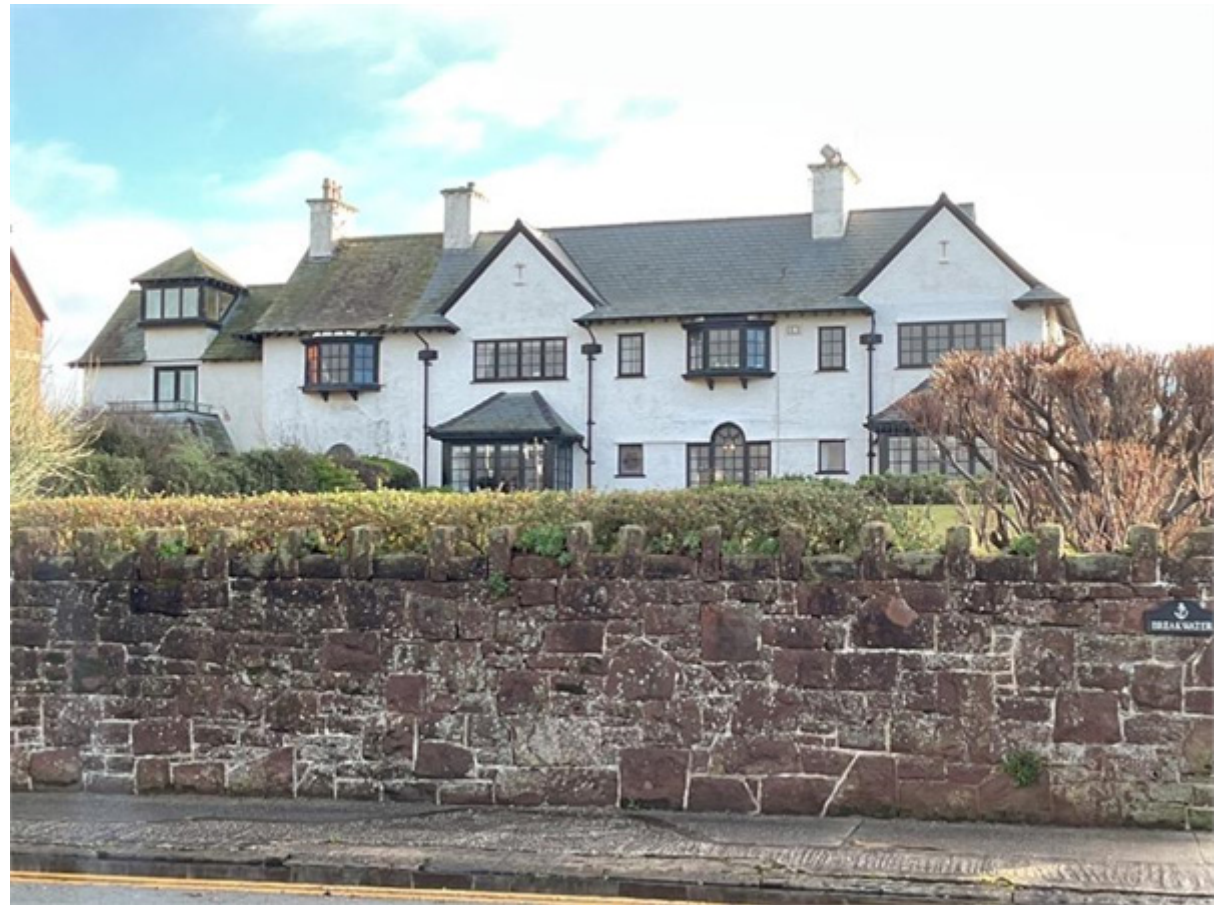
## Building ID: 42a

Wide frontage of painted render under slate roof, late example of Arts and Crafts style. Small panel casement windows throughout. Front-facing gables with hipped roof bay windows at ground floor. Central projecting bay at first floor above, Serliana (Venetian) window to ground, similar arrangement to I/h too. Lower block with observation style dormer at I/h. Slate roof with chimney stacks. Some slates retained. Low stone boundary wall and front garden retained. Rear on Marine Road has interesting stone wall, turreted castle-style gate piers and Art Nouveau timber gates.

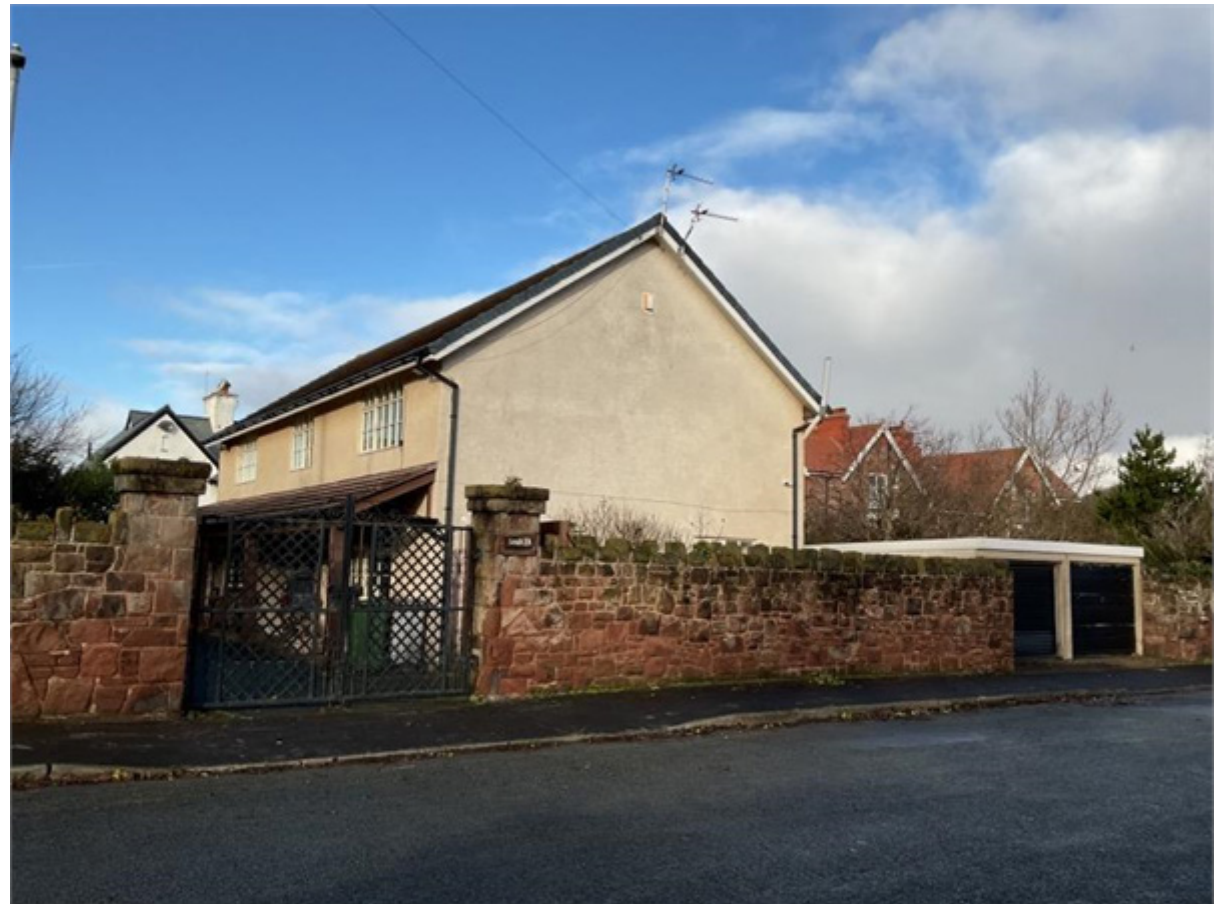
## Building ID: 43

Blank gable end to road. Materials generally later, e.g. uPVC windows. Double garage.

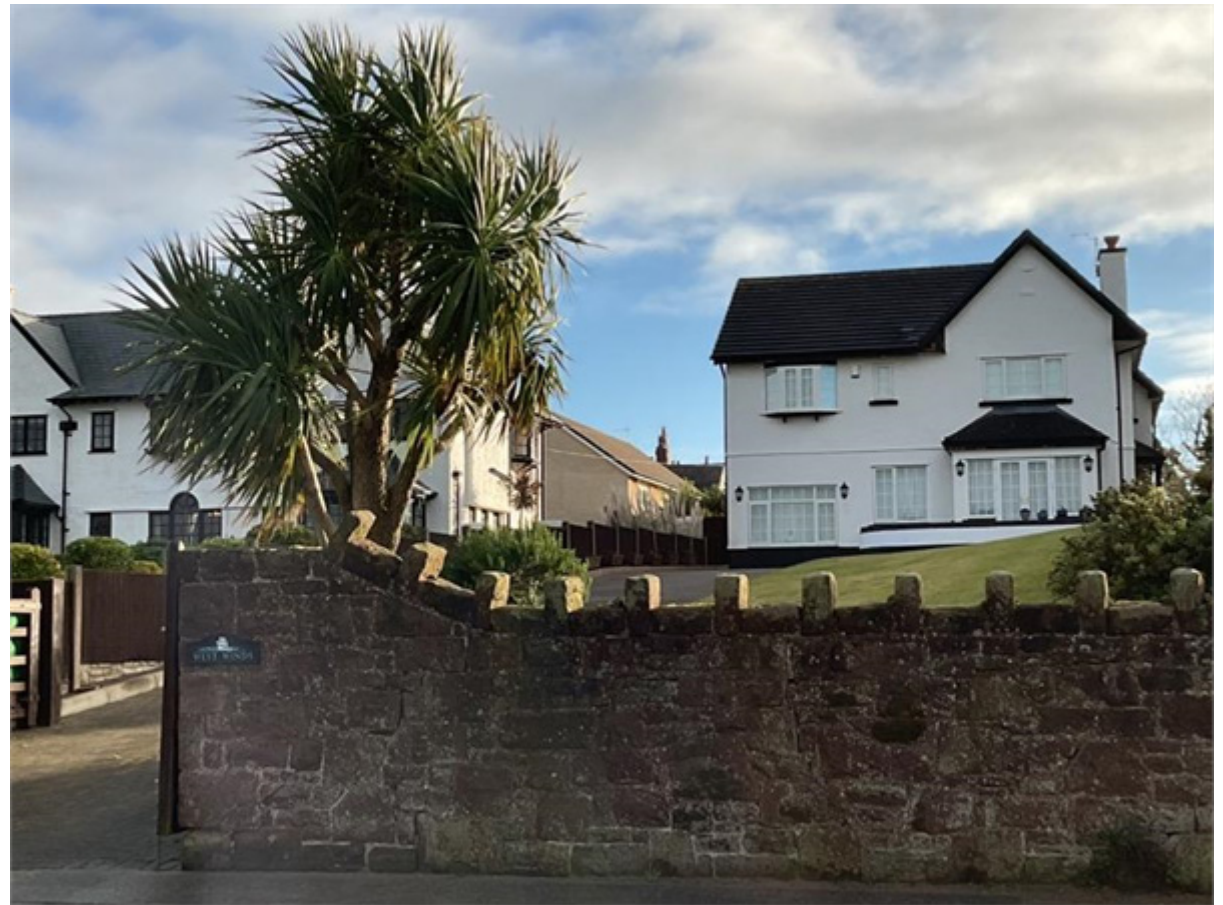
## Building ID: 43a

Later infill within plot of adjacent house (Building 42)

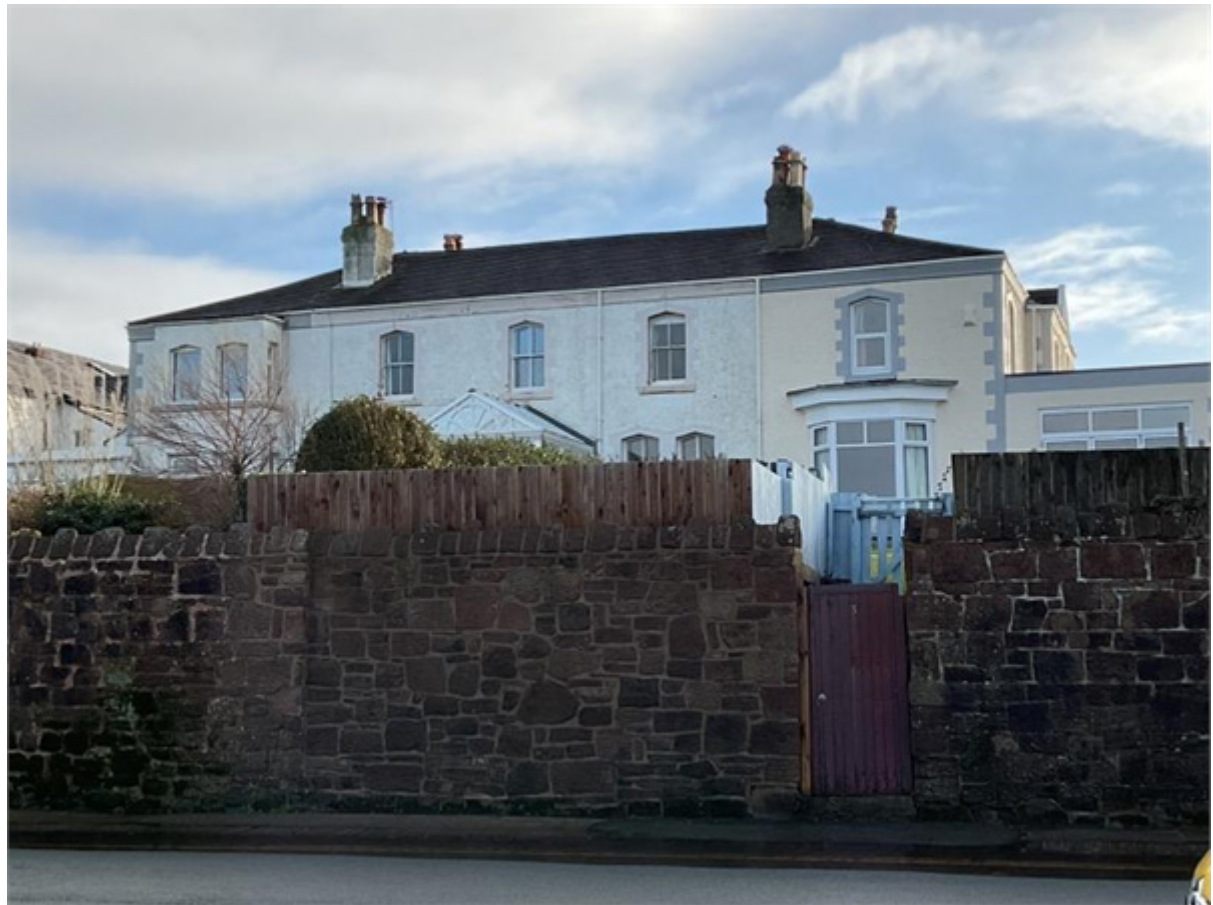
## Building ID: 48

Replacement windows. Some materials lost, including roof tiles (concrete replacements). Side extensions and conservatory-style front porch. Fencing added to stone boundary wall to r/h. Garages to Marine Road.

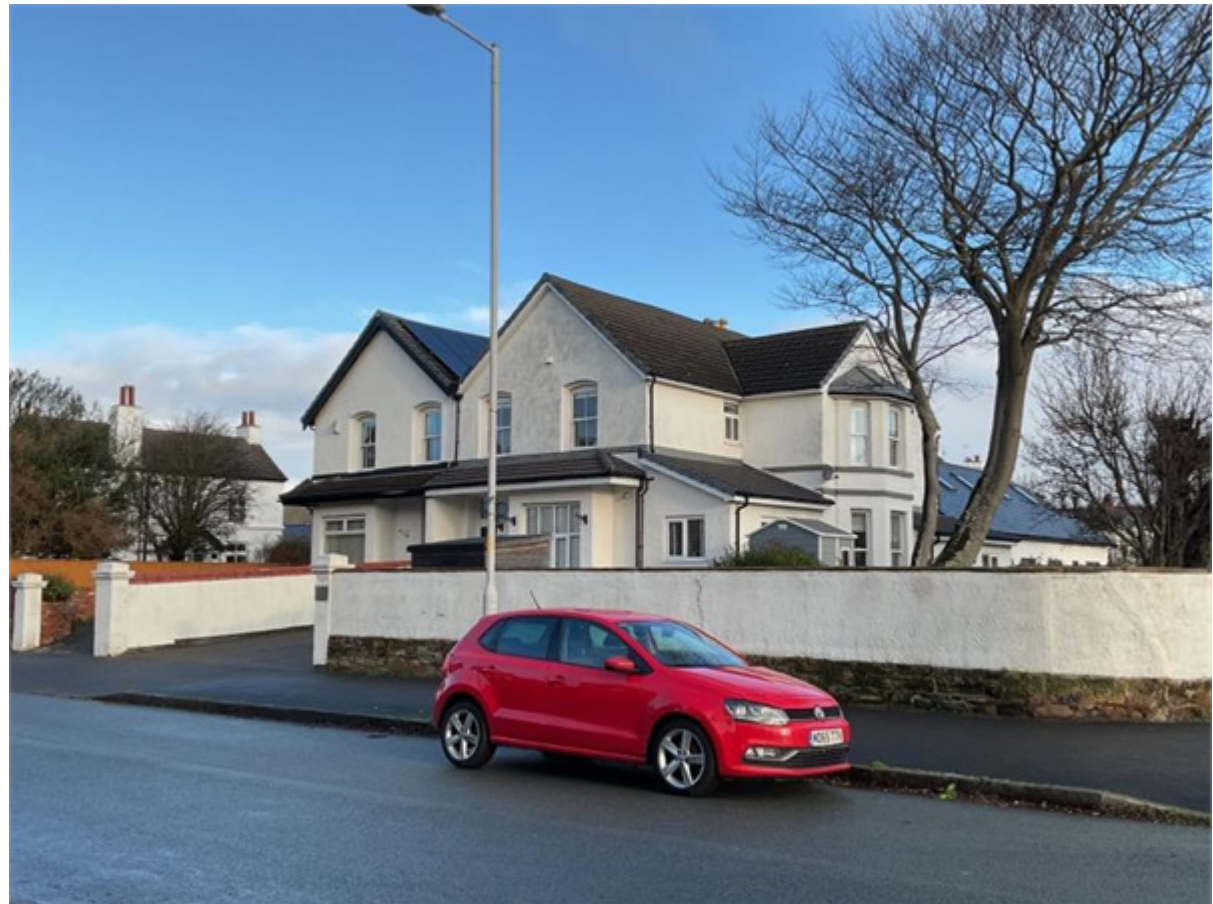
## Building ID: 52

Roof tiles replaced and other detailing such as bargeboards replaced (uPVC). Very large extension to the rear (visible on Warren Road), likely separated into separate dwellings. Front gardens lost, hardstanding for driveways and removal of boundary wall to r/h.

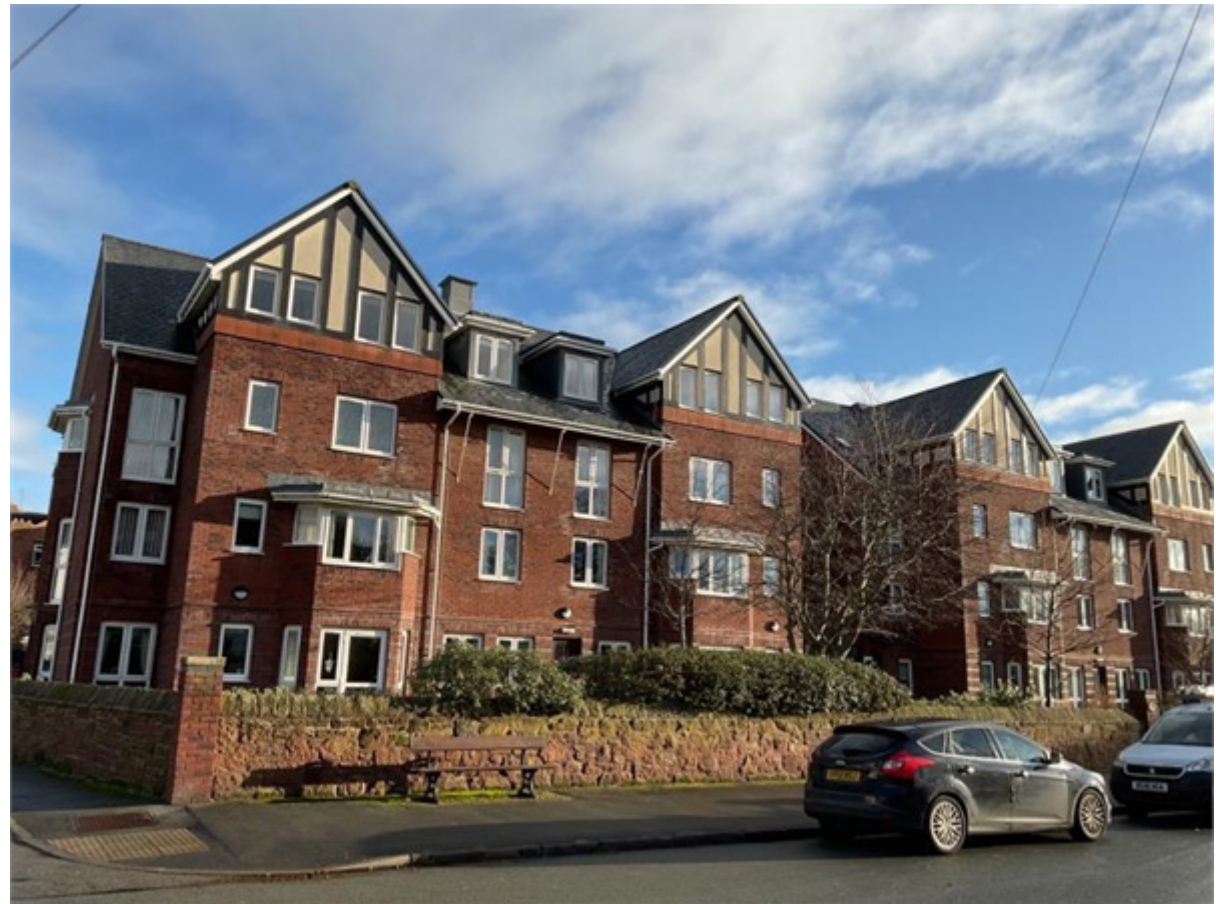
## Building ID: 53

Large apartment block intensifying the plot and of greater height than surrounding buildings. Identified as C as it is a more interesting example than other apartments in the area.
