**Donald Insall Associates**  
Chartered Architects and Historic Building Consultants

The King's Gap Gazetteer

## Introduction

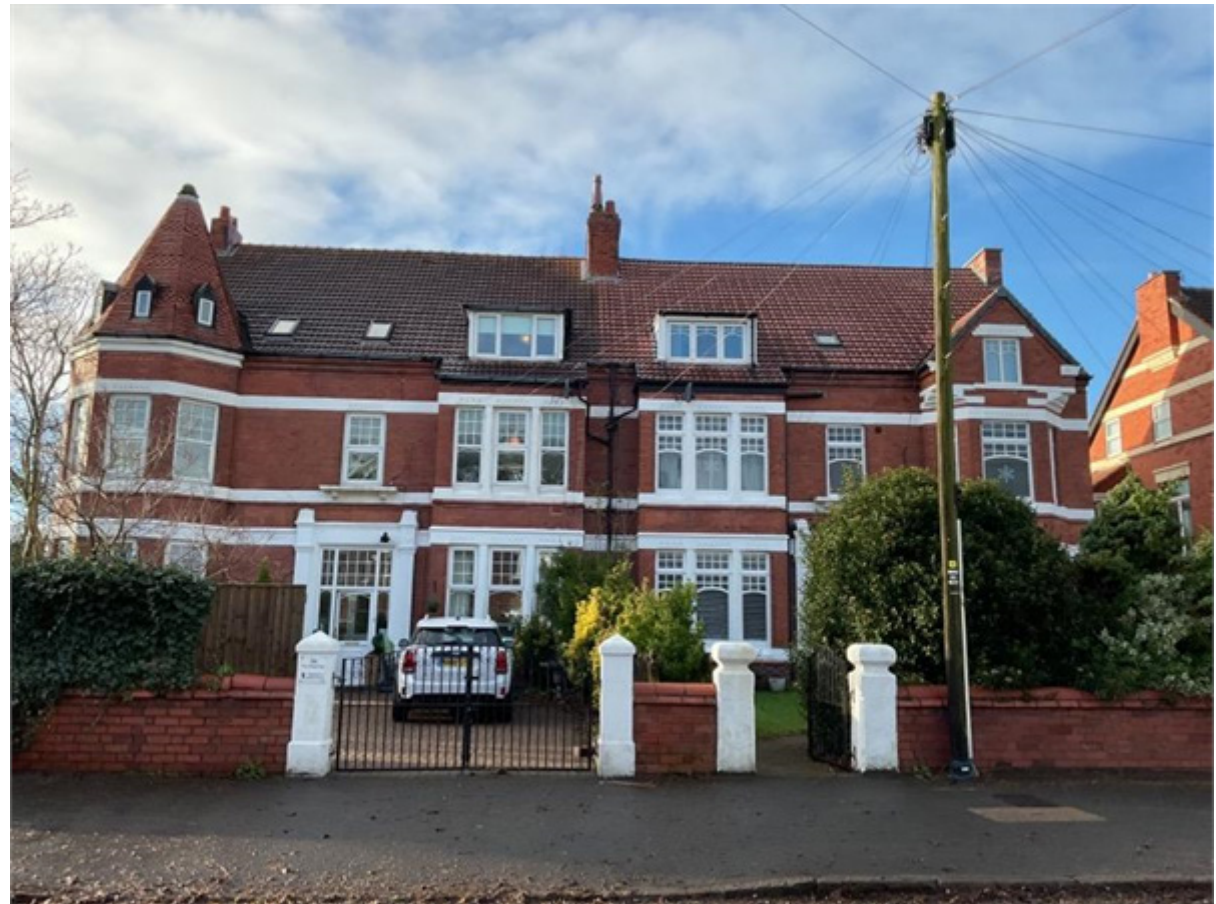
## Building ID: 54

Some detail replaced including windows (uPVC), roof tiles and bargeboard. Hard landscaping added to front, with some boundary fencing atop wall. Side boundary to r/h lost.

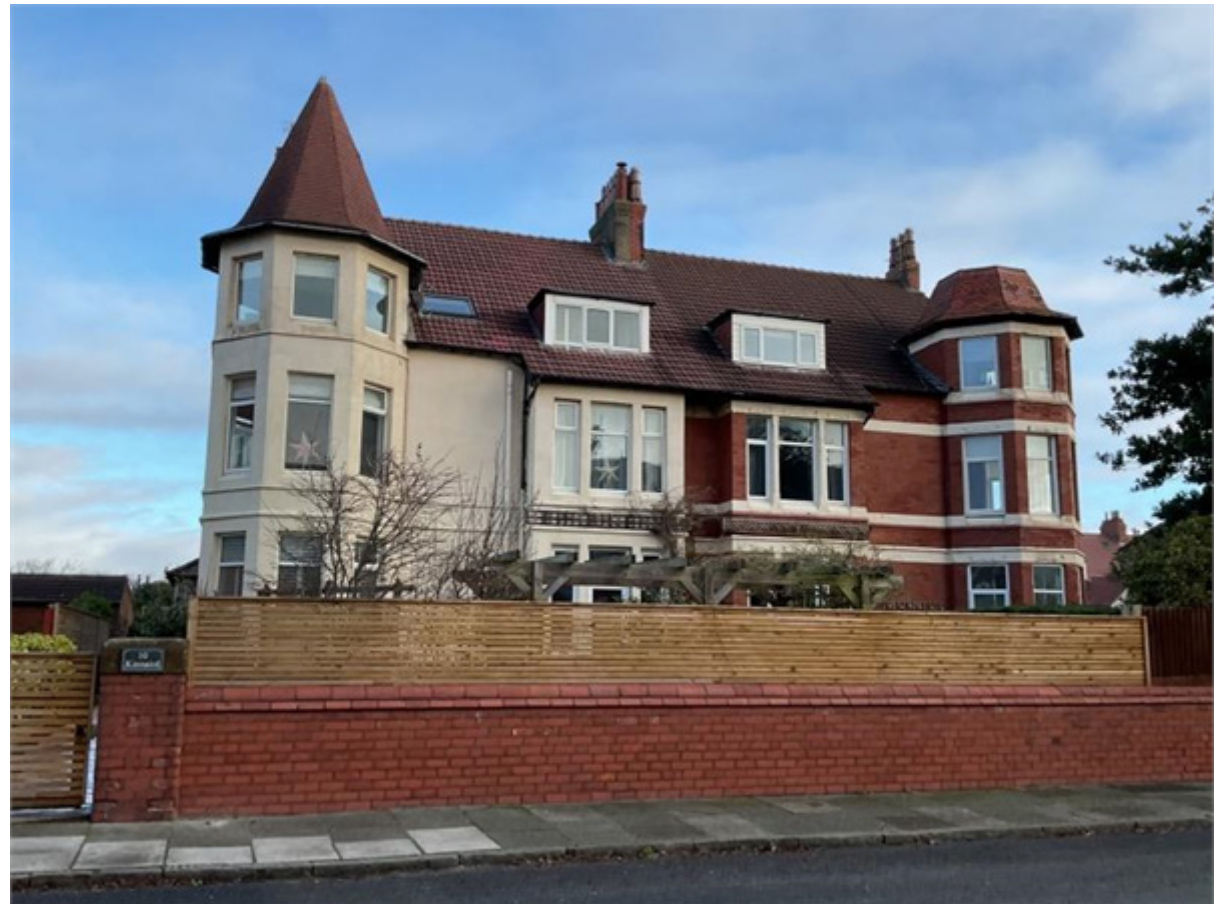
## Building ID: 58

L/h has been rendered, impacting symmetry and covering stone detailing. Roof tiles and windows replaced. Turret to r/h has been truncated. Fencing added to wall.

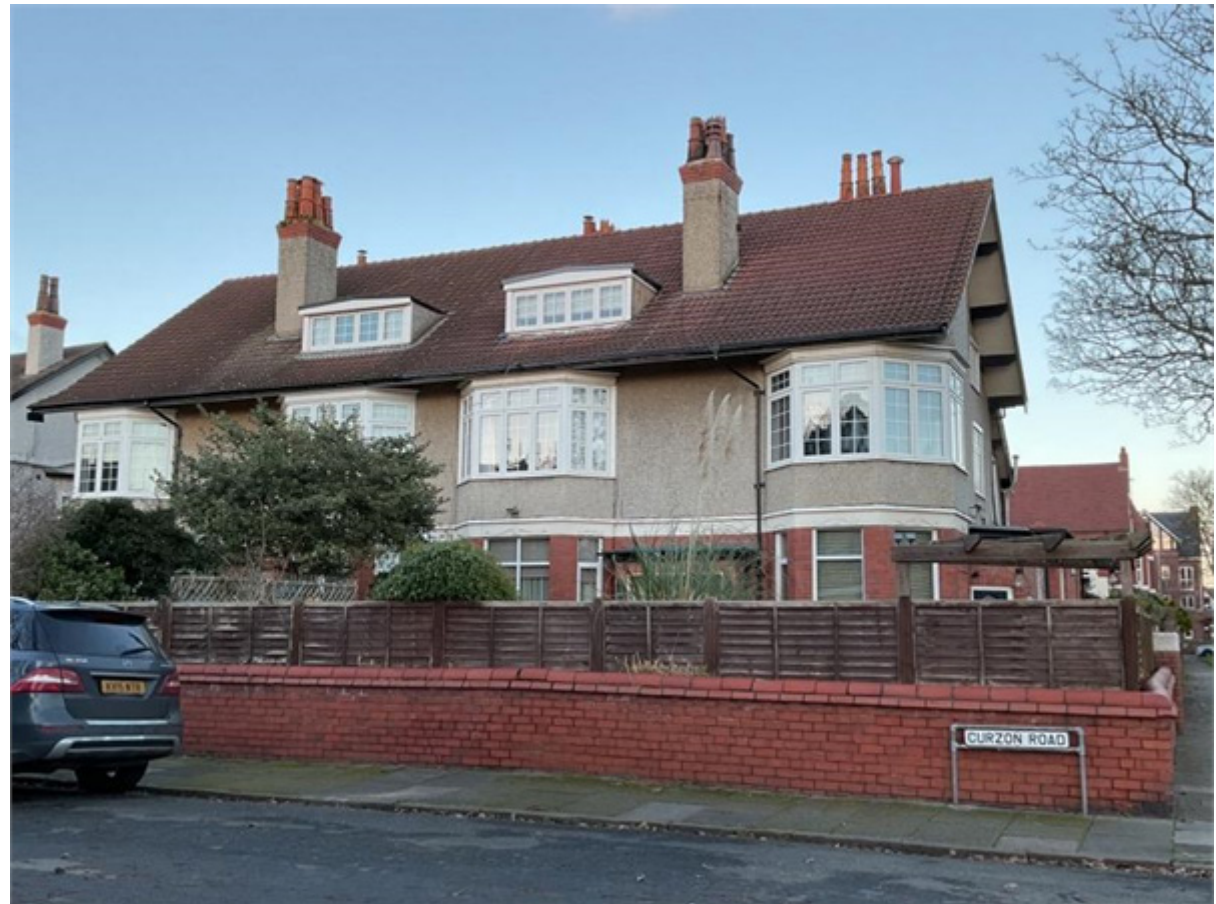
## Building ID: 60

Concrete tiled roof. Replacement windows. Poor extension to rear. Fencing added to front boundary wall, side boundary wall altered / replaced.

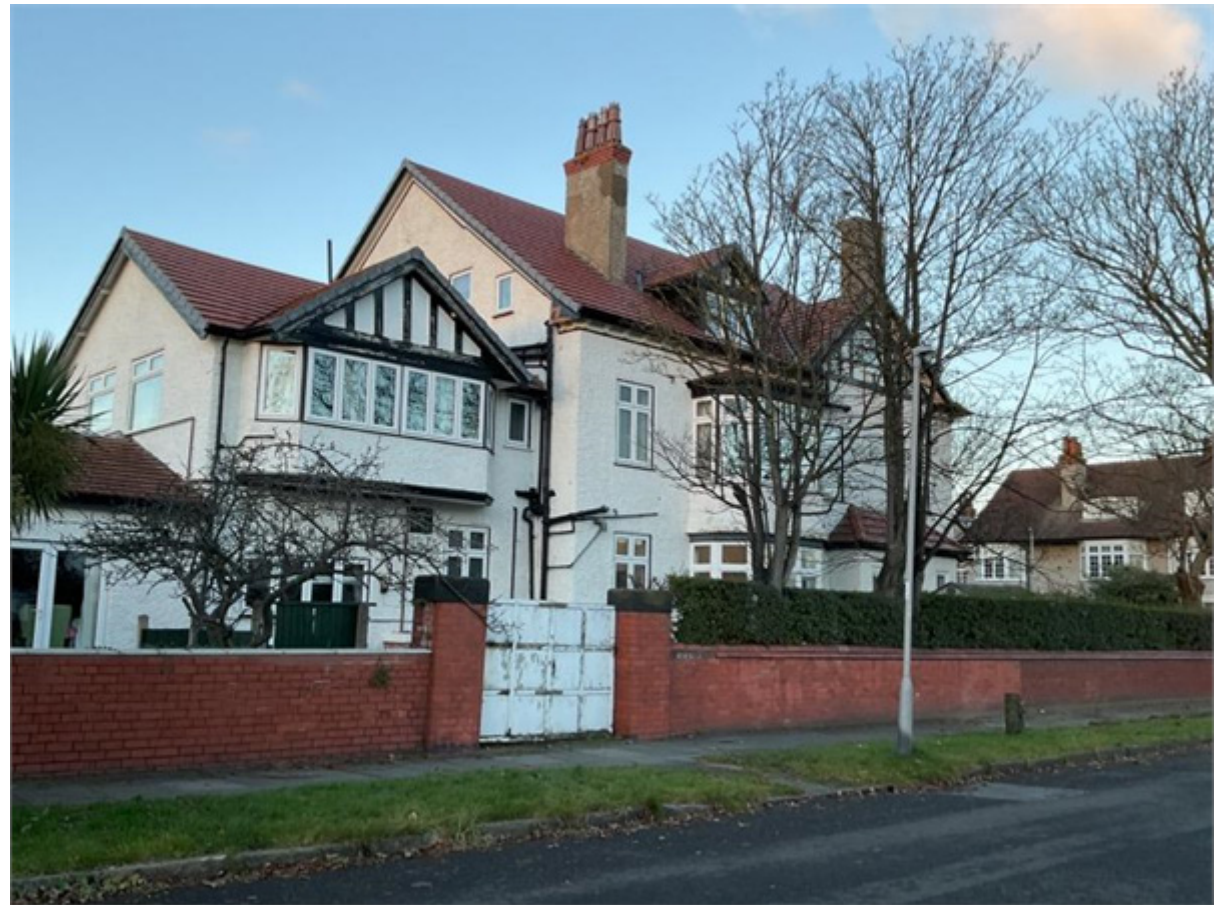
## Building ID: 61

UPVC windows. Concrete tiled roof.

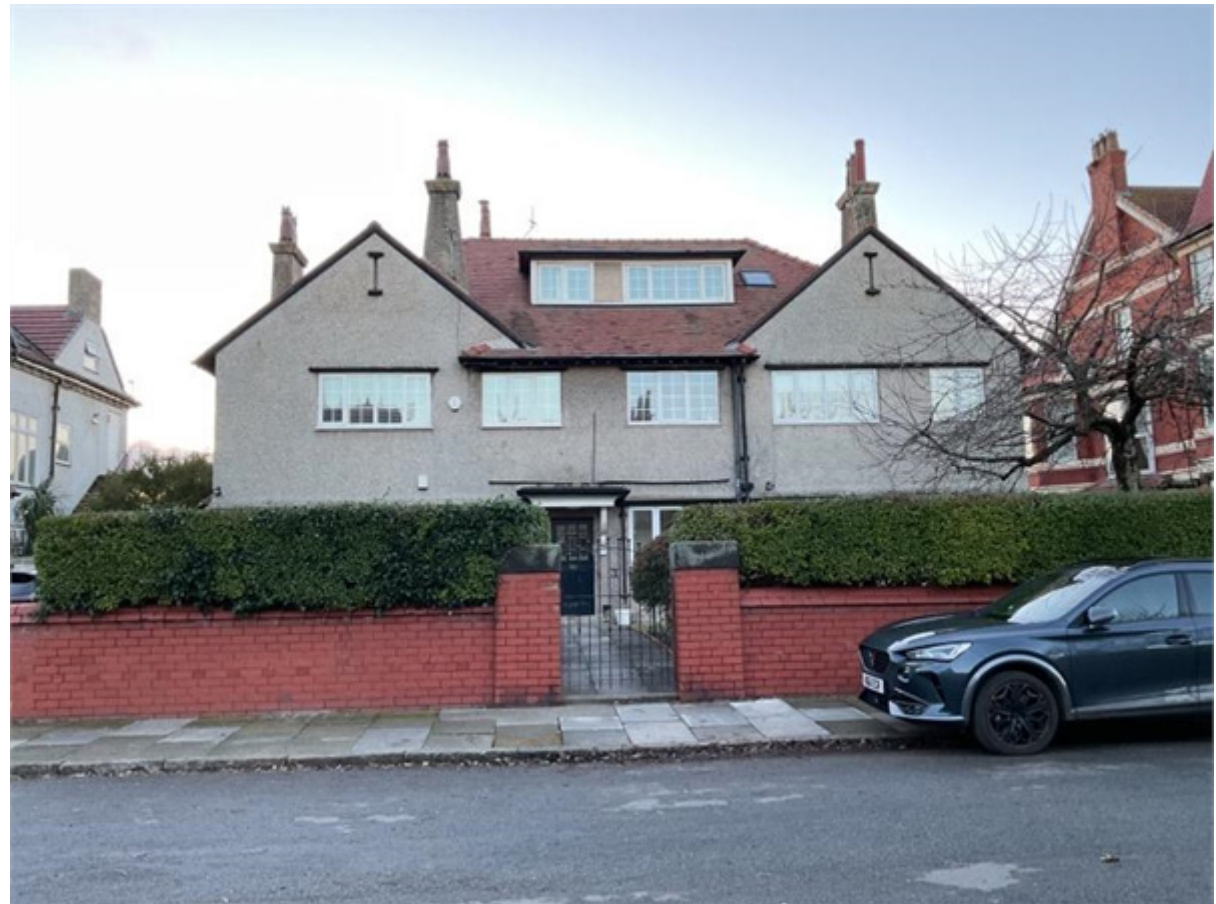
## Building ID: 62

Windows replaced. Some poor hardstanding to frontage.

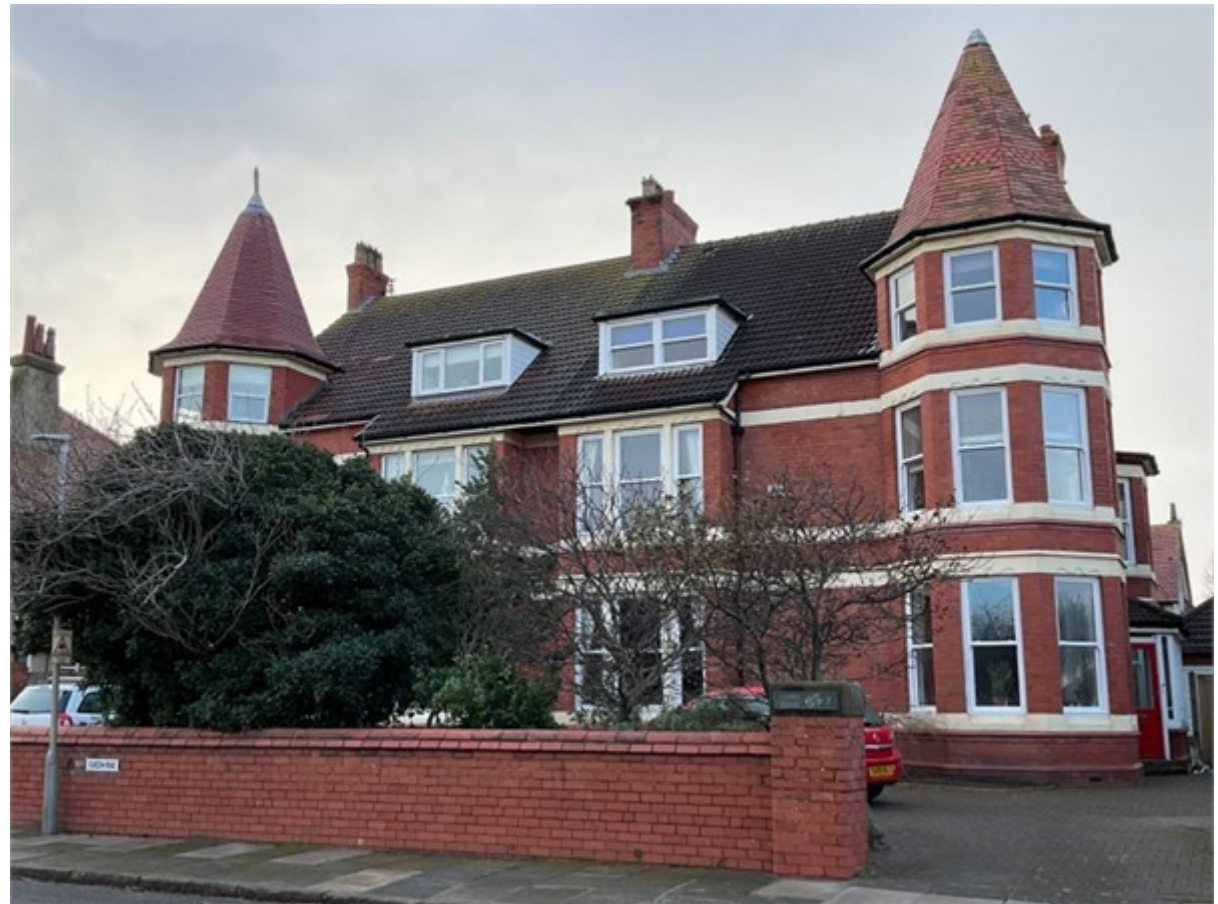
## Building ID: 63

Roof tiles replaced. UPVC windows to l/h. Hardstanding for driveways, including some loss of wall.

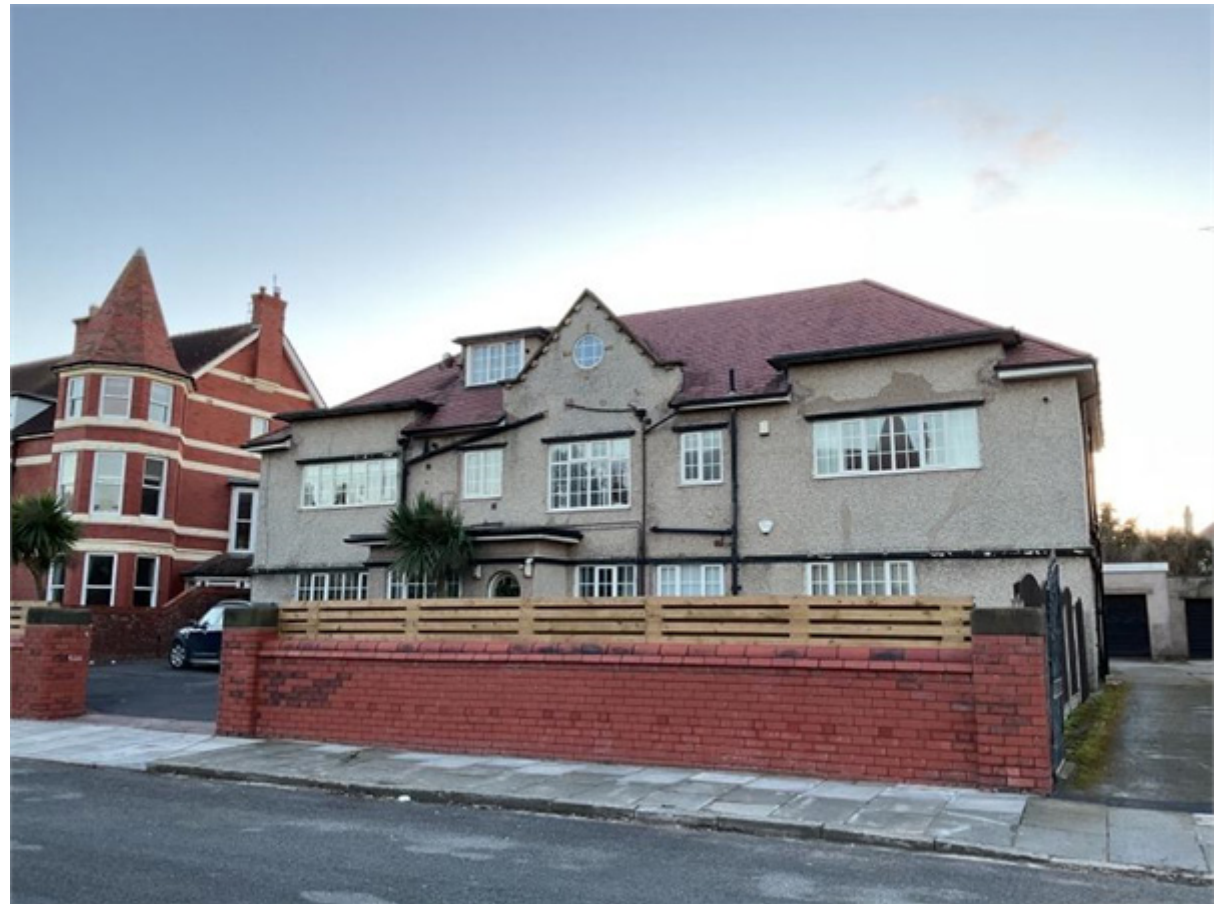
## Building ID: 64

Windows replaced. Chimney stacks lost. Replacement roof tiles. Fencing atop front wall.

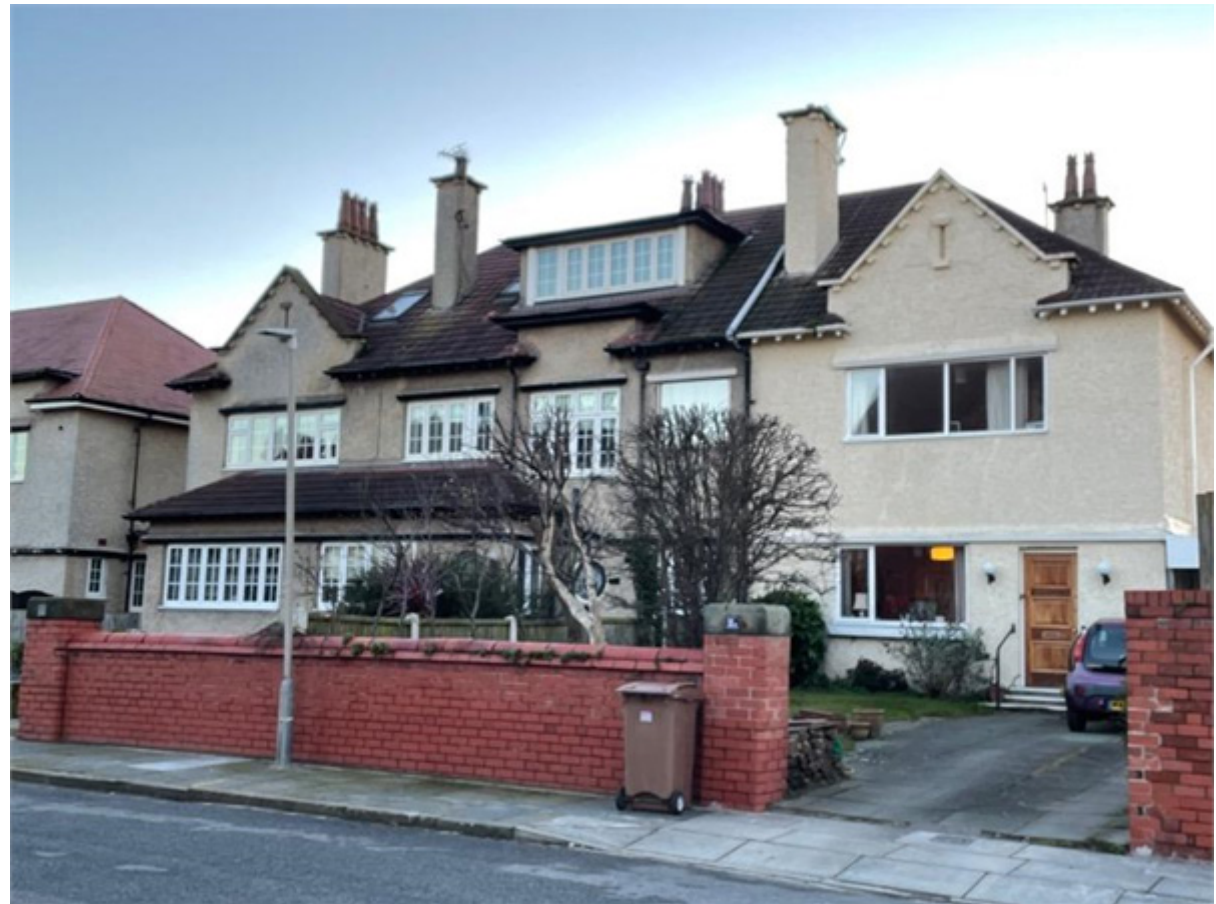
## Building ID: 65

Property has been split into two dwellings with different decorative schemes undermining the original unified appearance. Replacement windows and roof tiles. Single storey porch extension to l/h. Hard surfacing to front.

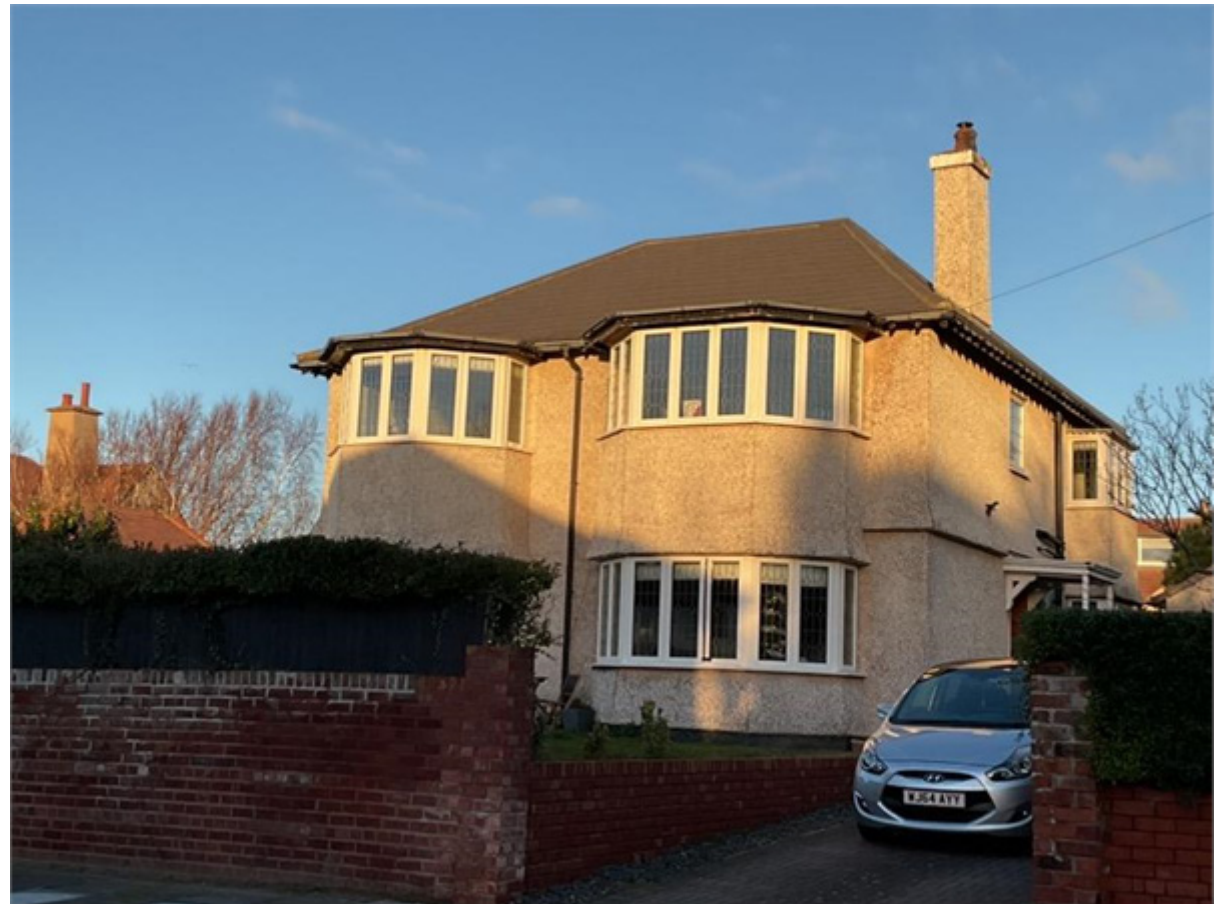
## Building ID: 68

Tiled roof finish. Roof shape suggests possible later alteration.

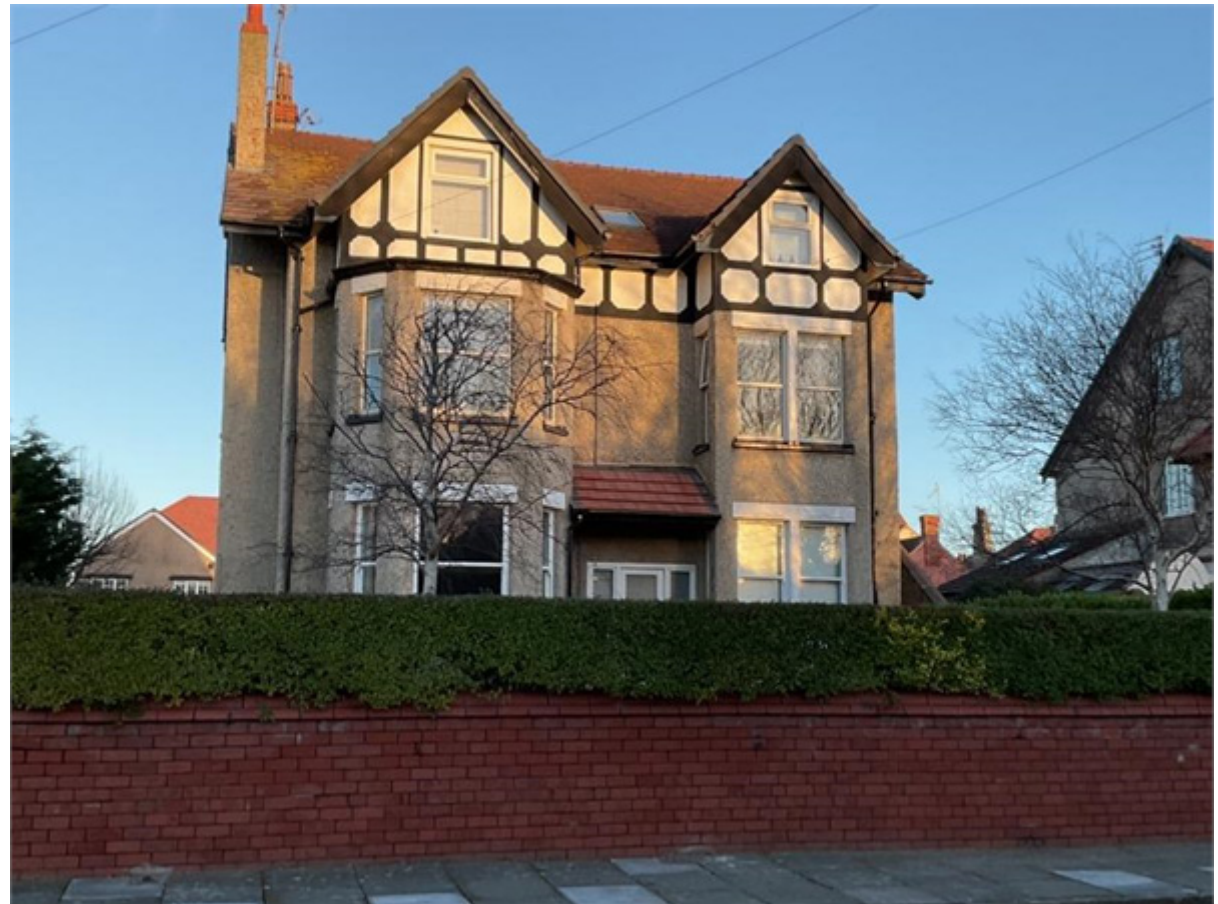
## Building ID: 69

May have been split in two, with large side access stairs. Replacement windows.

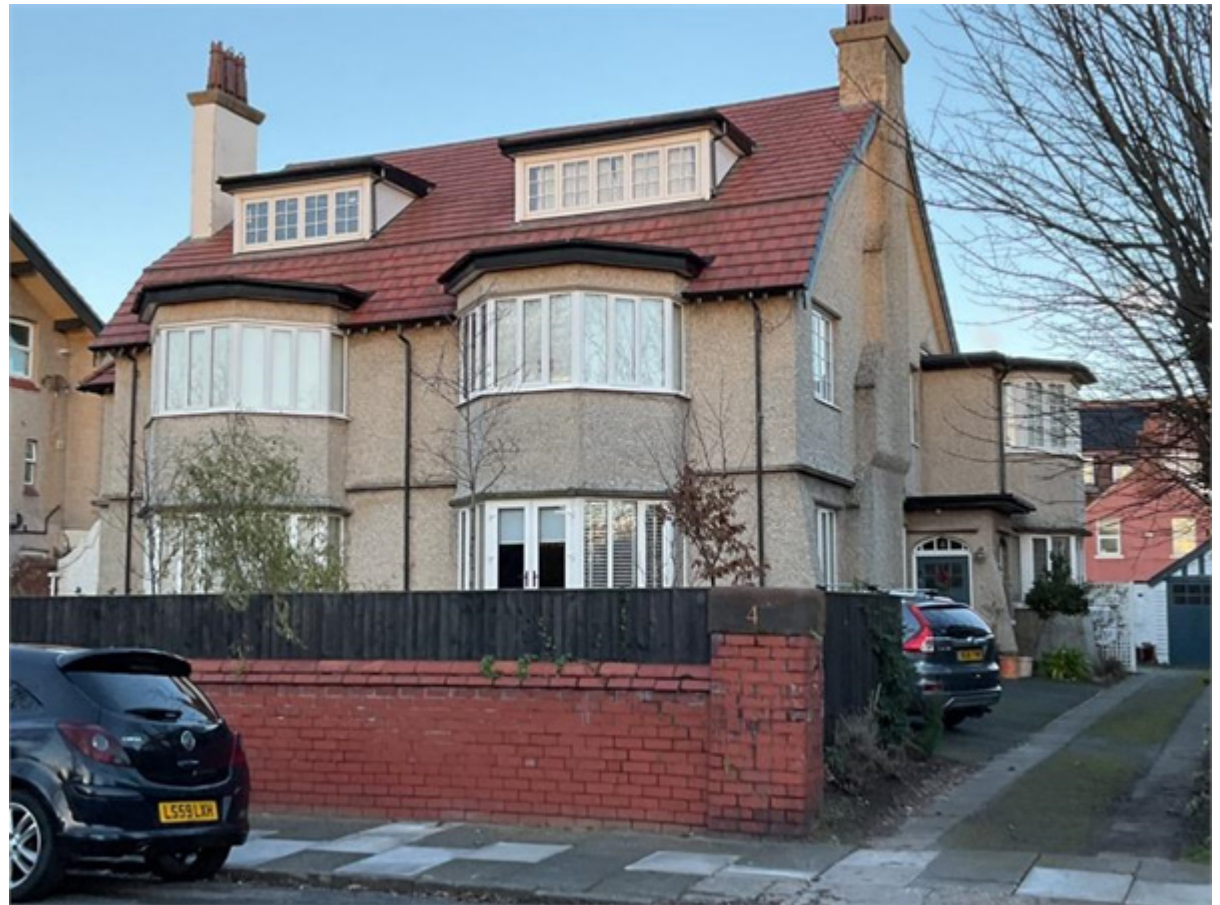
## Building ID: 70

Windows replaced. Replacement roof tiles. Long drive, though garage well setback. Fencing atop wall.

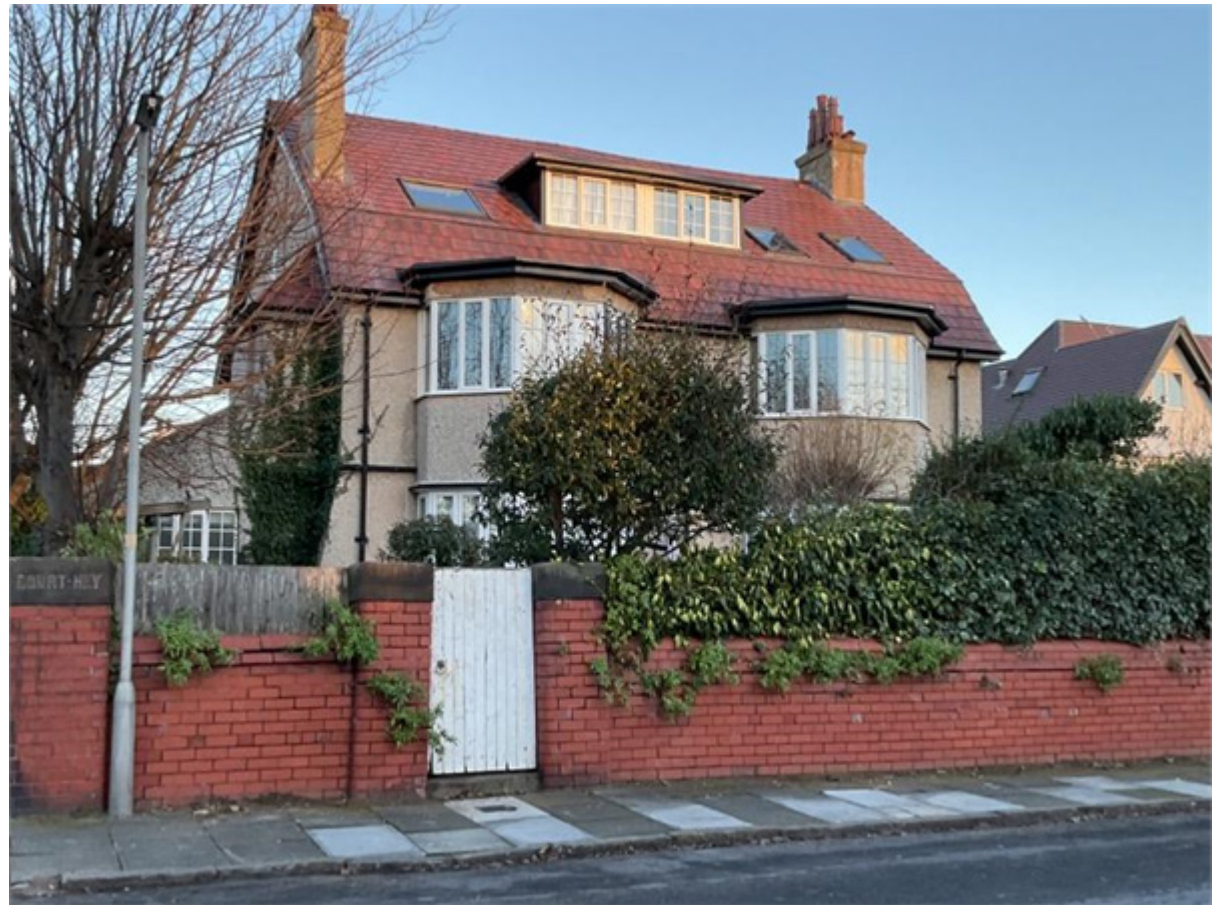
## Building ID: 71

Windows replaced. Side extension.

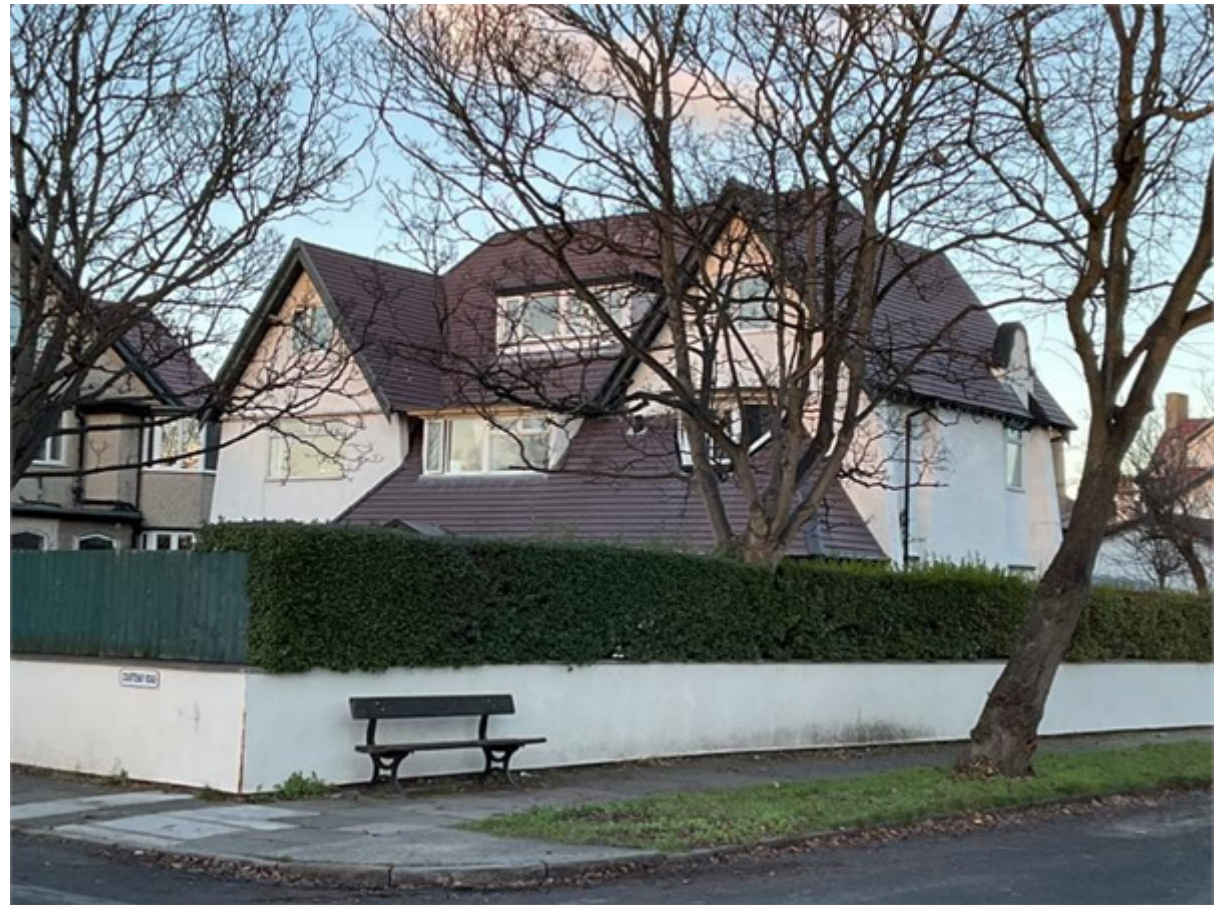
## Building ID: 72

Much altered, including replacement windows and concrete tiled roof. Use as a residential care home has led to a large number of rear extensions, prominent on the road. Boundary wall is rendered, with close board fencing.

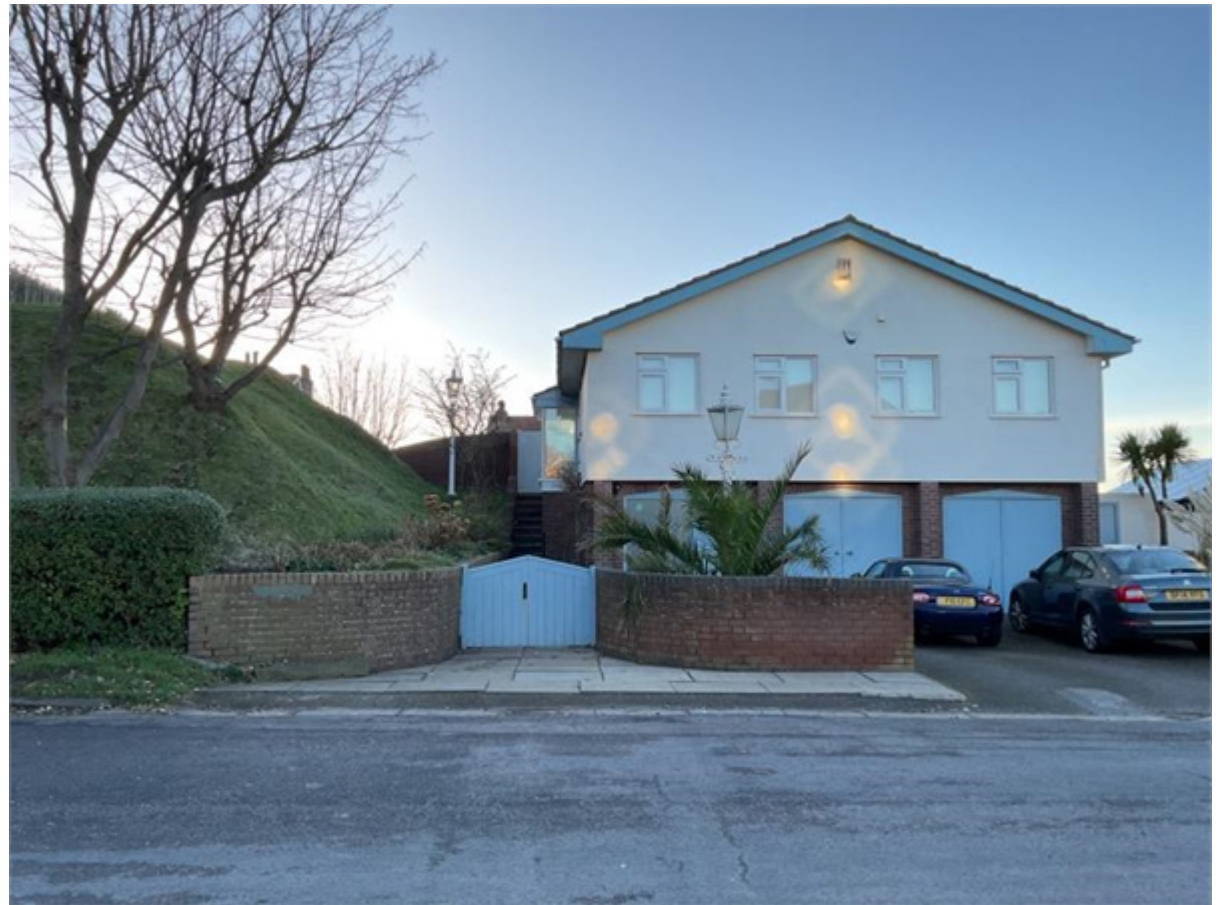
## Building ID: 74

Rather plain gable frontage to road, with dominant garage doors. Open driveway on approach to beach. May incorporate remnants of dune system (now grassed).

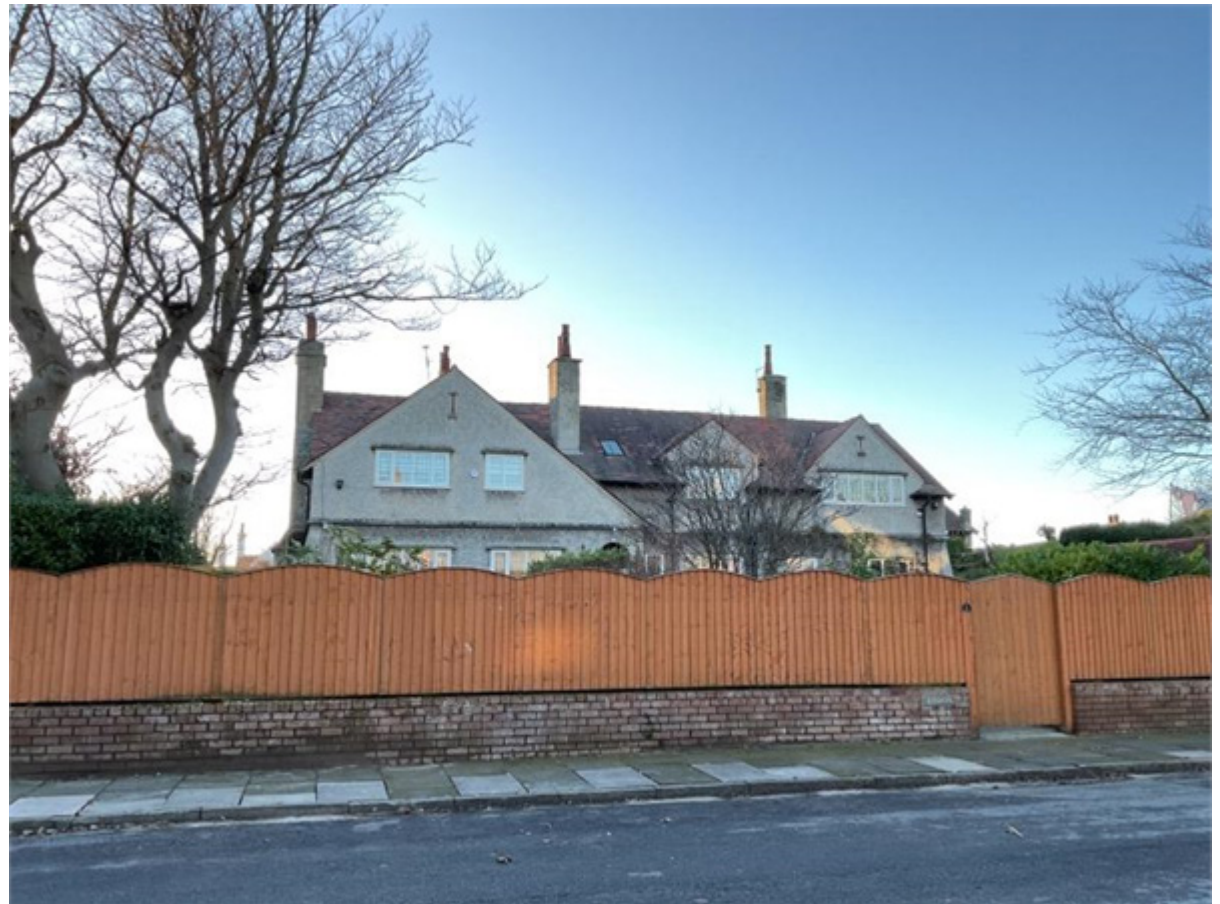
## Building ID: 75

Prominent garage. Front boundary wall is modern and also incorporates close board fencing.

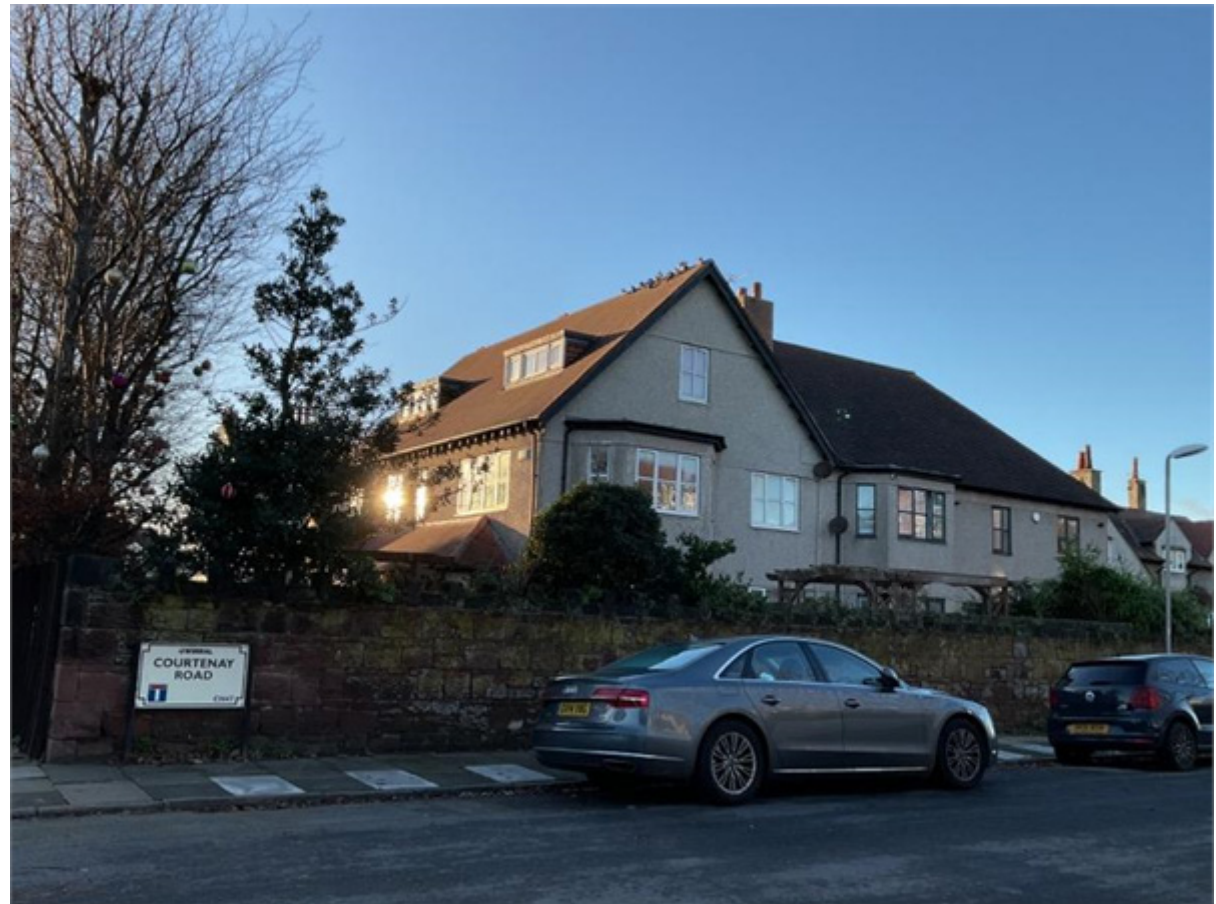
## Building ID: 76

Windows replaced. Single-storey extension and conservatory extensions to Barton Road elevation. Fencing to Barton Road.

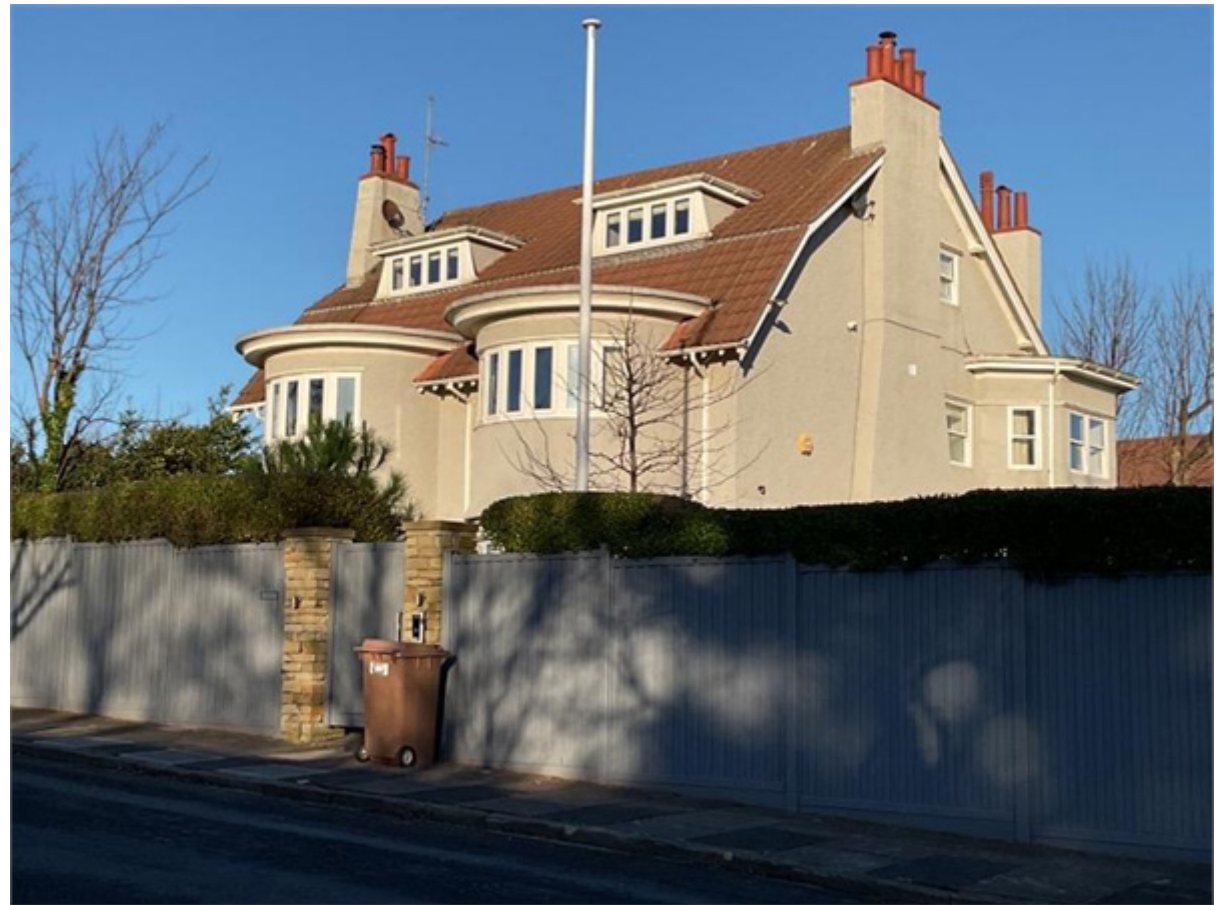
## Building ID: 77

Windows replaced. Concrete roof tiles. Boundary is close board fencing.

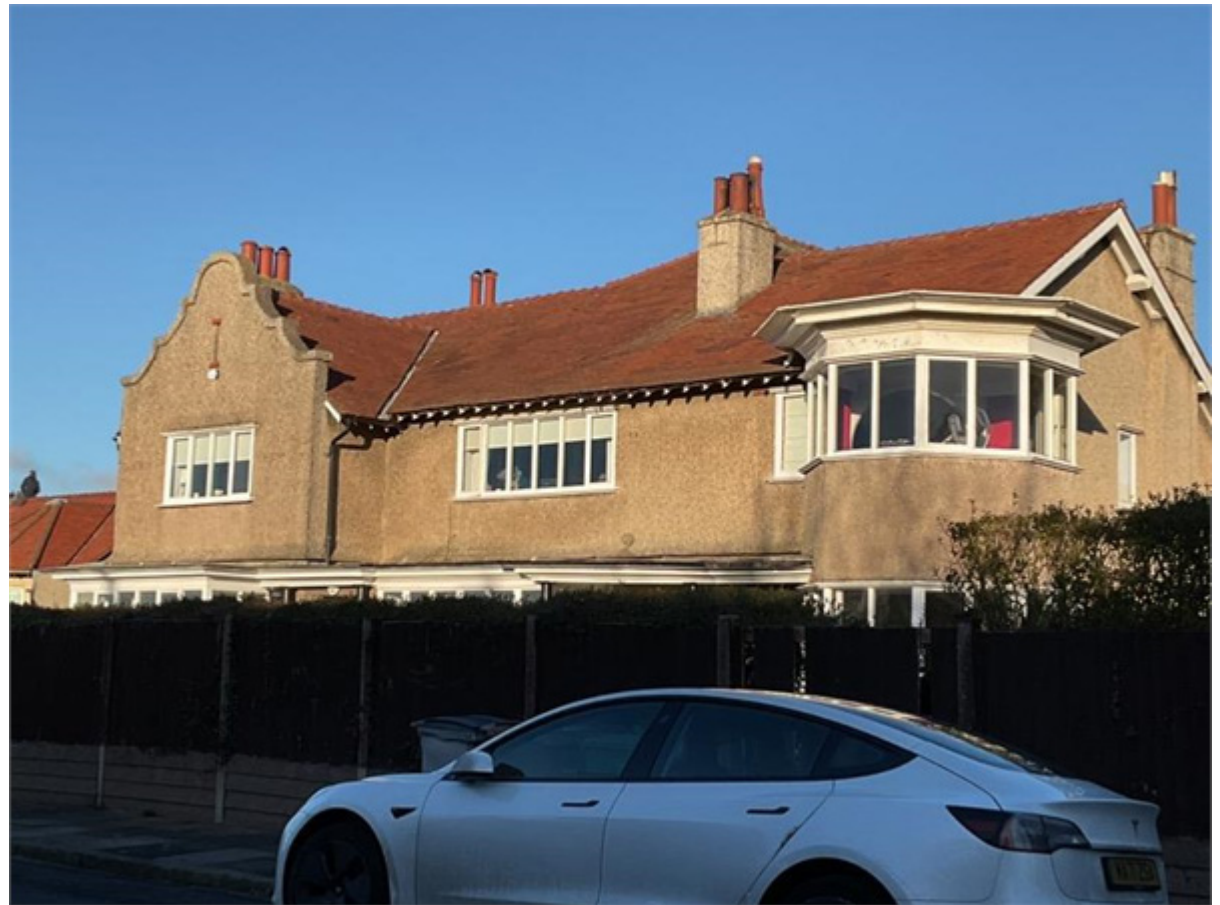
## Building ID: 78

In need of repair. Replacement windows. Poor extension to side, and front boundary is a mismatch of fencing and concrete panels.

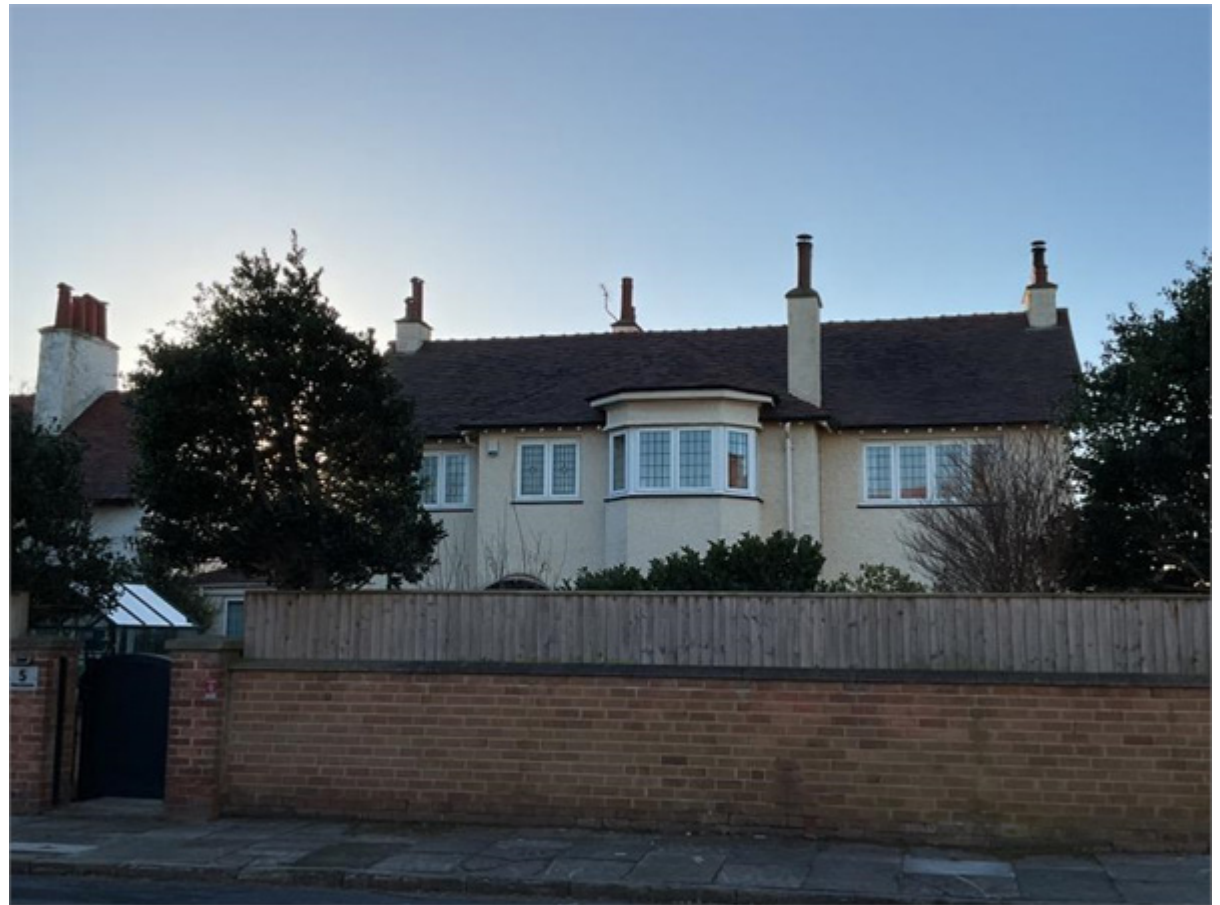
## Building ID: 81

Windows replaced. Front boundary is modern brick and incorporates fencing atop.

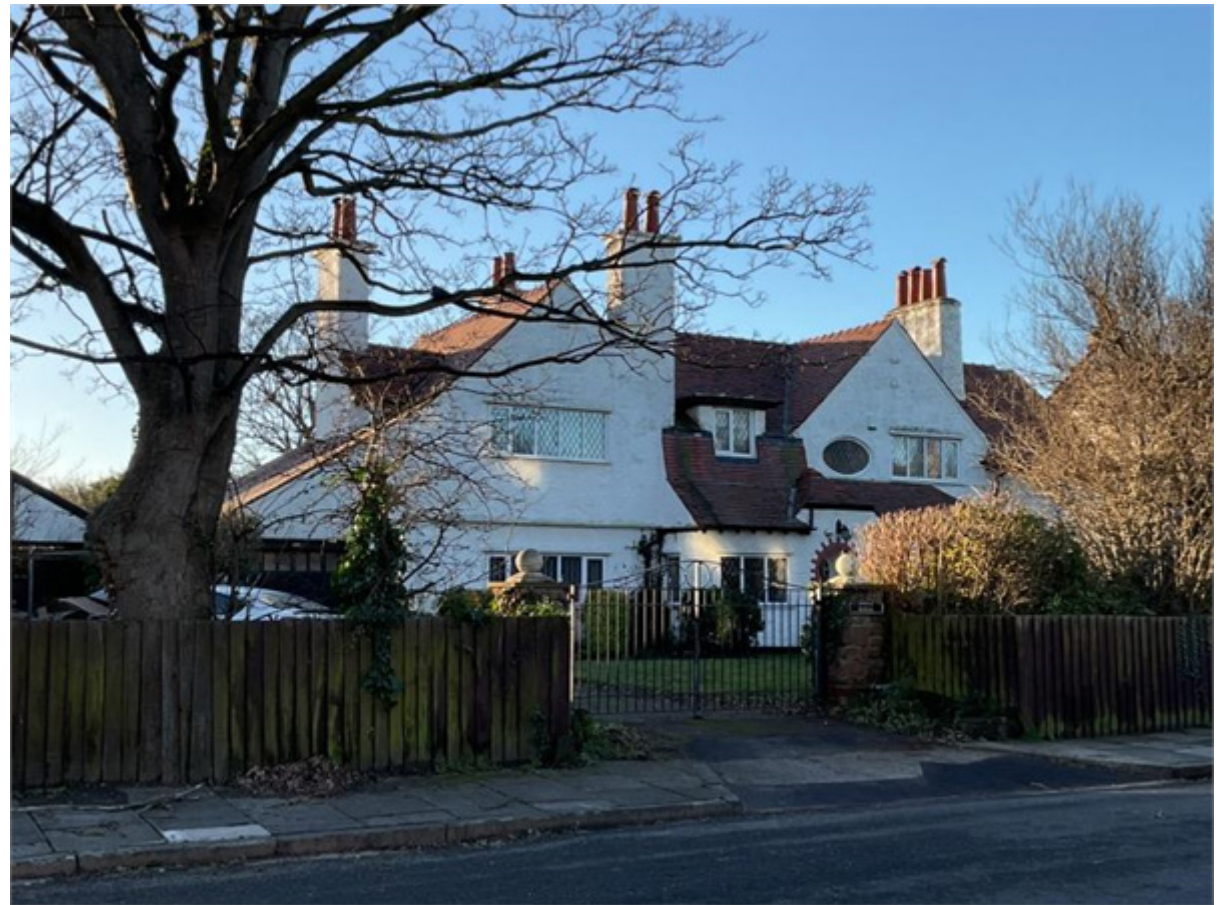
## Building ID: 82

Replacement windows. Front boundary of poor with fencing.
