**Donald Insall Associates**  
Chartered Architects and Historic Building Consultants

The King's Gap Gazetteer

## Introduction

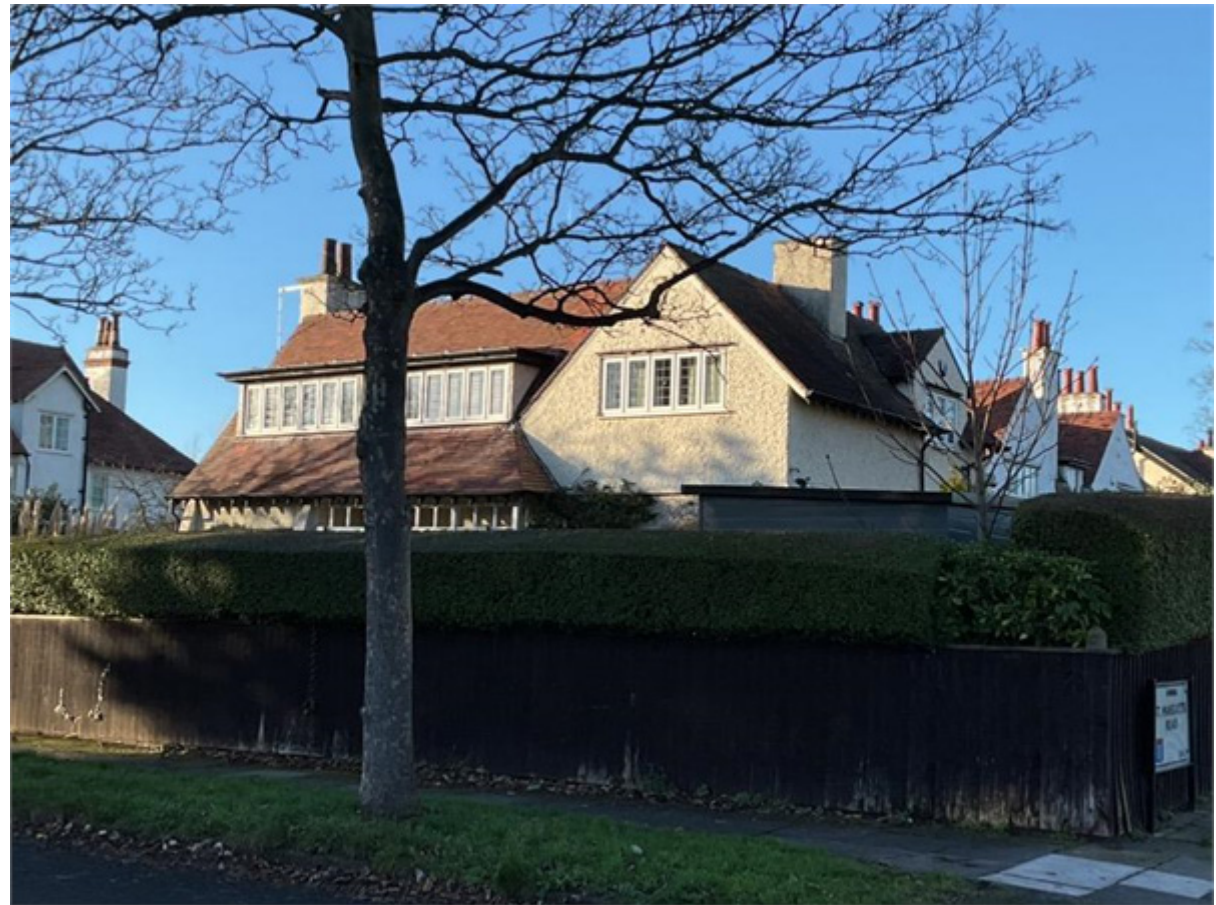
## Building ID: 83

Replacement windows. Boundary fencing poor, on a prominent corner.

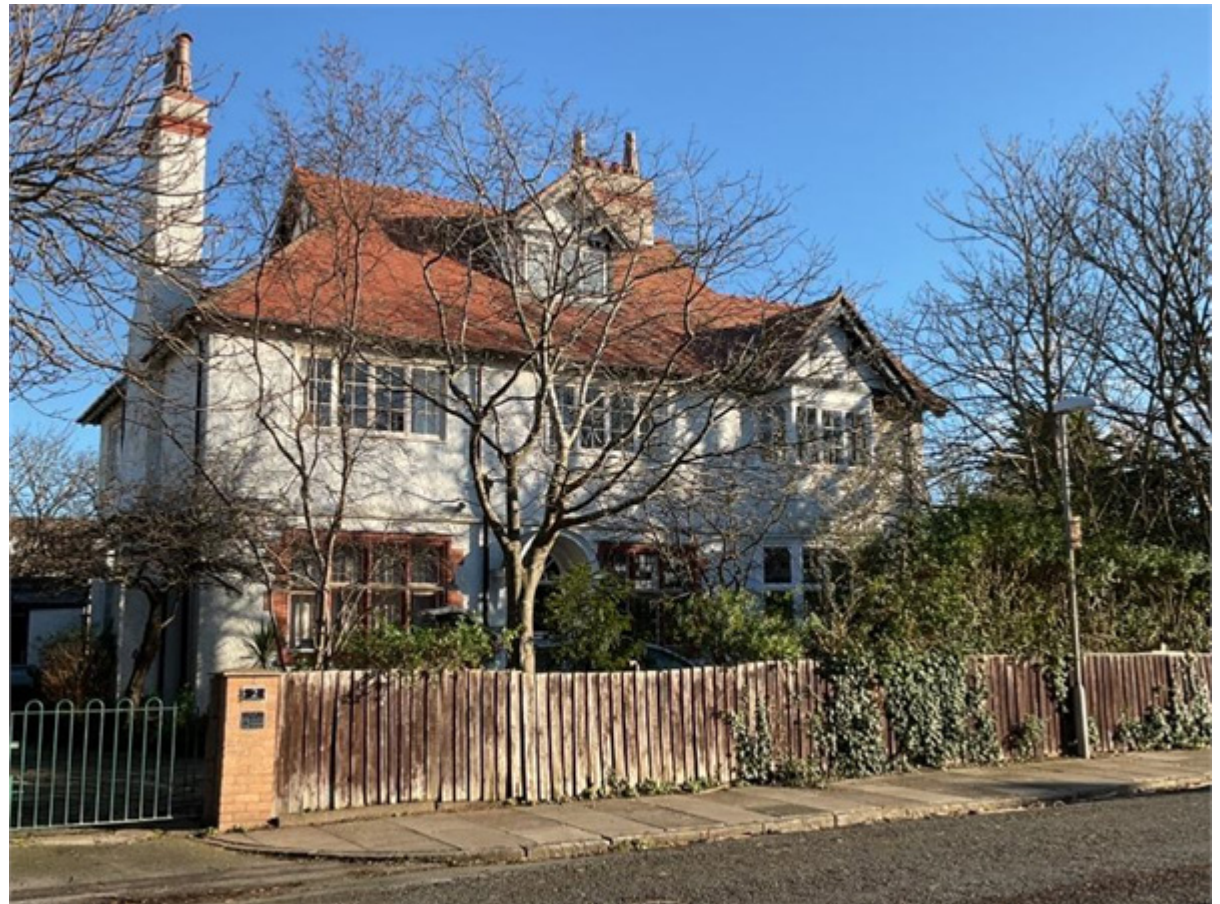
## Building ID: 84

Boundary fencing to Penrhos Road is poor.

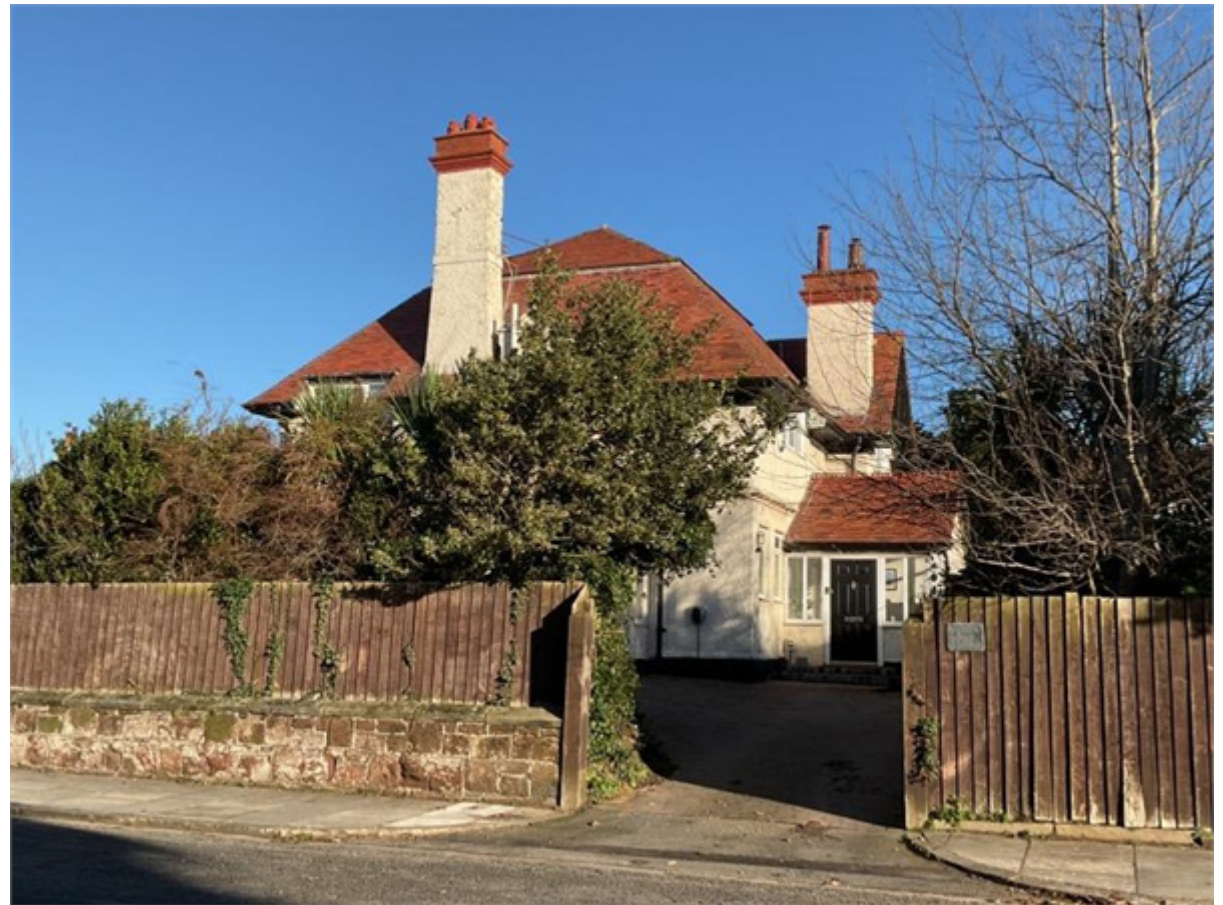
## Building ID: 85

Replacement windows. Fencing added atop boundary wall. Hardstanding to frontage.

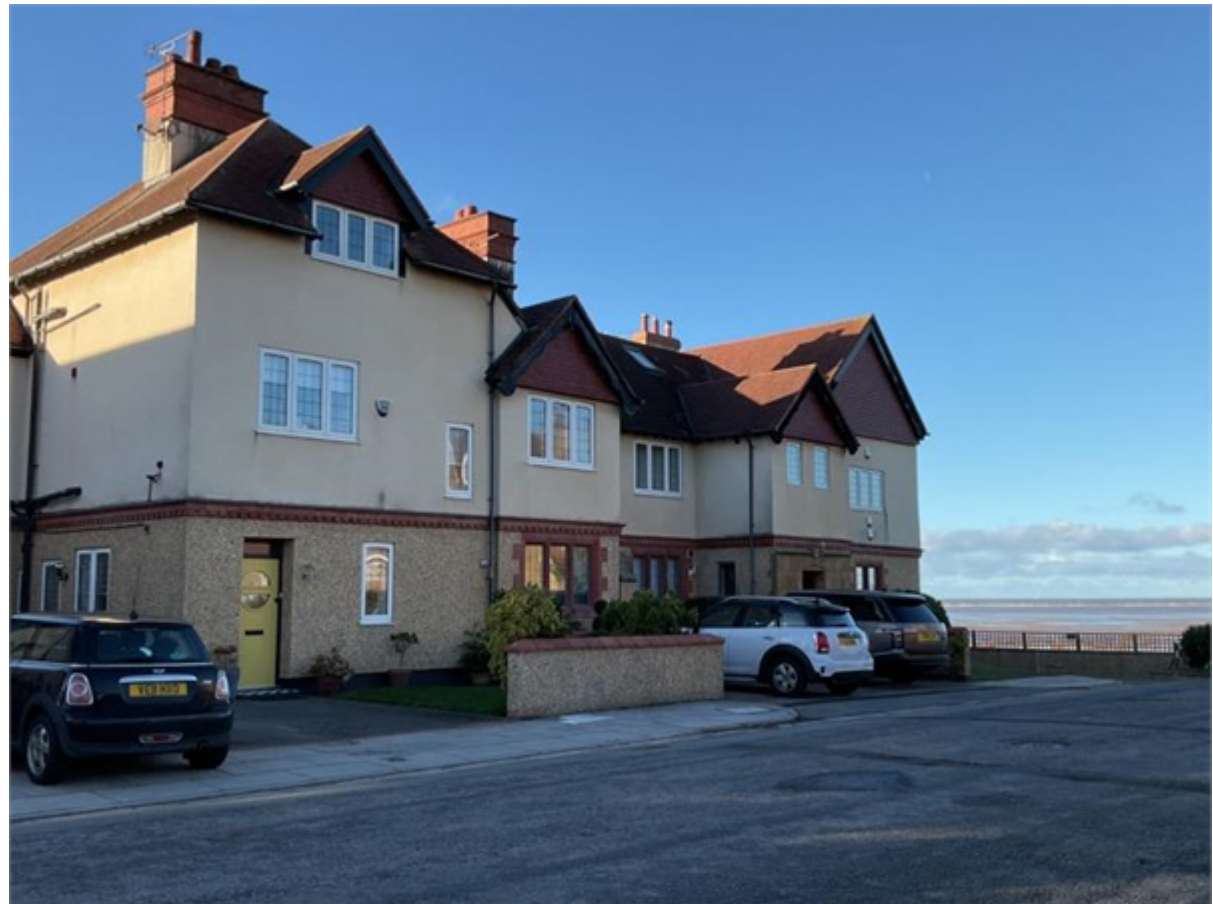
Side elevation overlooks the north coastline, visually bulky.

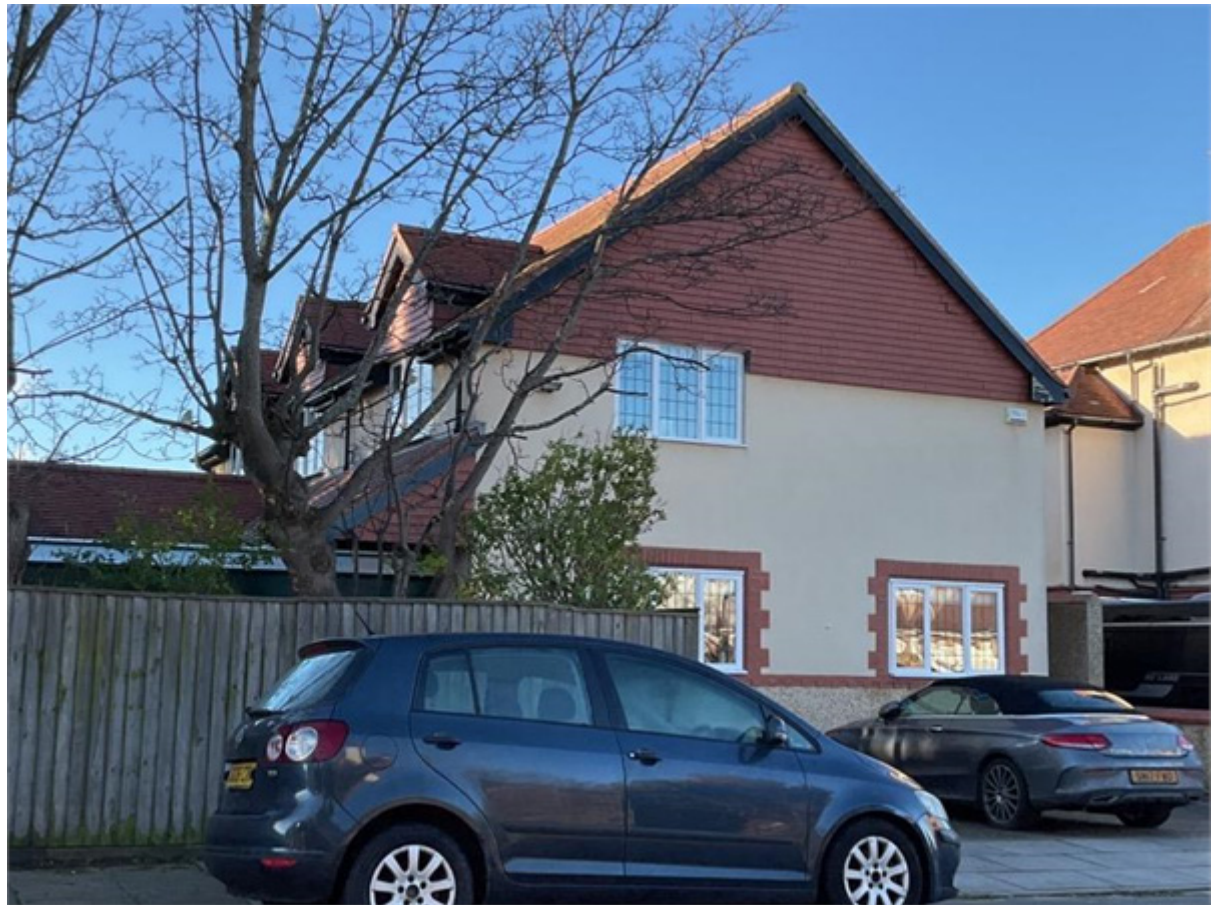
## Building ID: 87

Rather bland gable elevation to the road. Prominent hardstanding and no boundary wall. High boarded fence to garden.

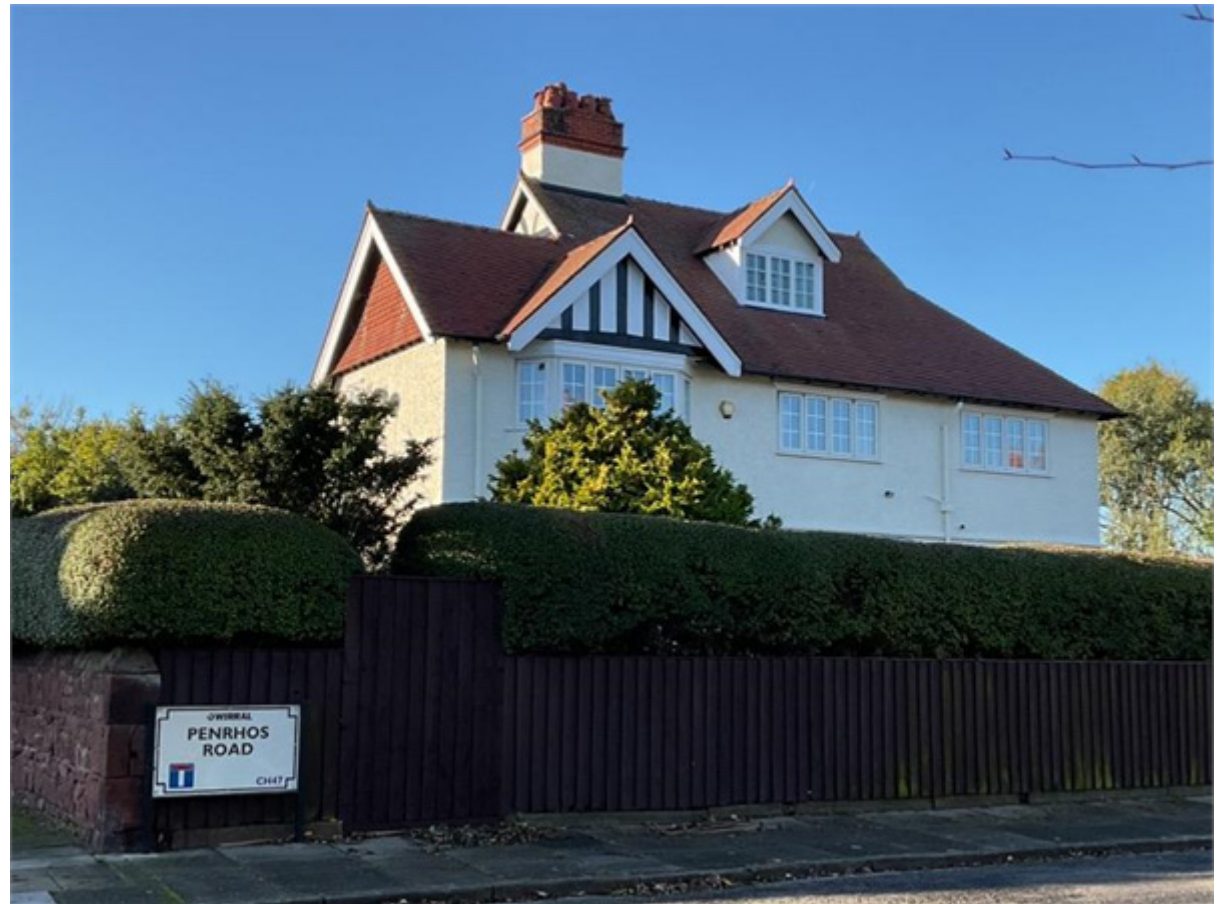
## Building ID: 88

Garage extension to rear. Penrhos Road elevation has poor fence to boundary. Fencing added behind wall to Barton Road.

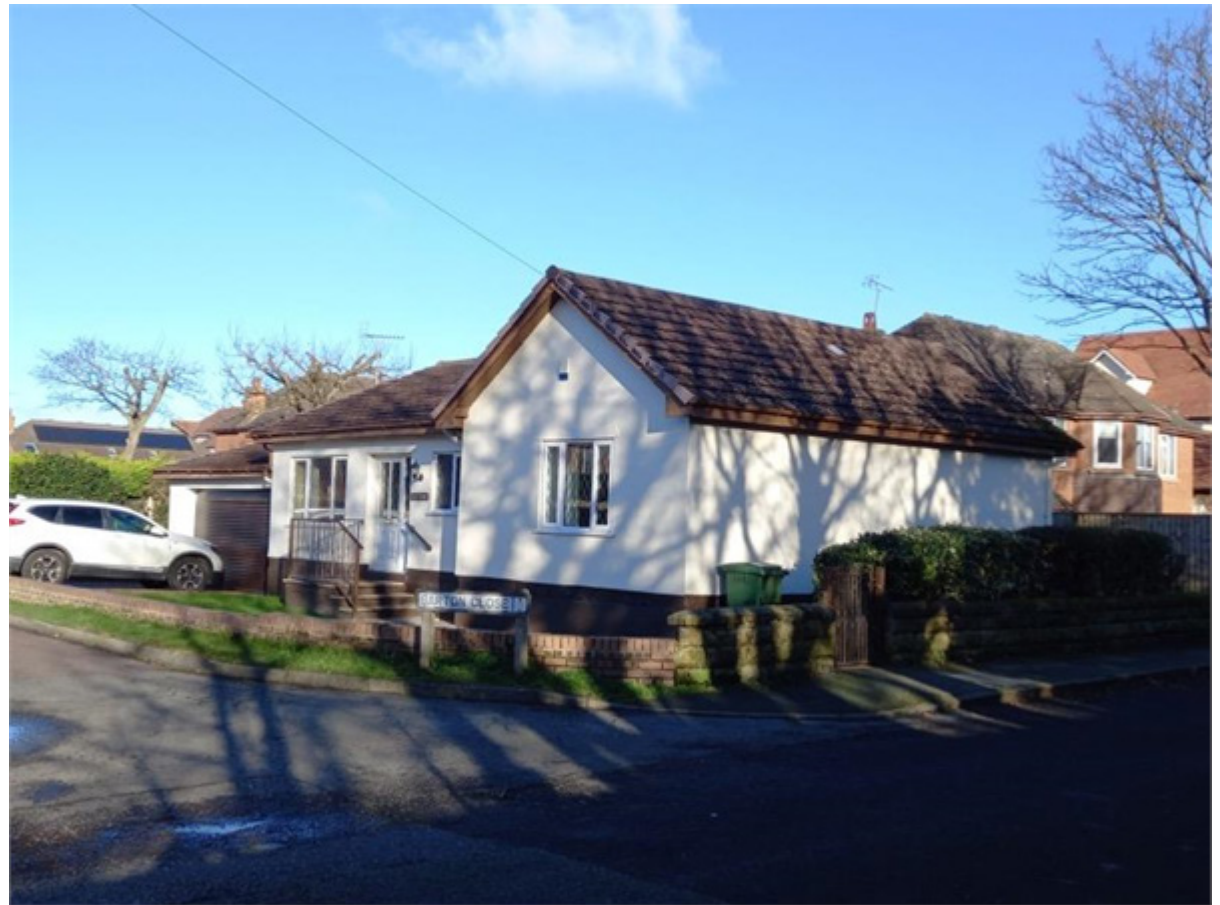
## Building ID: 89

Conventional suburban bungalow form, concrete roof tiles and modern windows. Lack of strong boundary to Barton Close frontage.

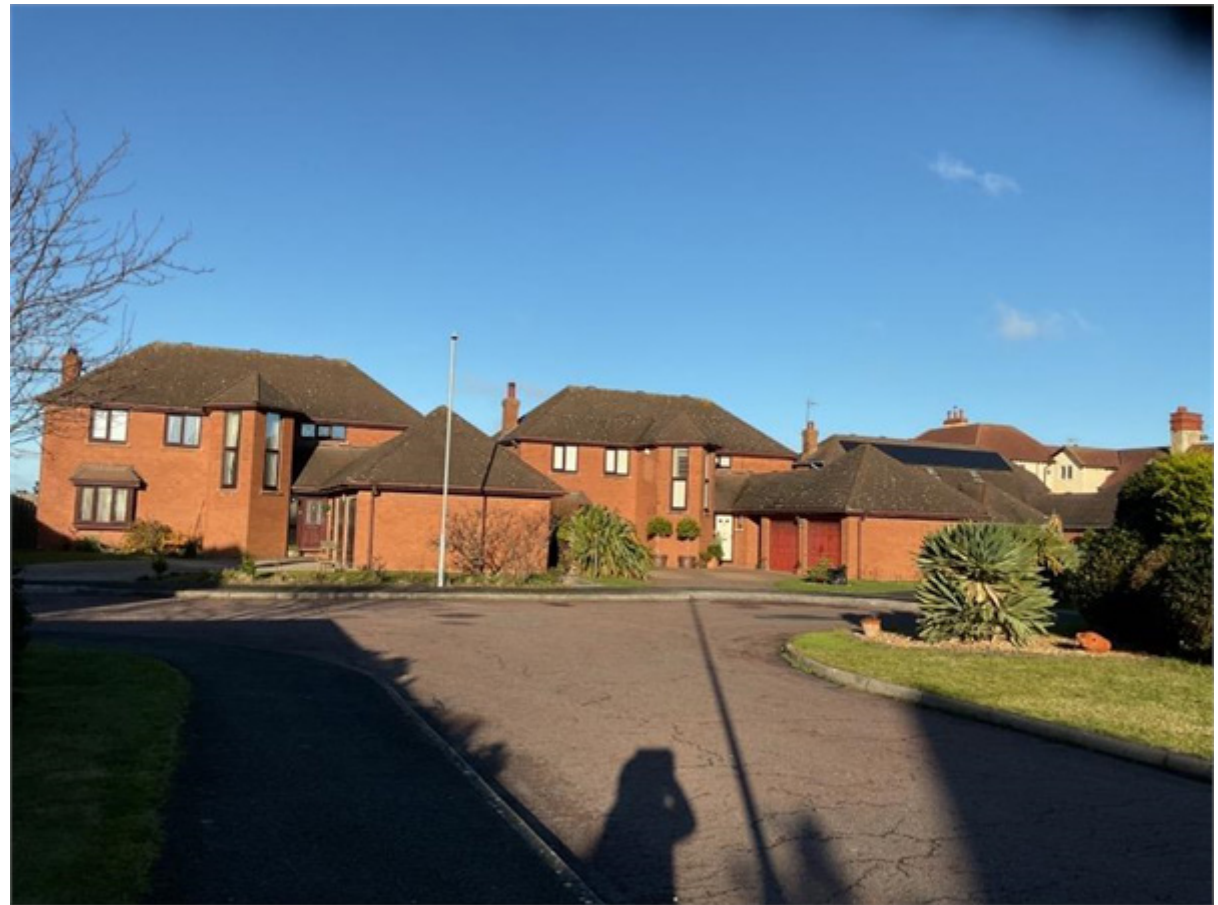
## Building ID: 90

Rear elevations overlook the north coastline, but set back, with a rise in land height. Has introduced fencing to boundary,

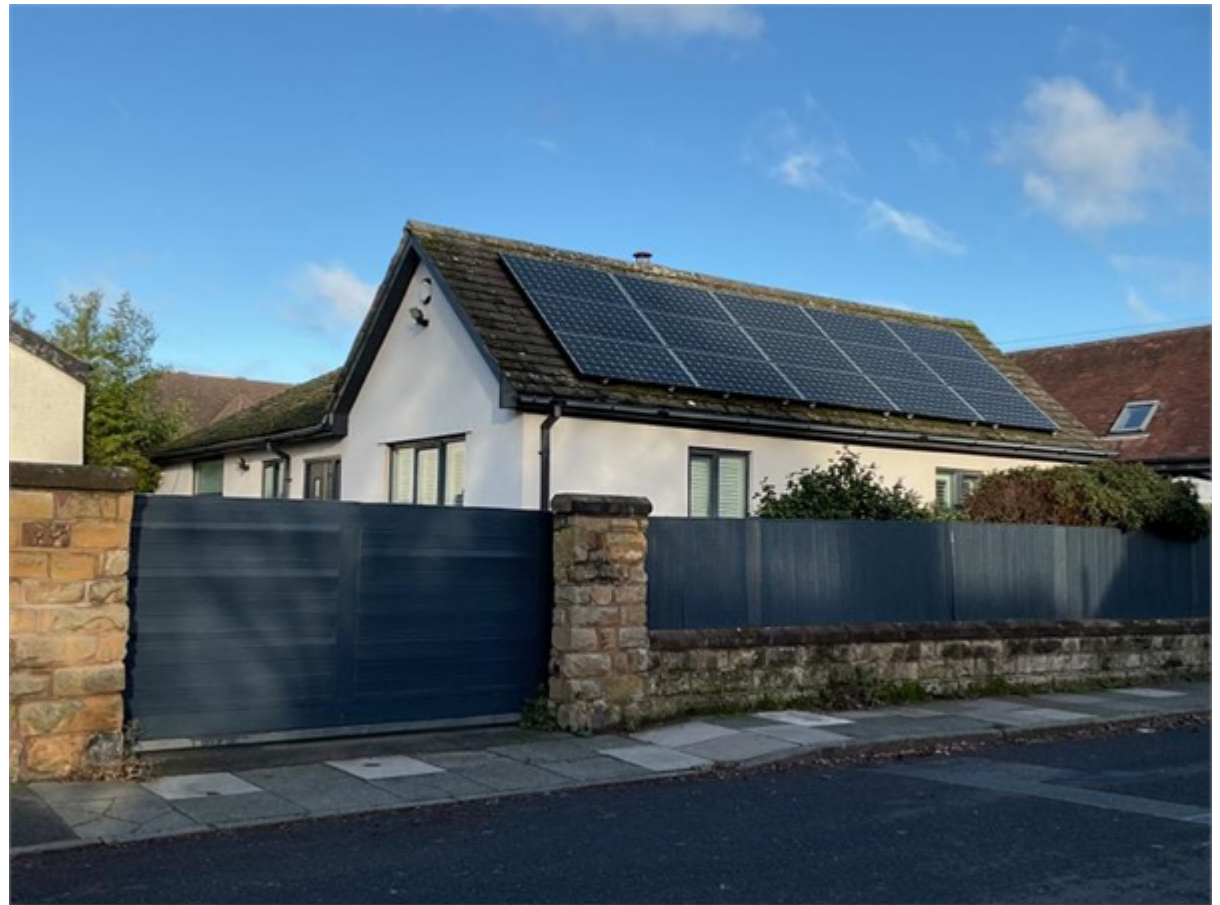
## Building ID: 92

Solar panels prominent. Fencing to boundary.

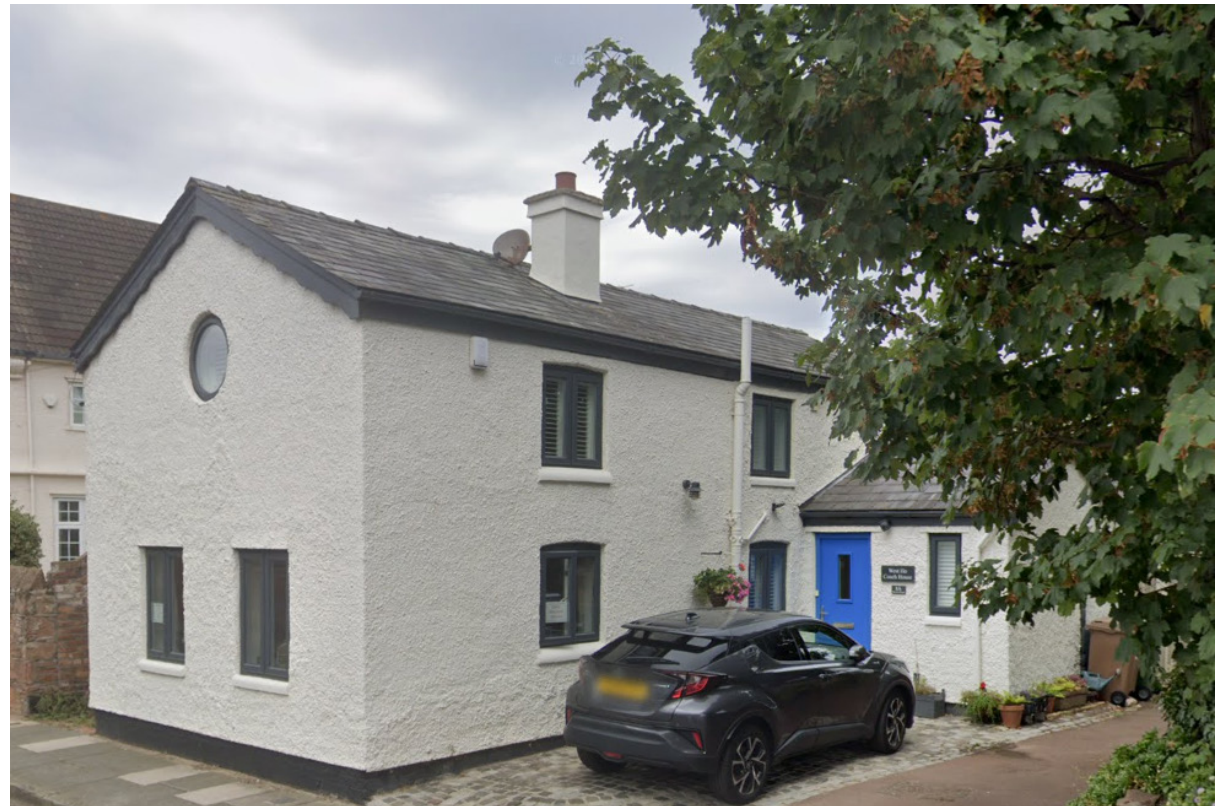
## Building ID: 92a

Replacement windows and possible disruption of historic fenestration.

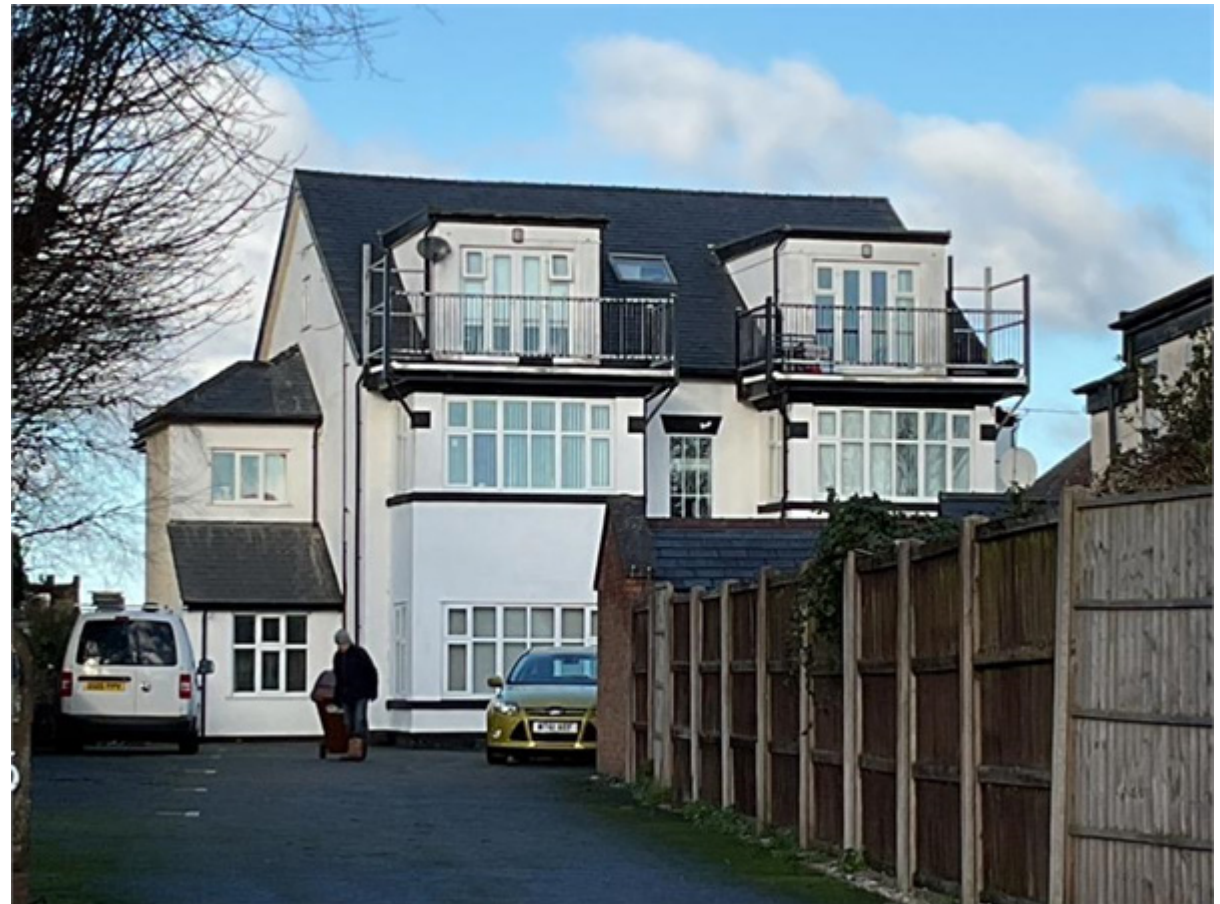
## Building ID: 93

Substantially altered, including side extensions, single-storey extension to beach frontage, balconies and large dormers. Replacement windows throughout. Poor in situ concrete wall to the beach. High border fence to access drive. Identified as C given alterations.

Rear elevation overlooks the north coastline, large flat dormers.

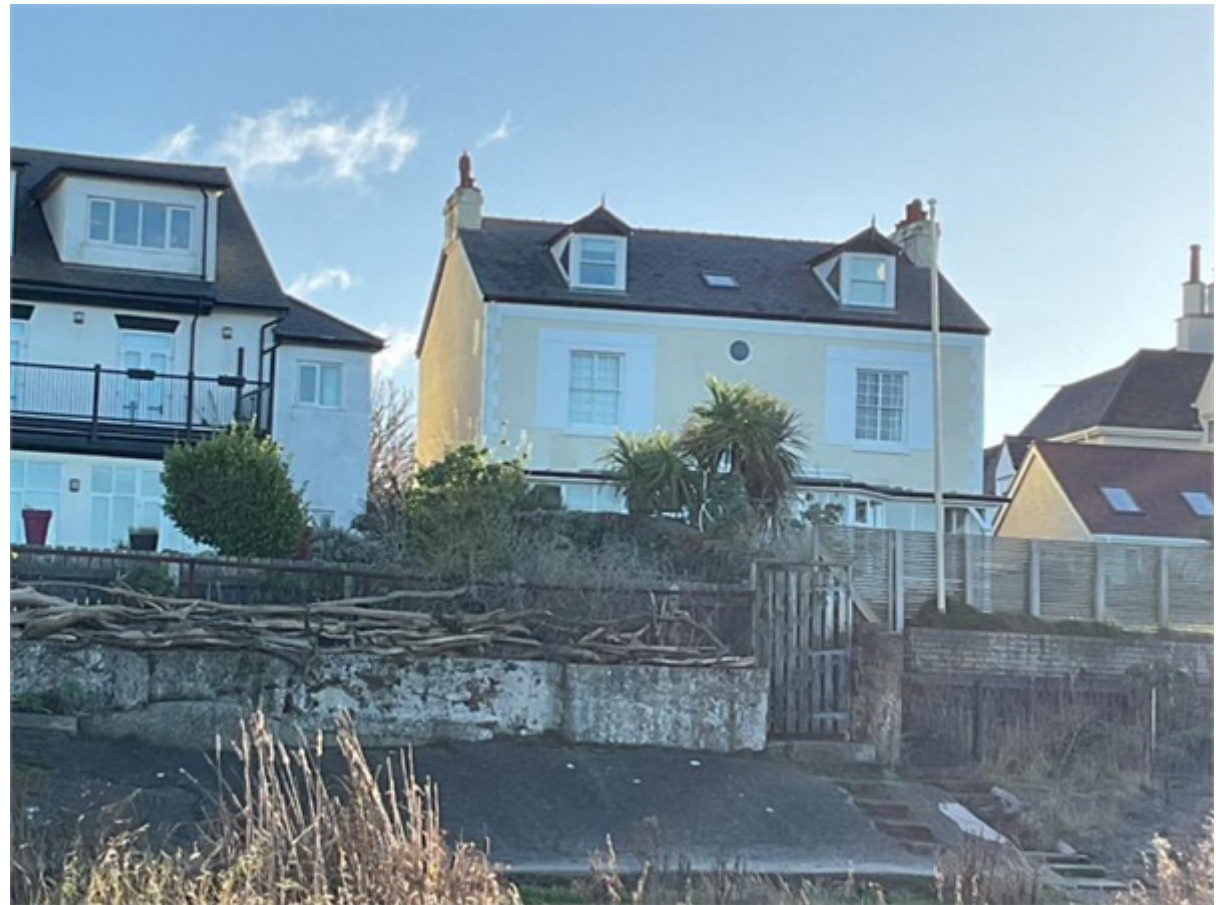
## Building ID: 94

Replacement windows to beach front elevation.

Rear elevation overlooks the north coastline, attractive. Fencing added to the boundary atop the wall.

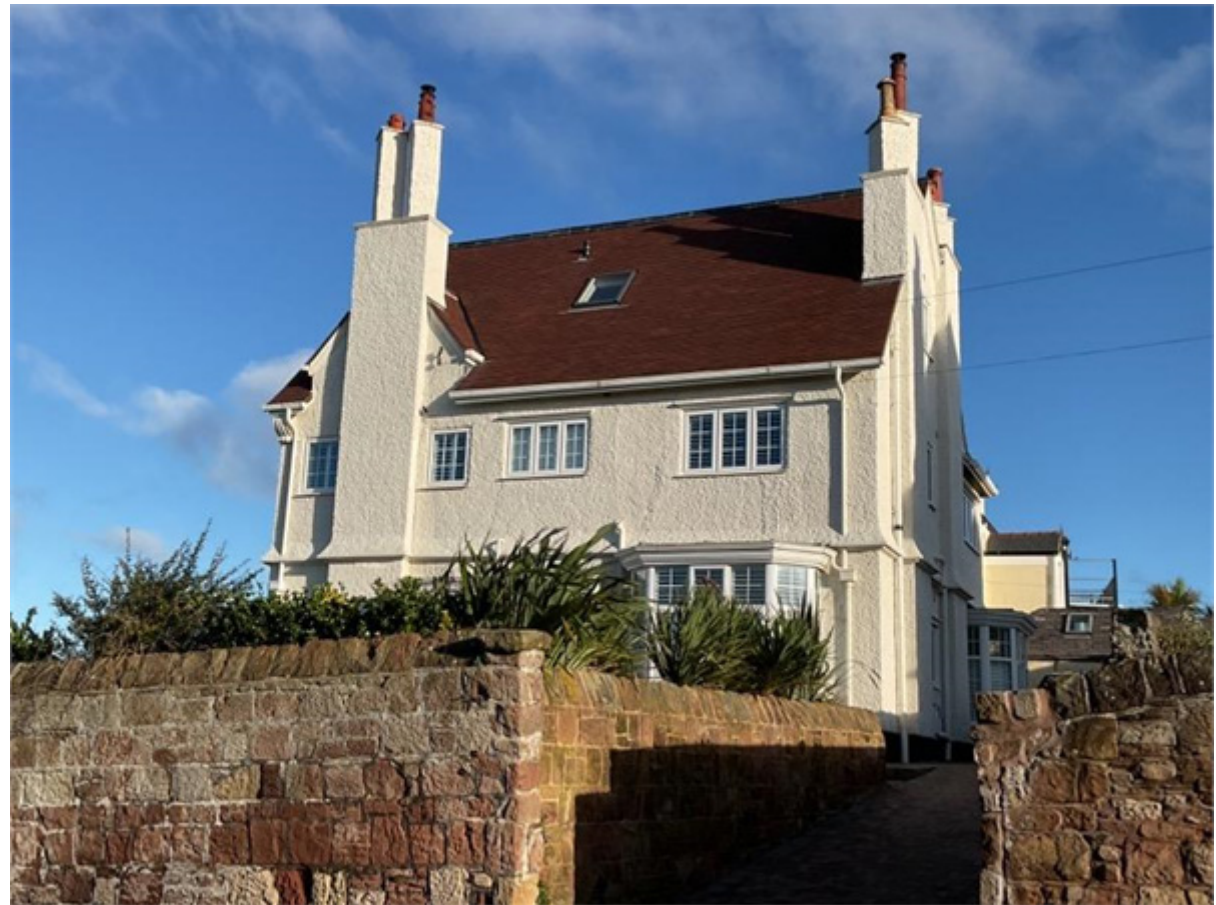
## Building ID: 95

Forms a group with Buildings 96 and 97. Prominent on the beach, and road. Arts and Crafts design with rough cast render; steep roof and small panel windows with decorative mouldings (mainly replacements). Tall form with prominent chimney stacks on front elevation and gable end, upper flues set on diagonal, and chimneypots. Clay tile roof. Scrolled corbel to eaves at gable end. Bay windows. Porch detail. Stone boundary wall.

Windows are replacements but are well proportioned.

Side elevation overlooks the north coastline. Important gateway to area, well detailed. Has added timber fencing.

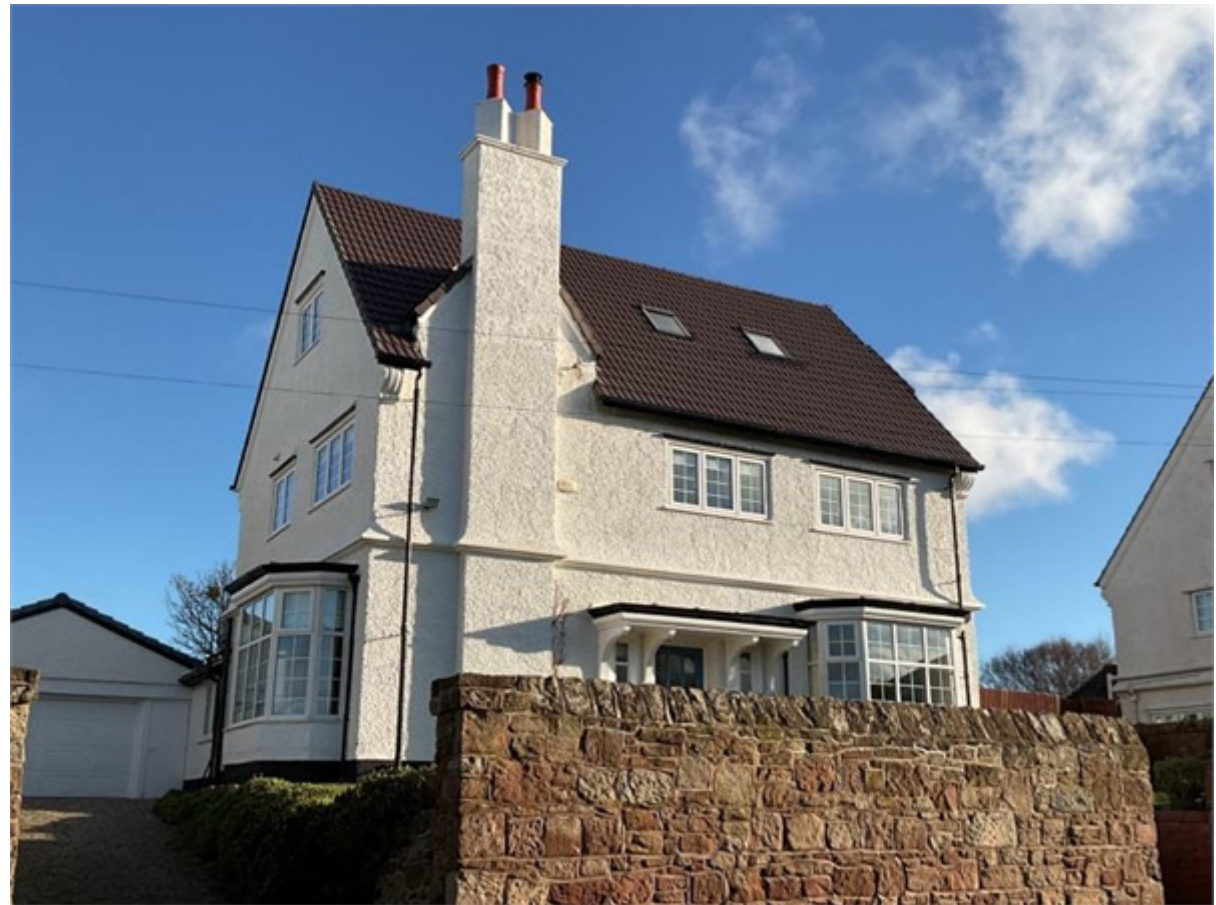
## Building ID: 96

Arts and Crafts design with painted rough cast render, steep roof and small panel windows (replacement). Forms a group with Buildings 96 and 97. Tall form with prominent front elevation and gable end chimney stacks, upper flues set on the diagonal, and chimneypots. Scrolled corbel to eaves at either gable end. Bay windows. Porch detail. Stone boundary wall.

Detached garage, roof tiles replace with concrete and windows replaced. End stacks removed.

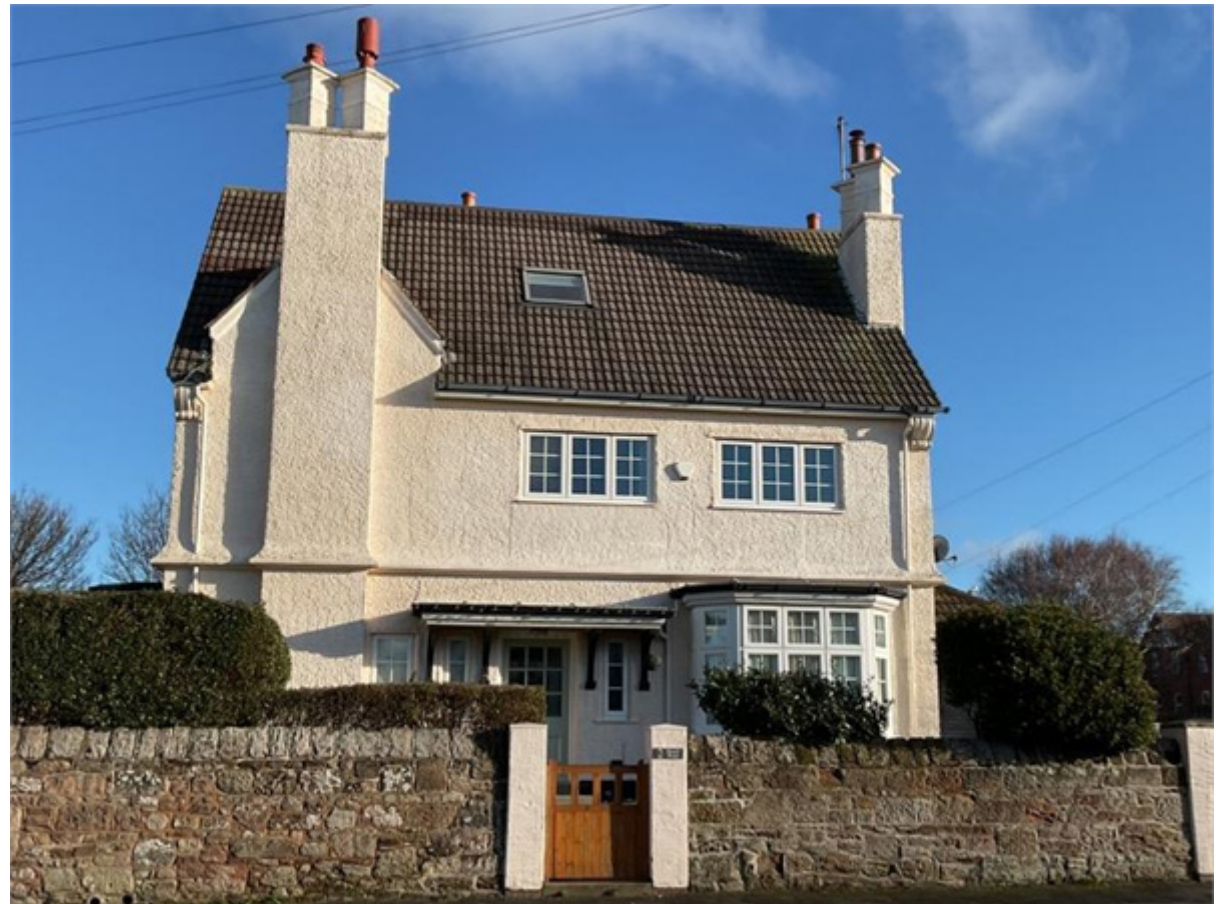
## Building ID: 97

Arts and Crafts design with painted rough cast render, steep roof and small panel windows (replacement). Forms a group with Buildings 95 and 96. Tall form with prominent front elevation and gable end chimney stacks, upper flues set on the diagonal, and chimneypots. Scrolled corbel to eaves at either gable end. Bay windows. Porch detail. Stone boundary wall.

Garage, roof tiles replaced with concrete. Windows replaced but well proportioned.

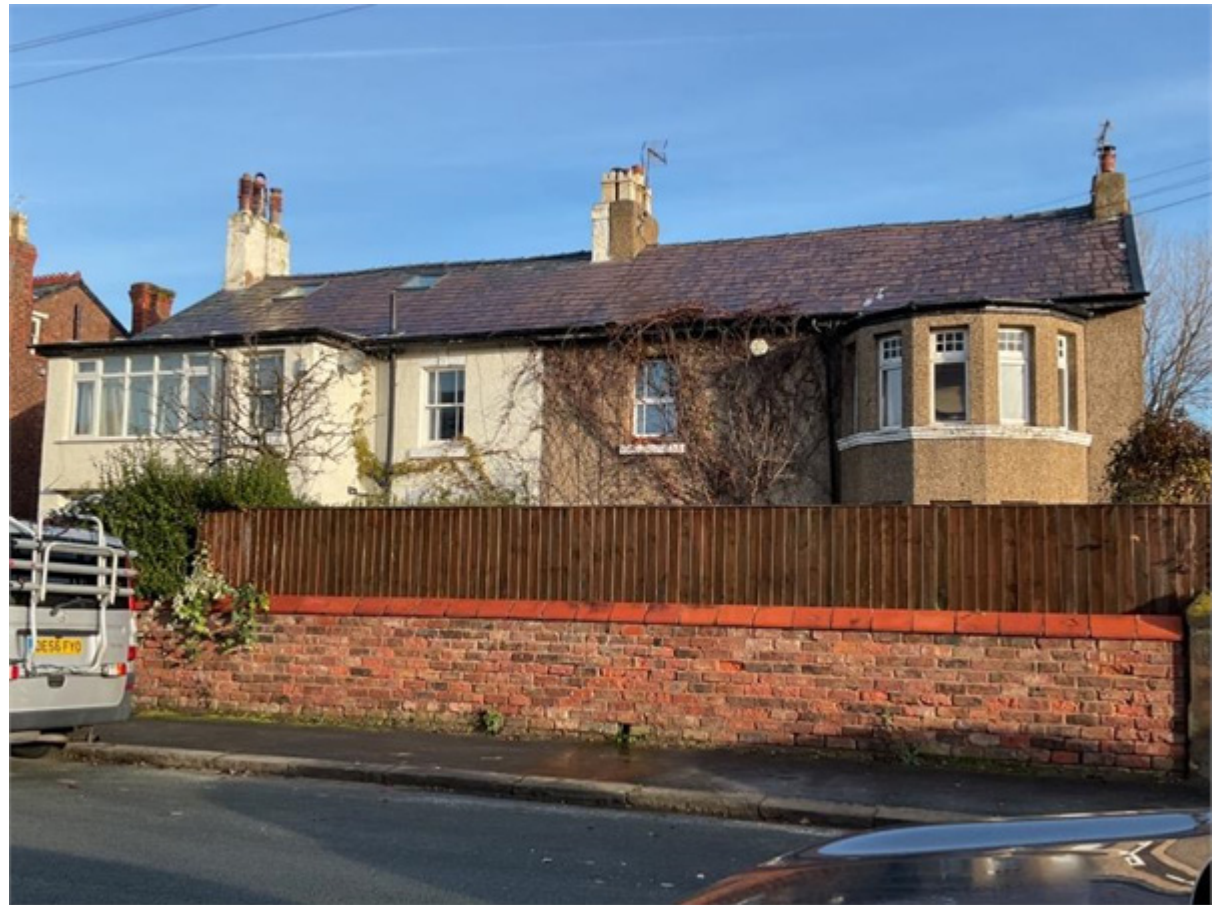
## Building ID: 99

Symmetry has been undermined by substantial alteration to r/h, with extended replacement of canted bay. Close board fencing also set behind brick wall. Range of mismatched replacement windows.

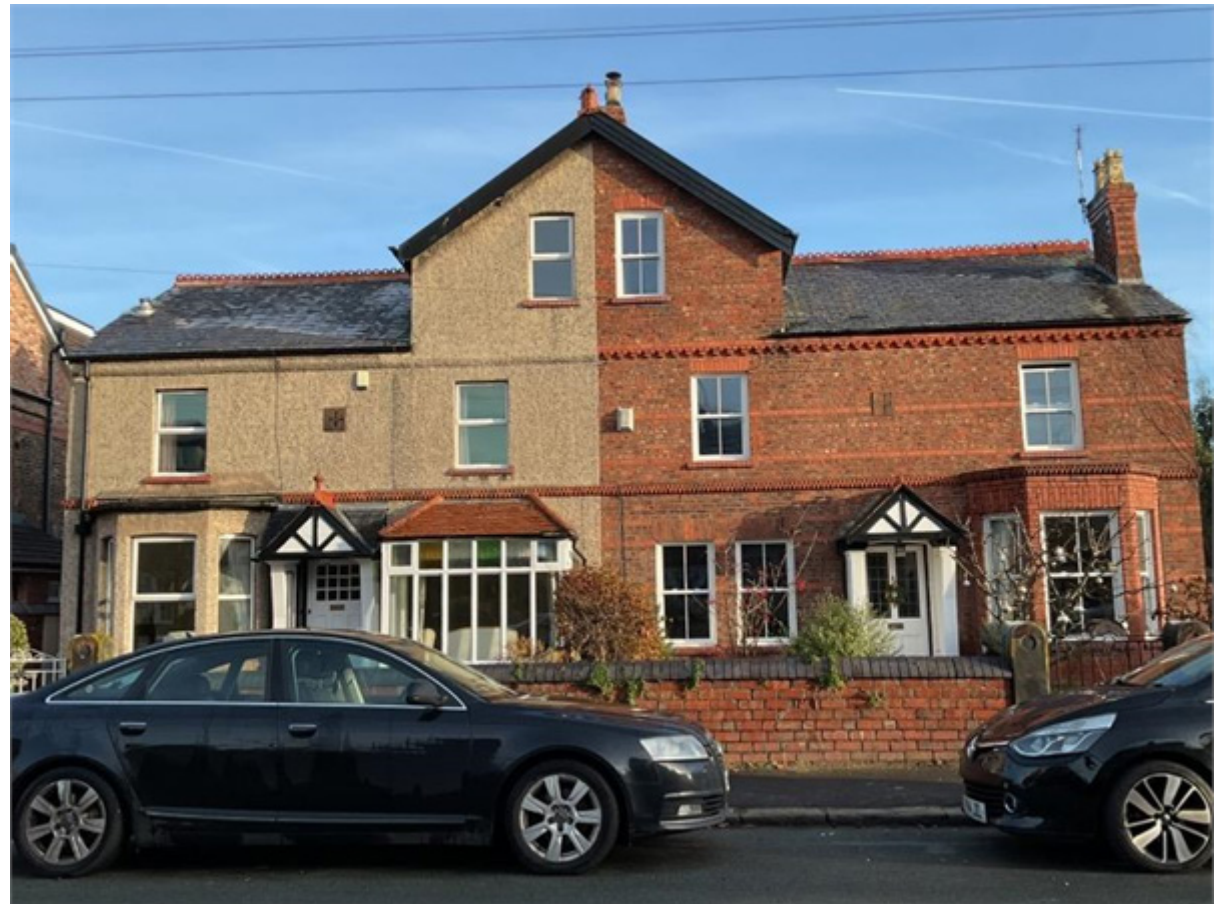
## Building ID: 100

L/h has been rendered and has replacement windows.

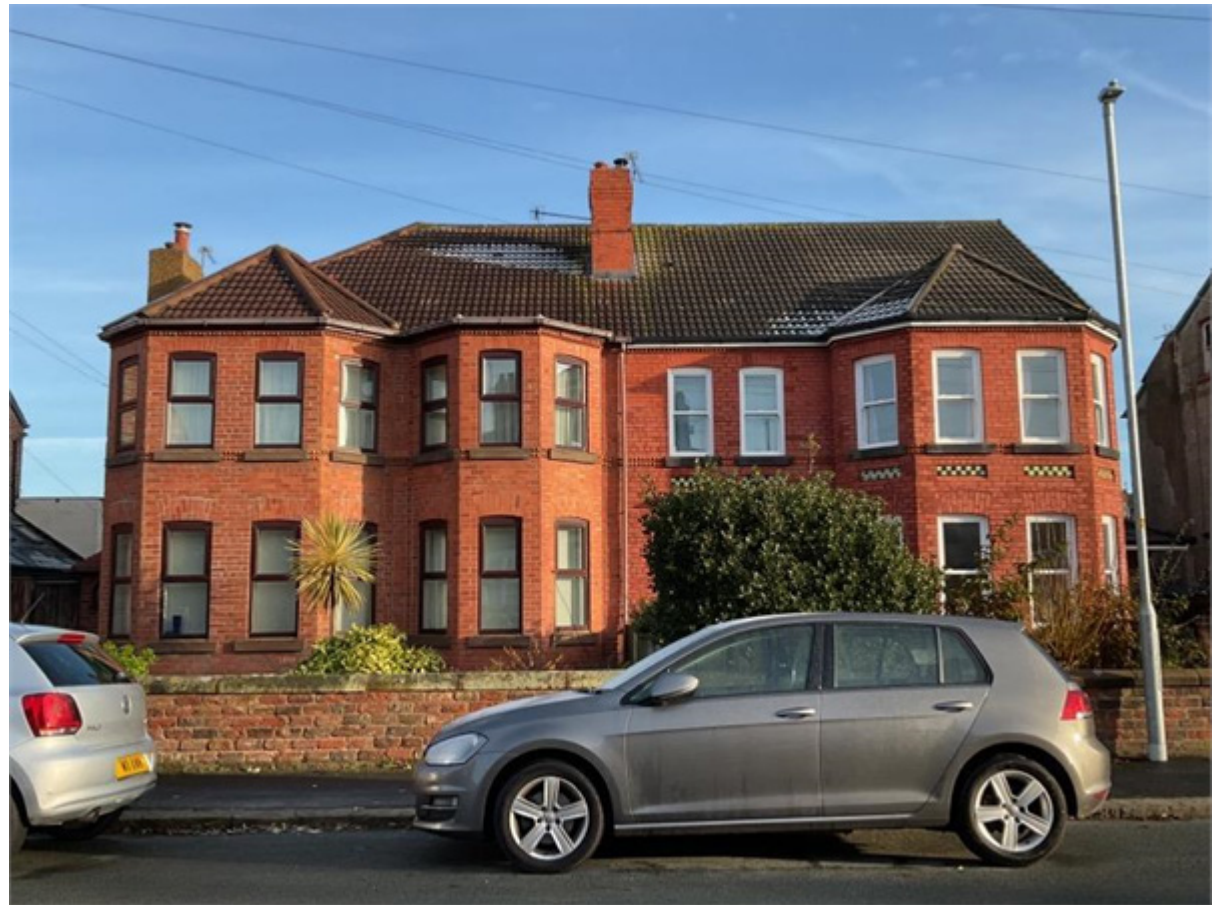
## Building ID: 101

Concrete roof tiles and replacement windows.  
Widened drive.

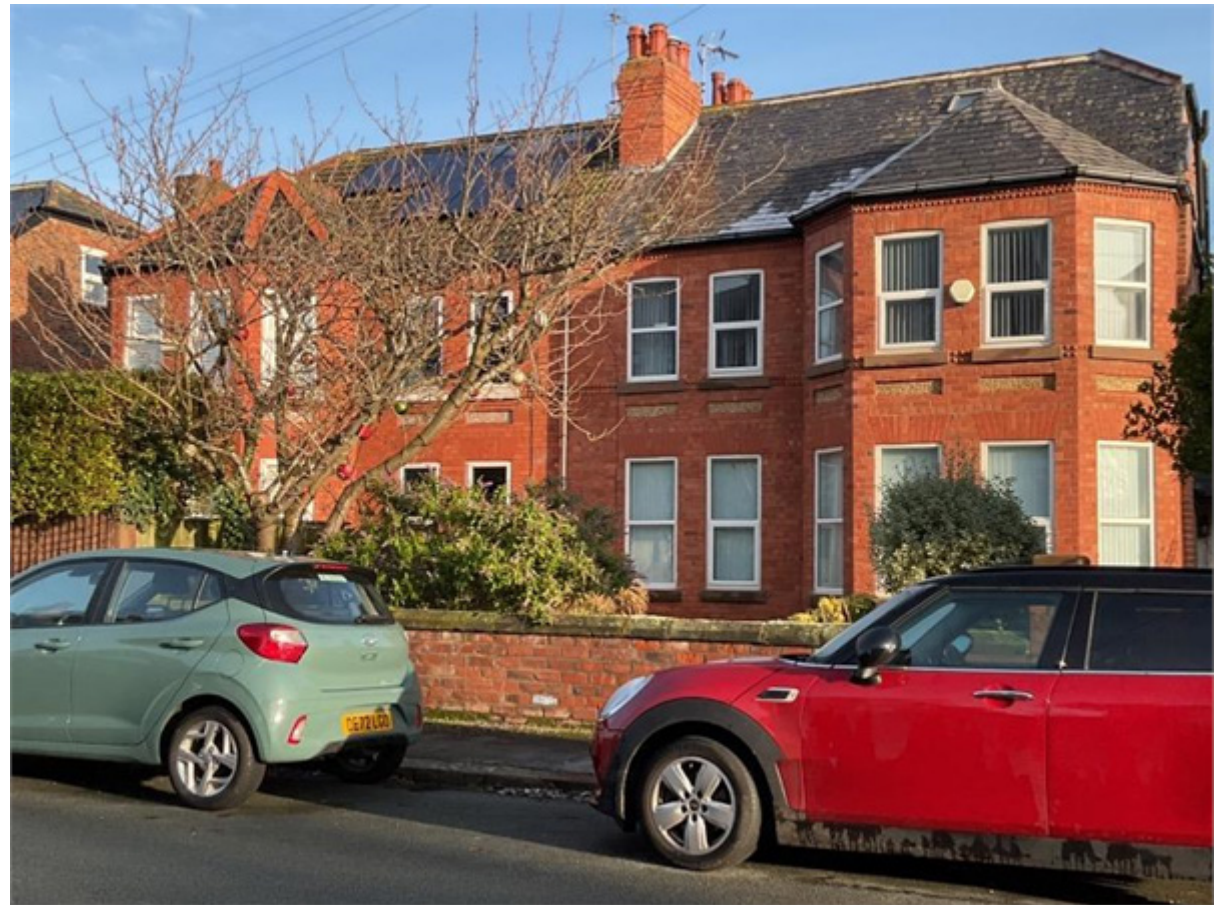
## Building ID: 102

Roof tiles replaced with concrete to l/h and windows replaced. Close board fence to l/h.

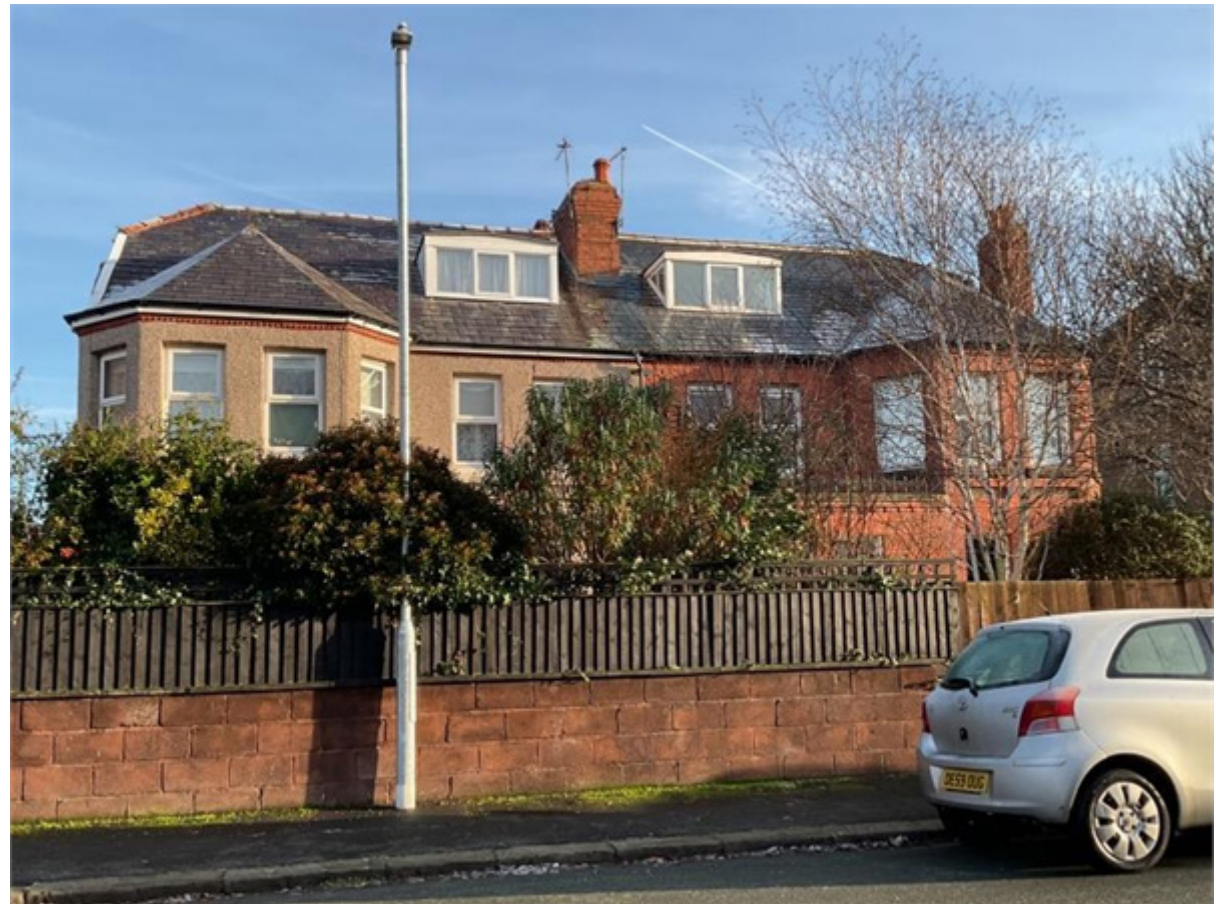
## Building ID: 103

L/h has been rendered. Windows replaced and modern dormers. Close board fencing on top of boundary walls.
