**Donald Insall Associates**  
Chartered Architects and Historic Building Consultants

The King's Gap Gazetteer

## Introduction

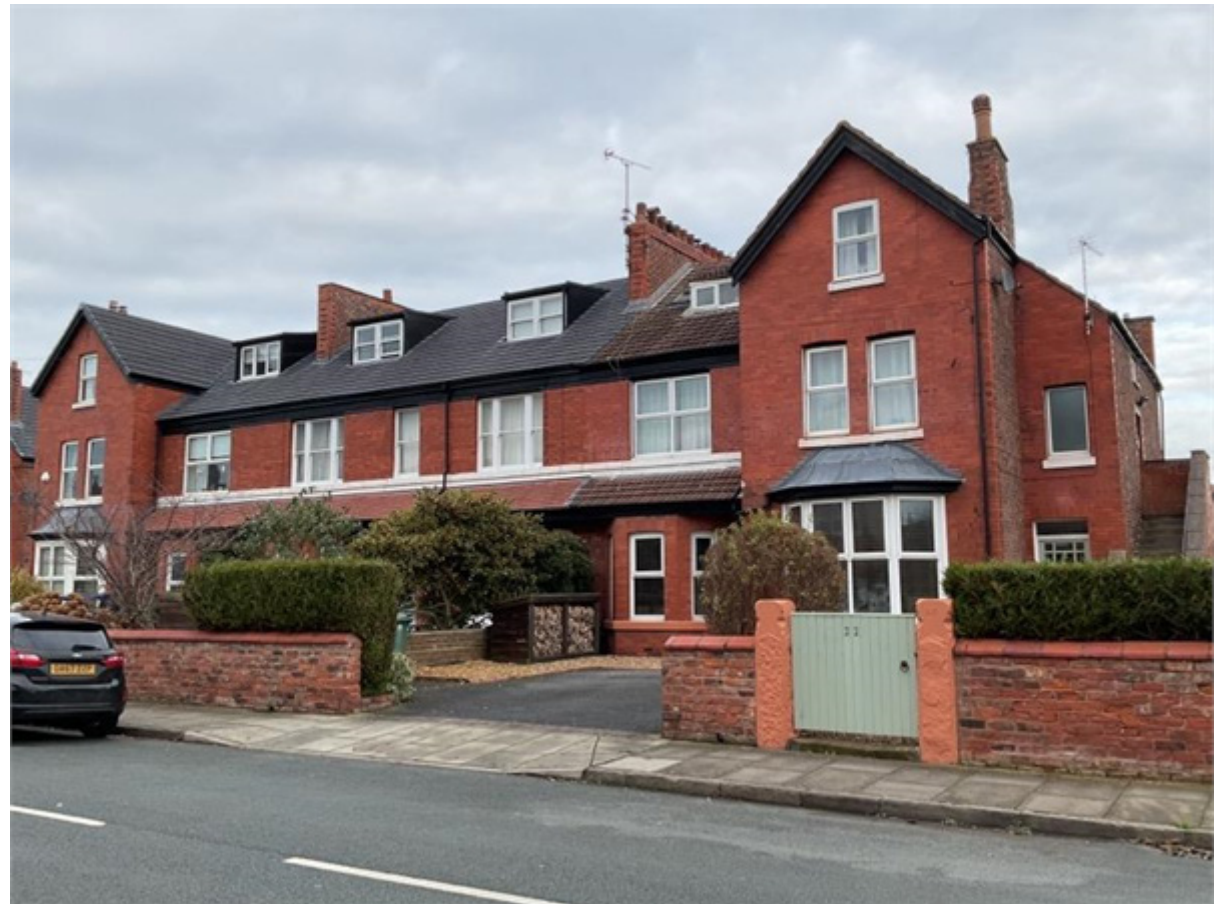
## Building ID: 104

Windows replaced to end properties and ad hoc replacement of roof tiles. Some chimney pots removed. External stair to r/h property. Sections of brick wall have been removed for driveways, and copings replaced.

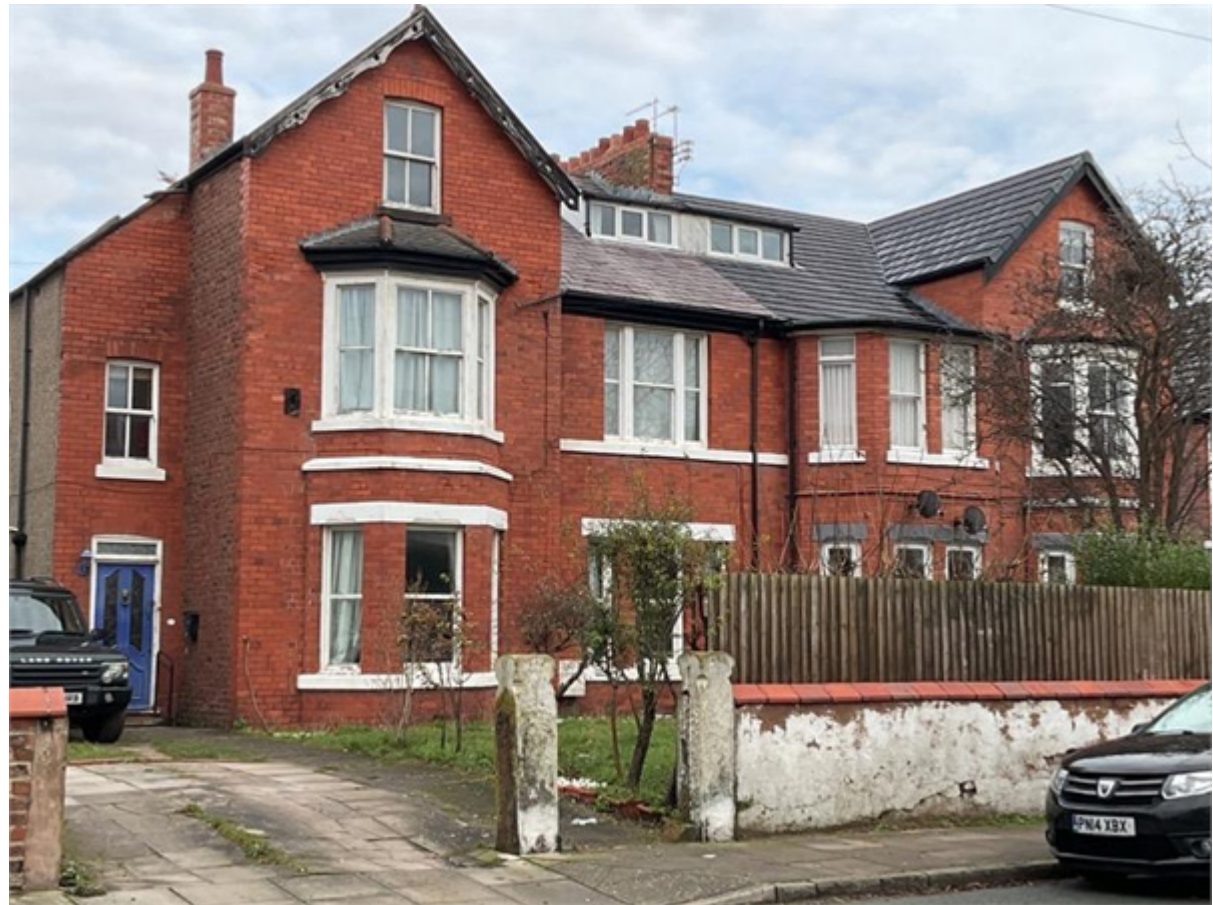
## Building ID: 105

R/h roof tiles replaced. R/h has lost detailing including bargeboards and finials. Most windows replaced. Boundary wall has been rendered, peeling, and close board fence added to l/h and part removed for driveway.

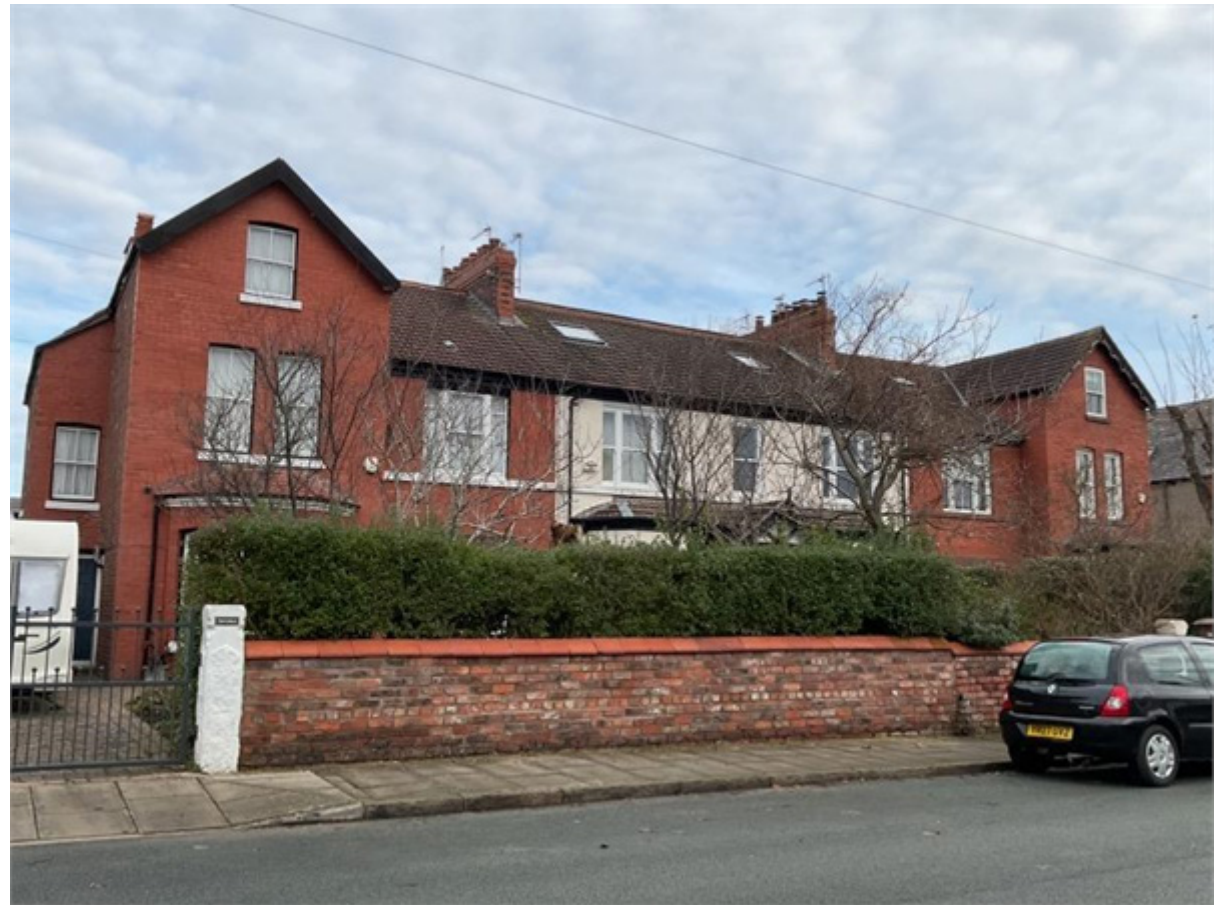
## Building ID: 106

Central section has been rendered, roof tiles replaced and some detailing such as bargeboards lost.

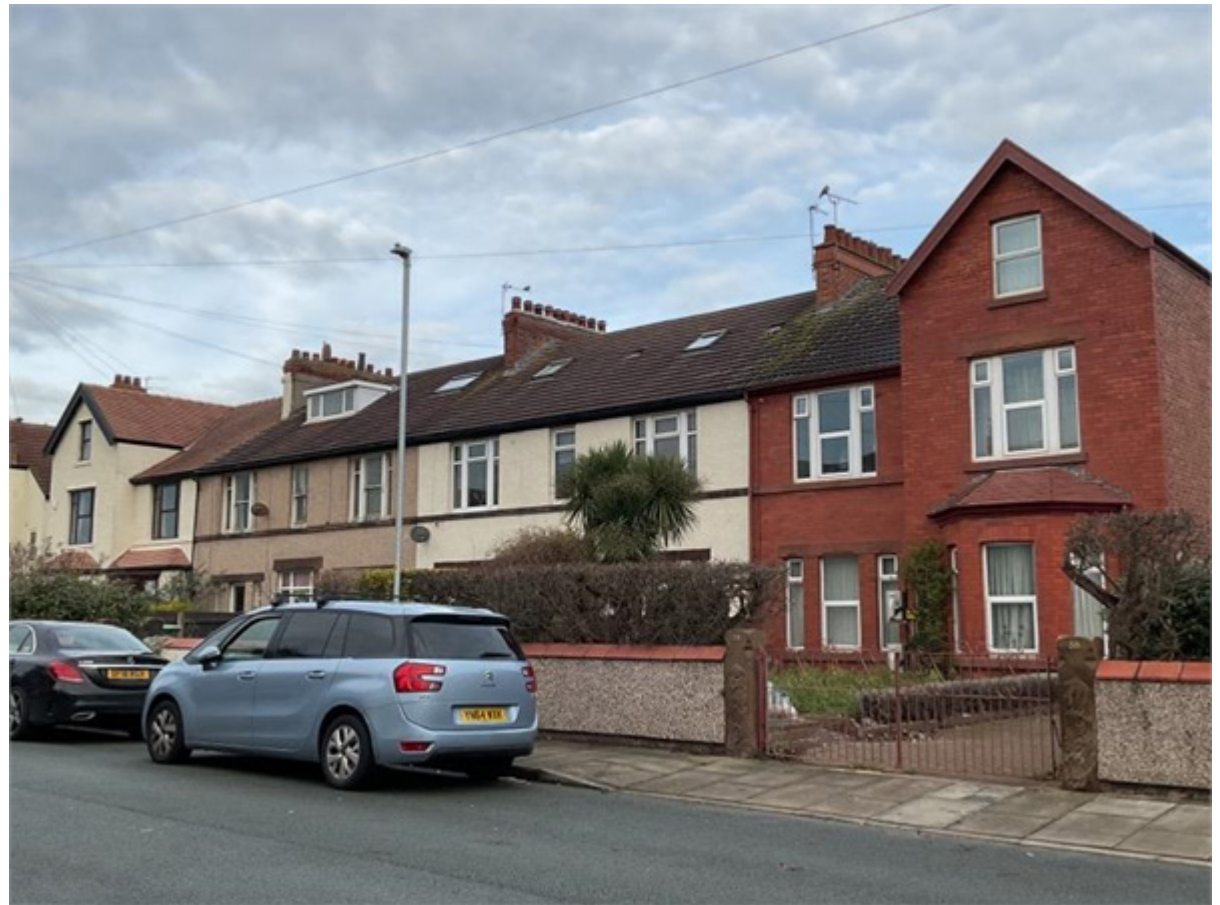
## Building ID: 107

Roof tiles replaced, three of the four sections are rendered. Windows largely replaced, and rooflights inserted. Modern dormer.

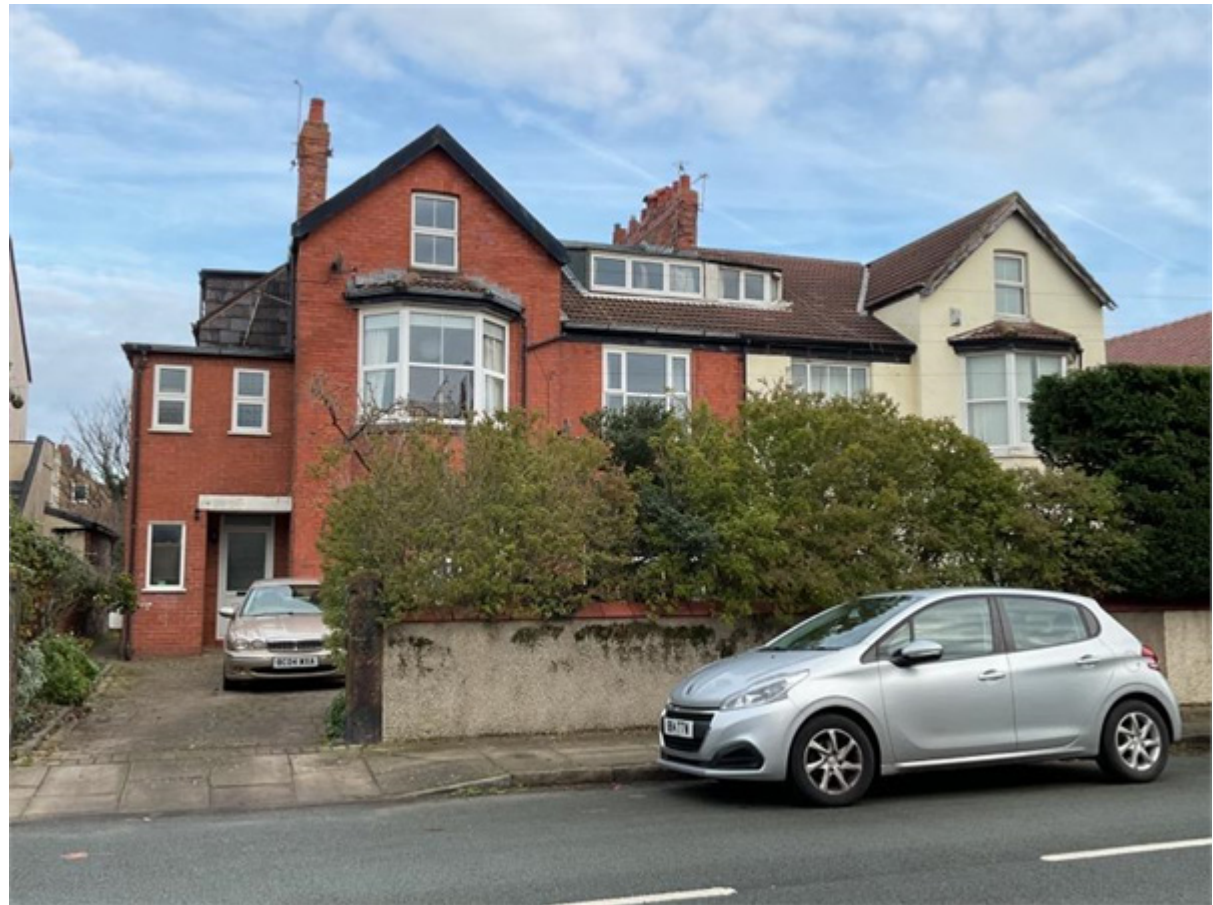
## Building ID: 108

Large modern extension to side of l/h (that to r/h more modest). R/h has been rendered. Retains low boundary wall with piers, but it has been rendered. Roof tiles replaced, replacement windows and dormers added. Tall Leyland hedge to r/h.

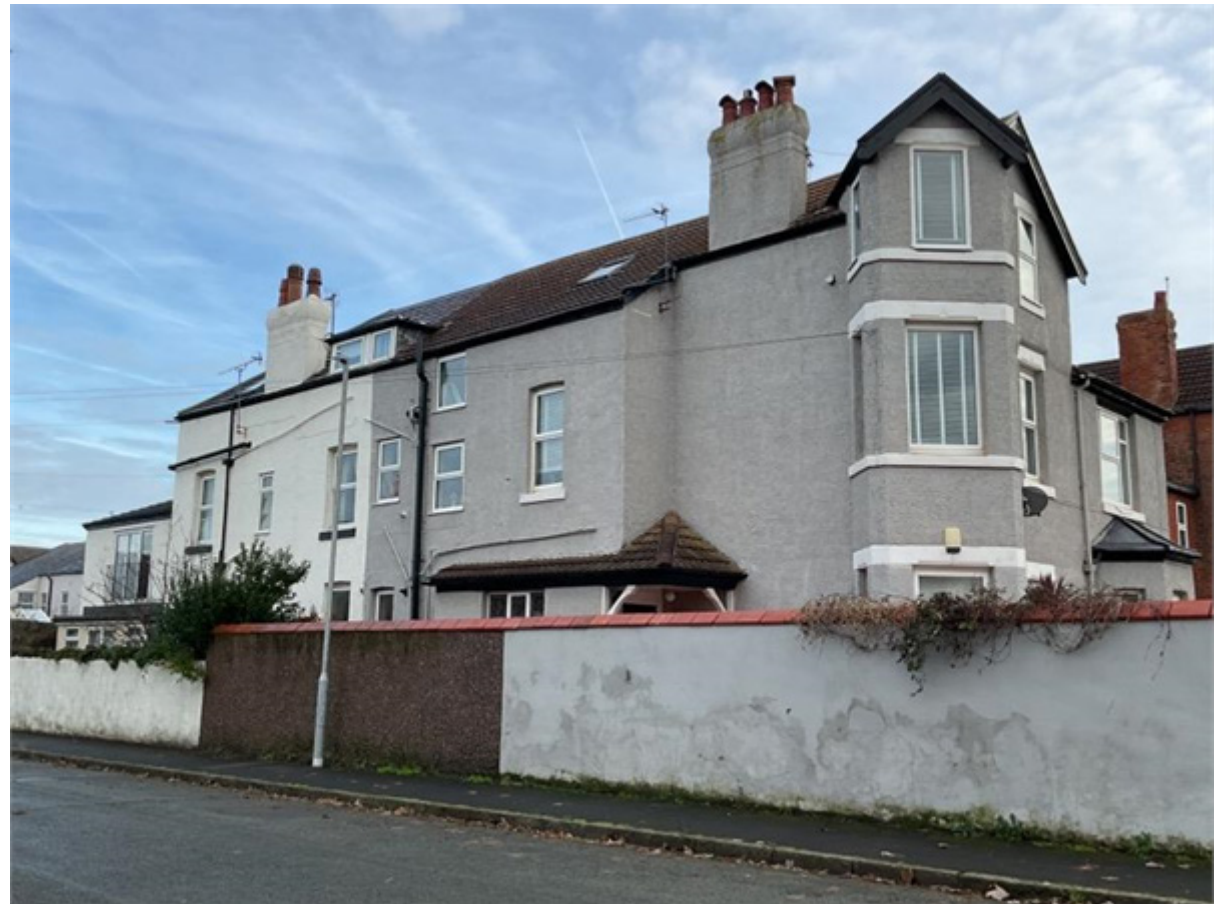
## Building ID: 109

Rendered, substantially extended and cluttered with pipe work. Much detailing, including roof tiles and windows, have been lost. Identified as C given alterations. Bland side extension. Boundary wall has been raised and rendered.

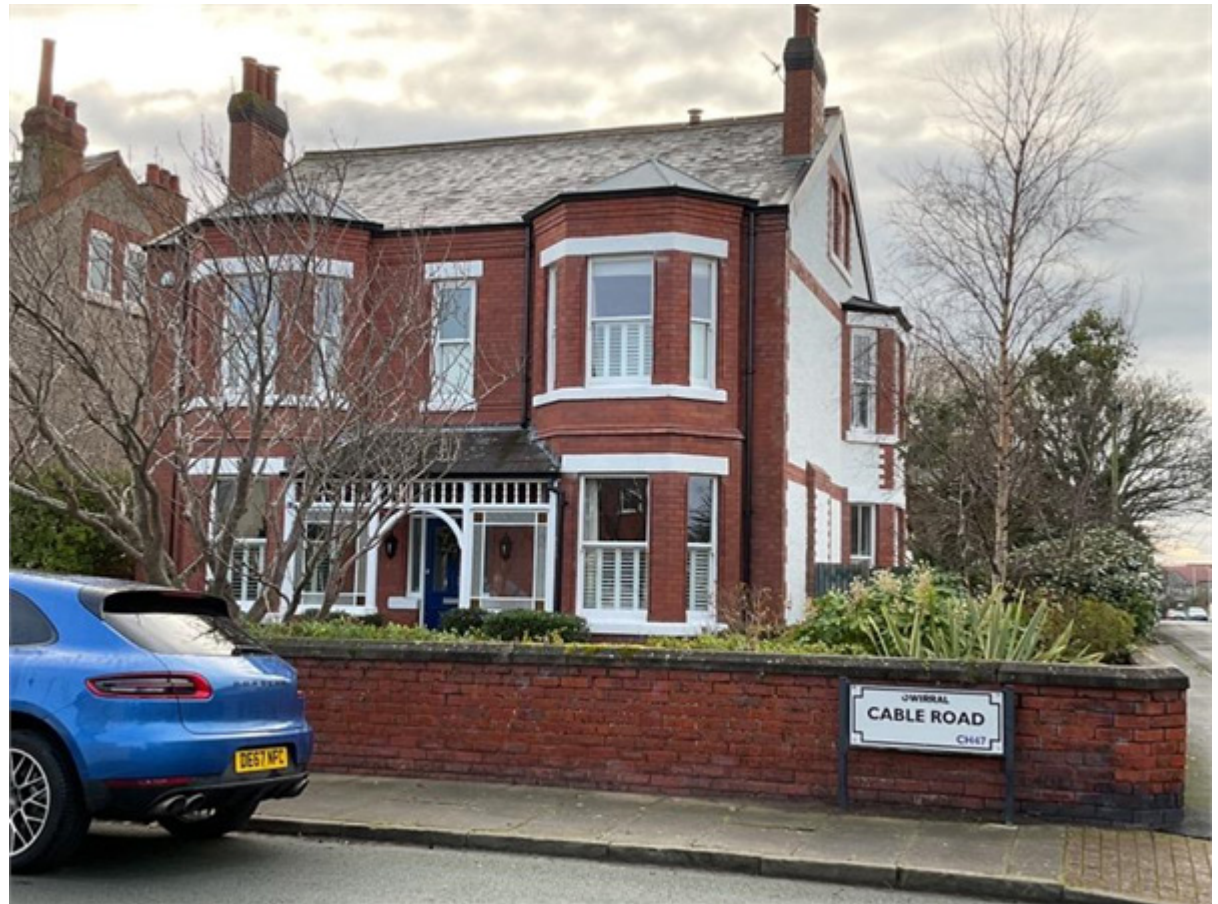
## Building ID: 110

Side boundary wall has close board fencing.

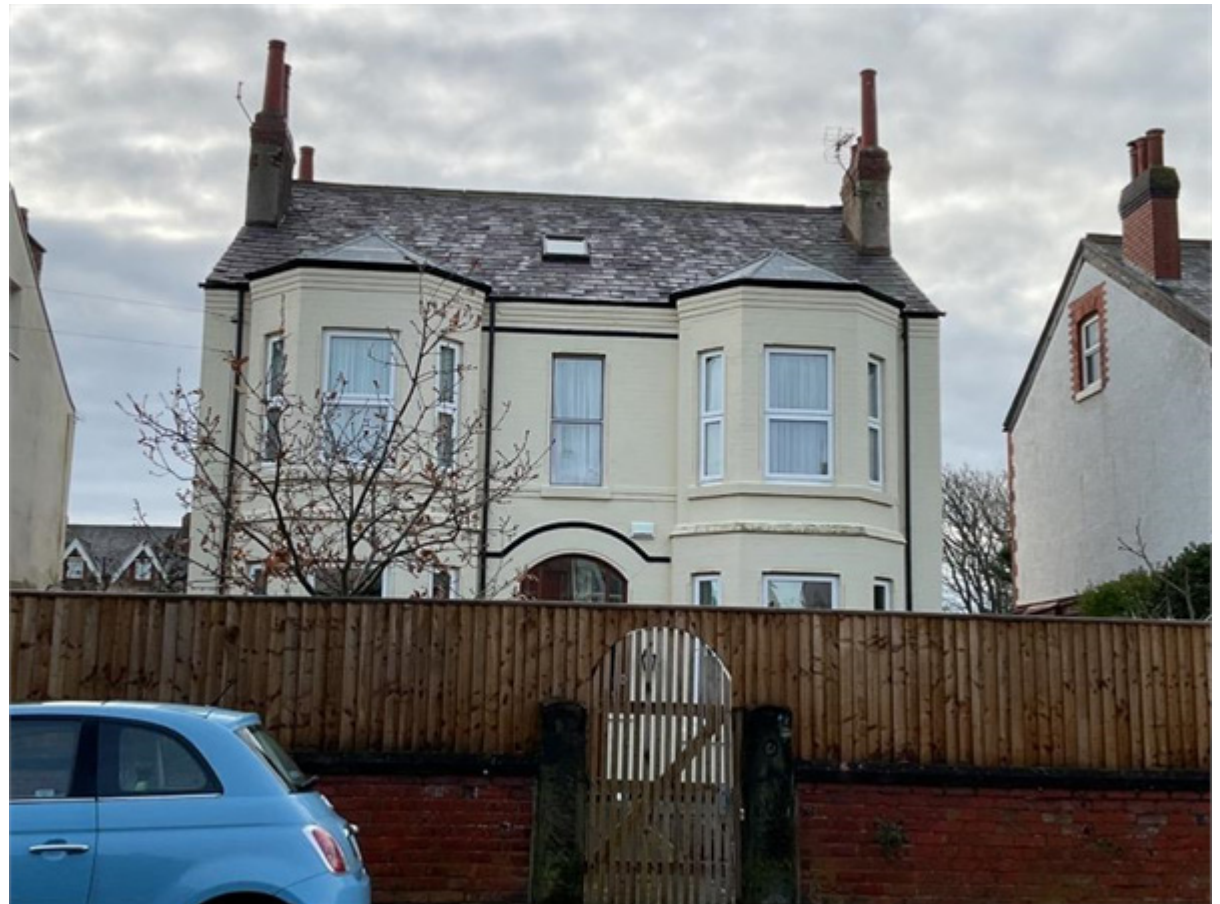
## Building ID: 111

Windows replaced. Building likely historically brick (as per Building 114) with door header detail, now painted. Large close board fence and gate atop / behind boundary wall.

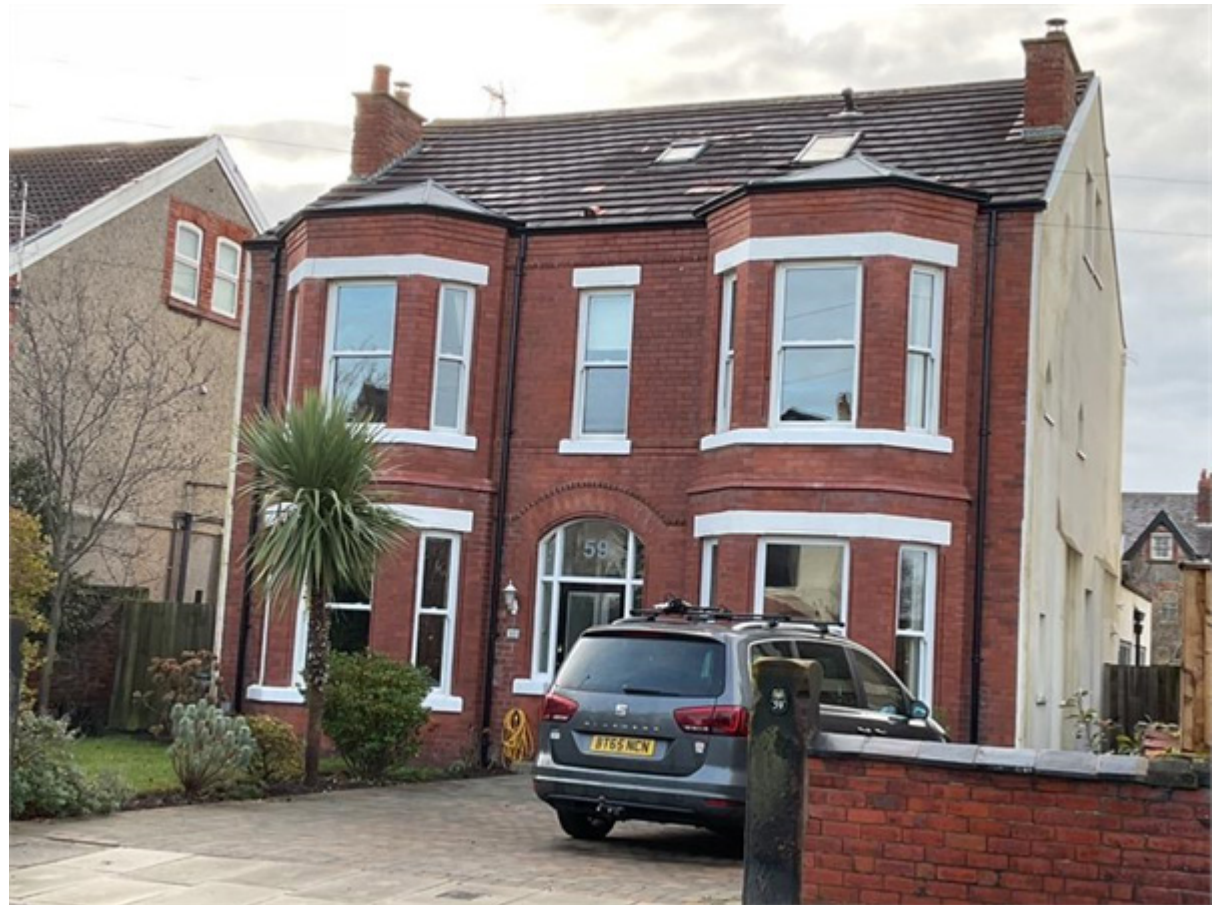
## Building ID: 112

Roof tiles replaced. Large section of the boundary wall lost for drive access (prominent hardstanding, but well detailed).

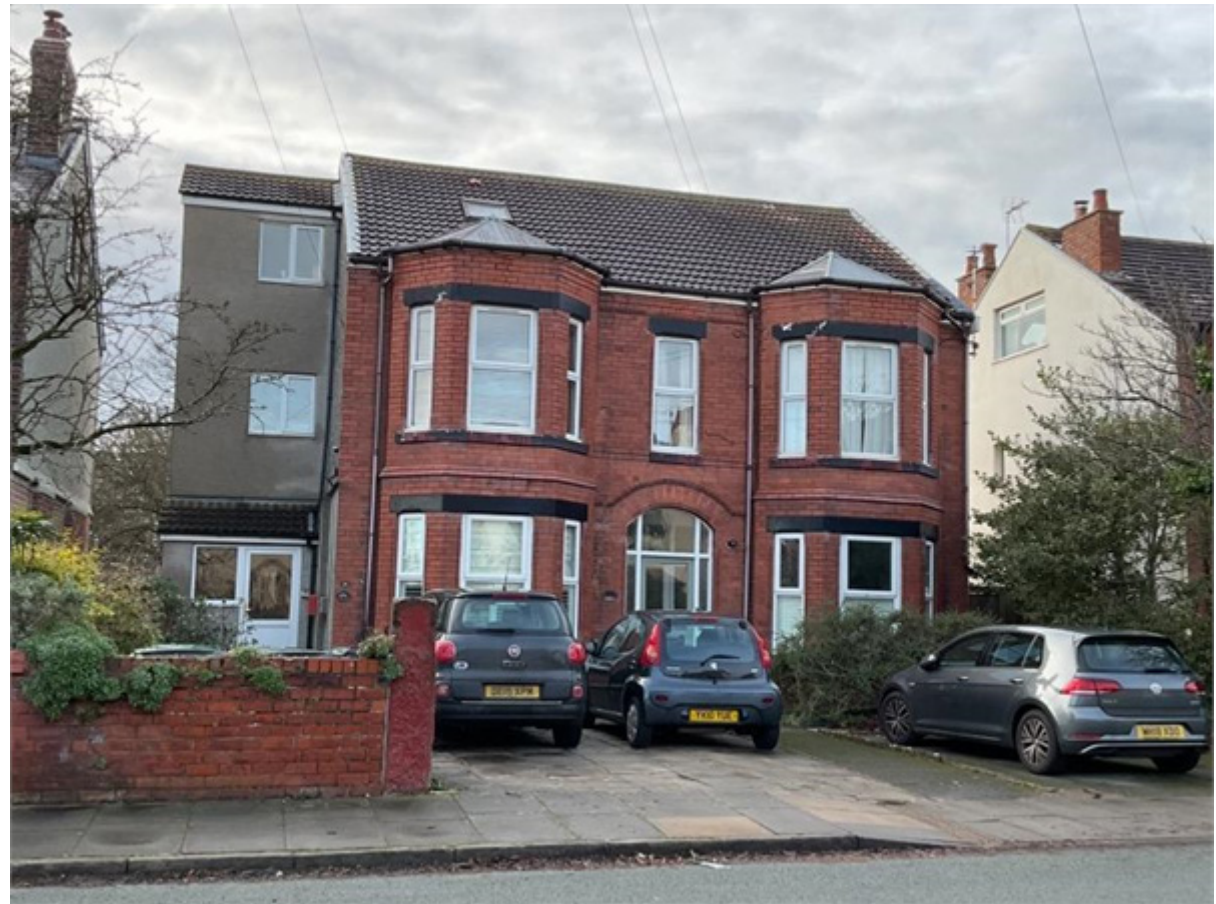
## Building ID: 113

Roof tiles (now concrete) and windows replaced. Chimneys removed. Modern extension to l/h. Most of the boundary wall lost for drive access (prominent and poor-quality hardstanding) although stone piers remain.

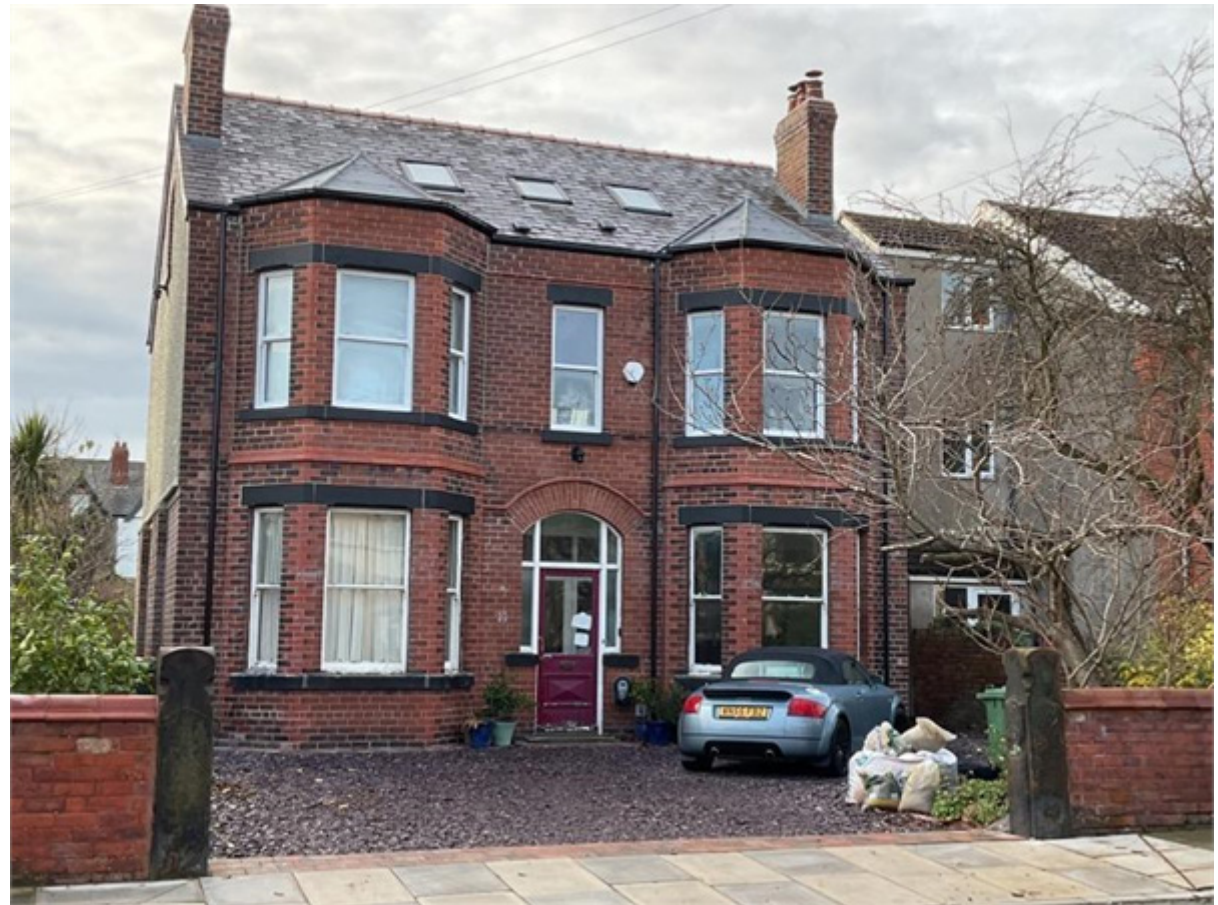
## Building ID: 114

Gate piers moved to provide wide driveway.

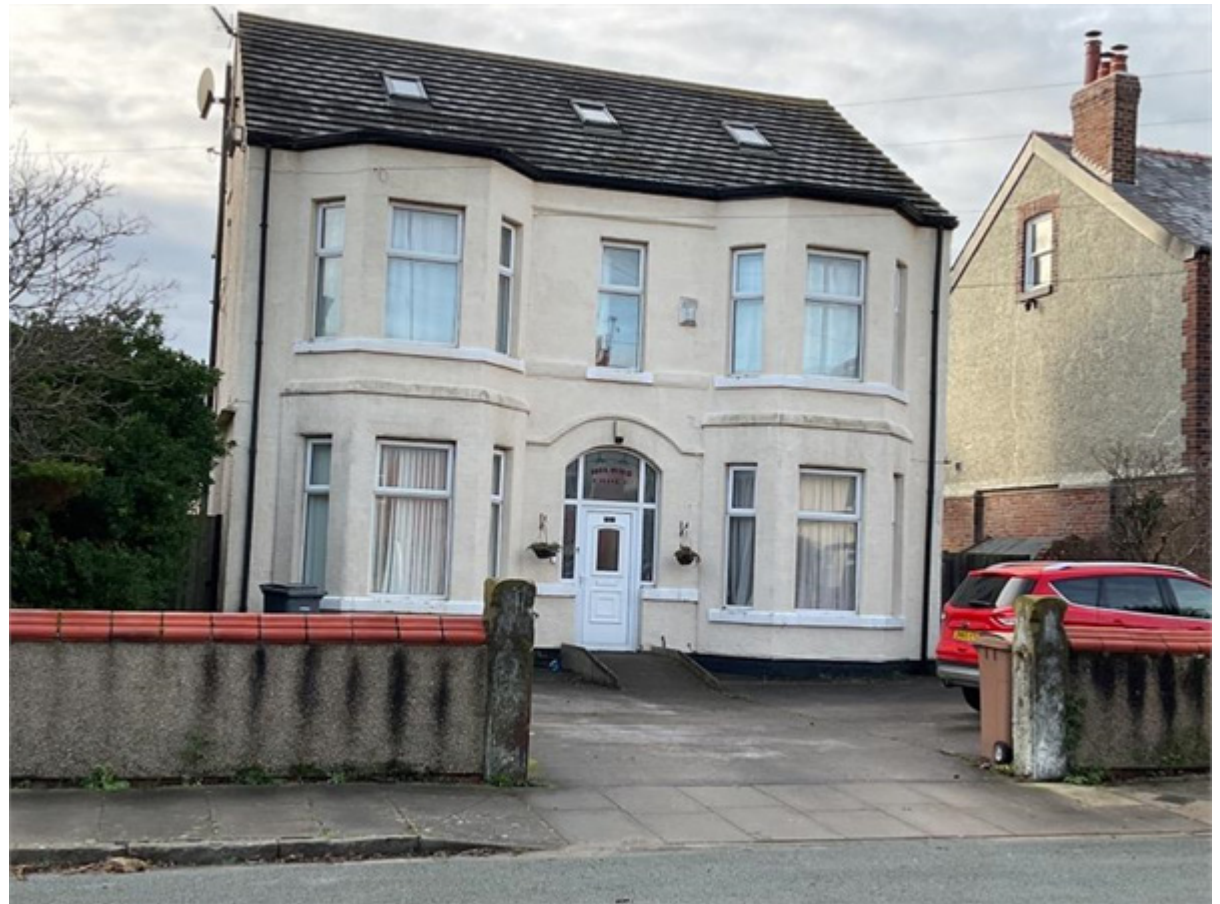
## Building ID: 115

Much altered. Roof tiles replaced, and chimneystacks lost. Replacement windows. Property and boundary wall rendered, part of the wall removed for driveway (majority of the front garden is hardstanding) although stone piers retained.

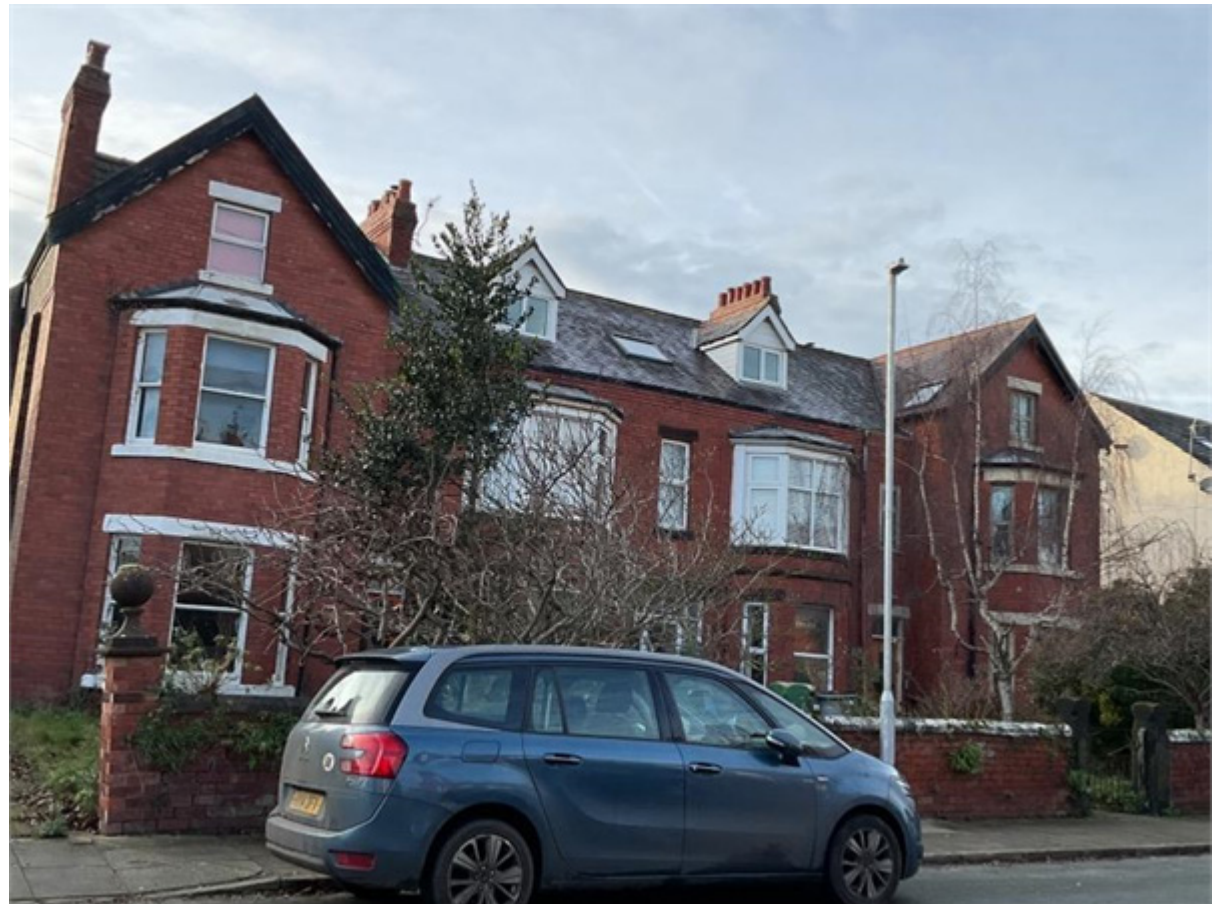
## Building ID: 116

UPVC window replacements, to centre house and elsewhere, including to prominent dormers.

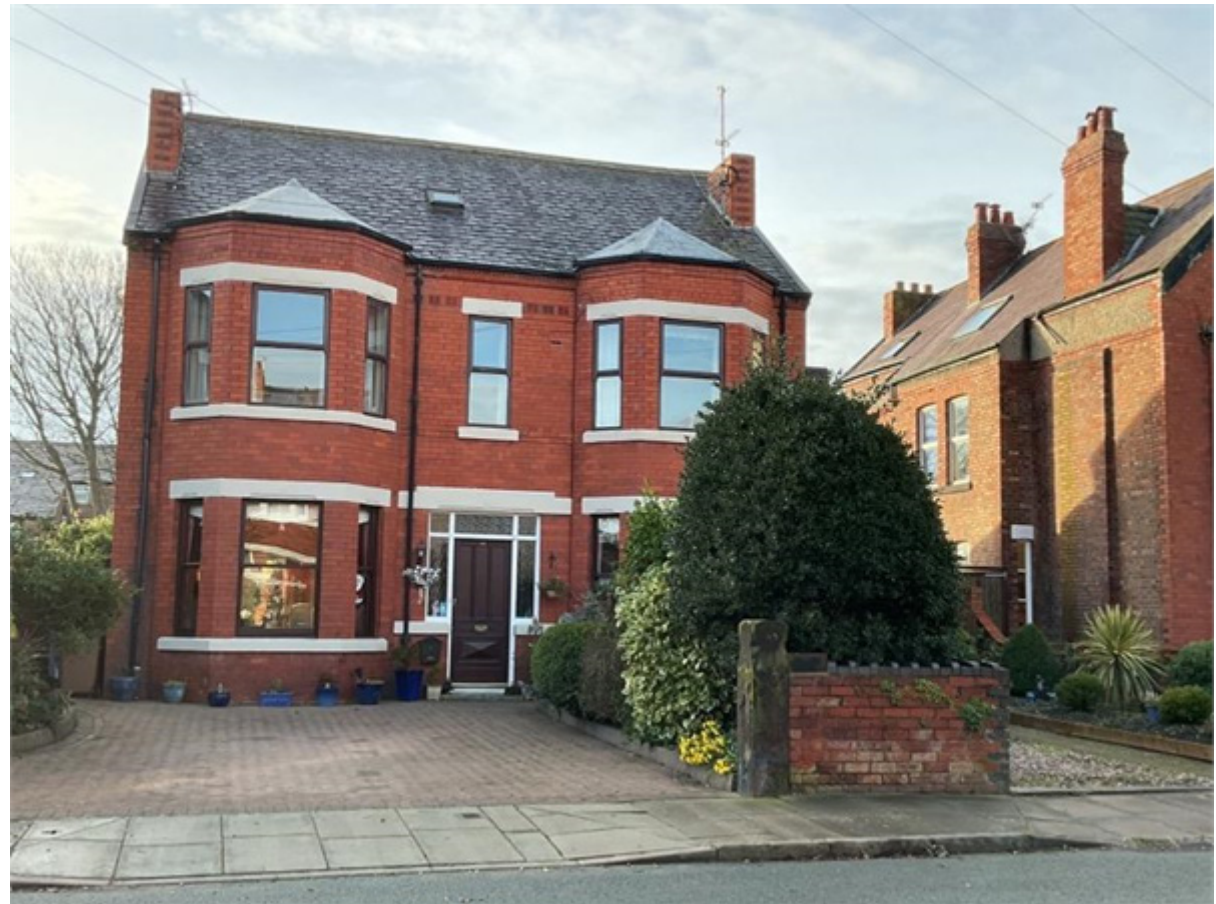
## Building ID: 117

Replacement windows. Vast majority of boundary wall lost for driveway (relatively poor), although piers are retained. Property has been split in two with r/h accessed from a poor modern extension.

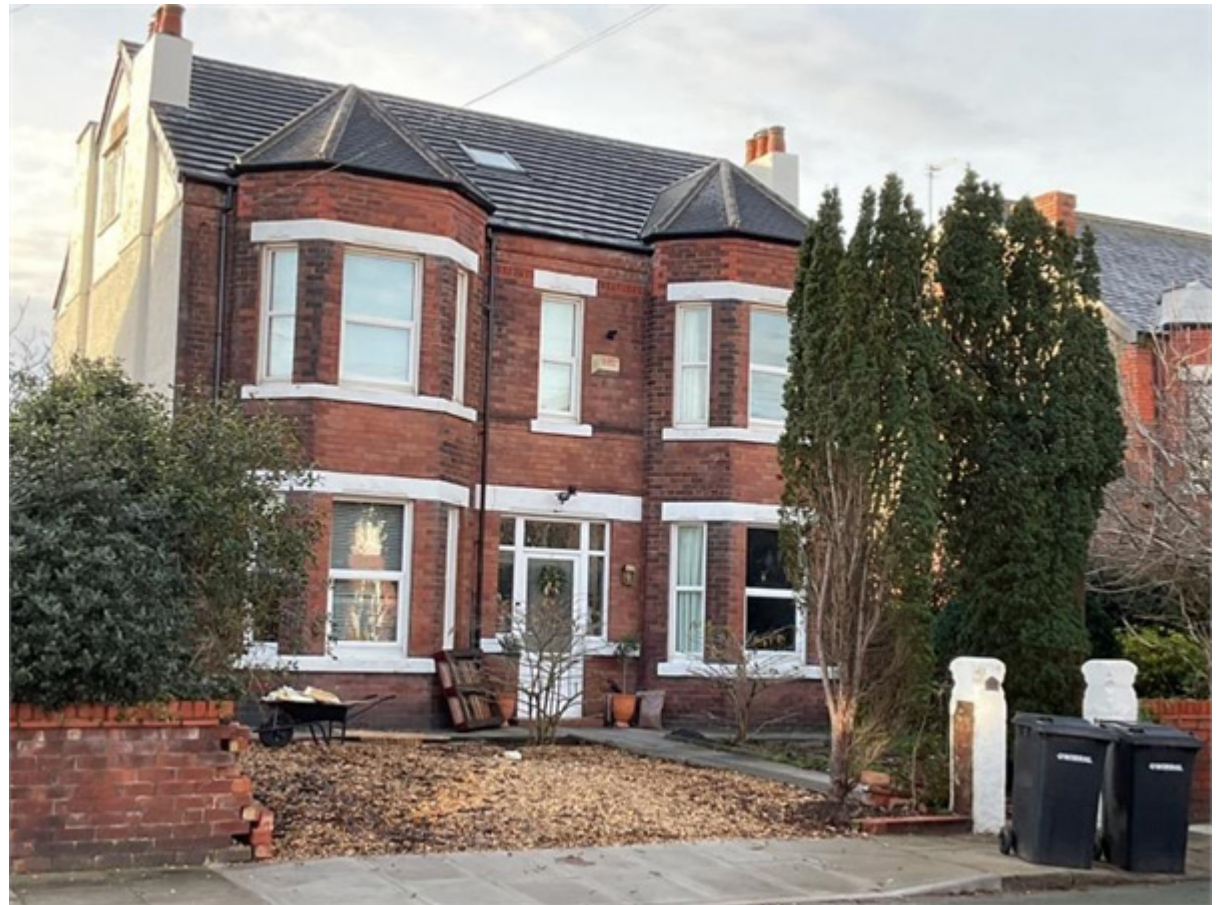
## Building ID: 118

Concrete tiled roof. Replacement windows. Half of boundary wall demolished and gravel hardstanding for parking.

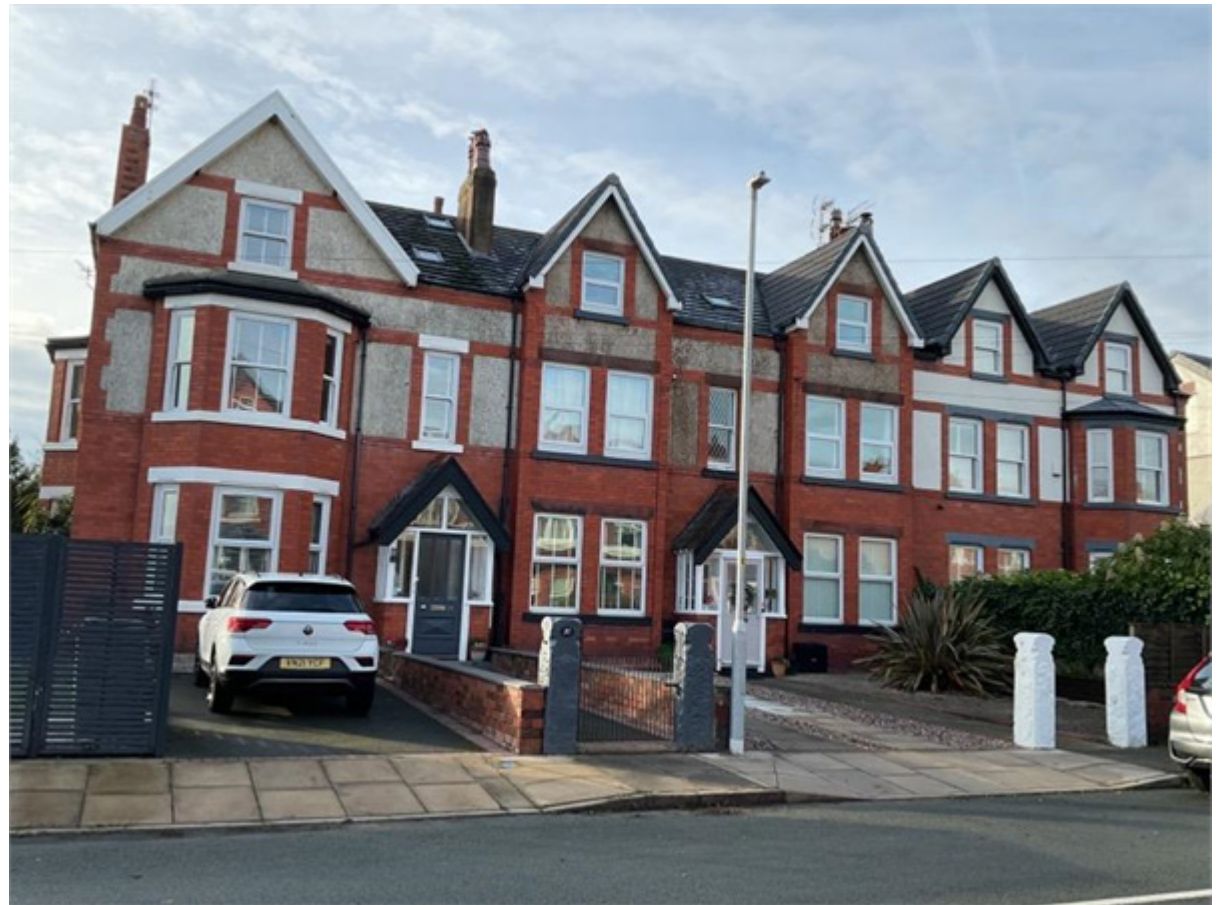
## Building ID: 119

Modern roof tiles (concrete) and bargeboards.  
Most windows replaced. Sections of walling lost for driveways and some fencing inserted.

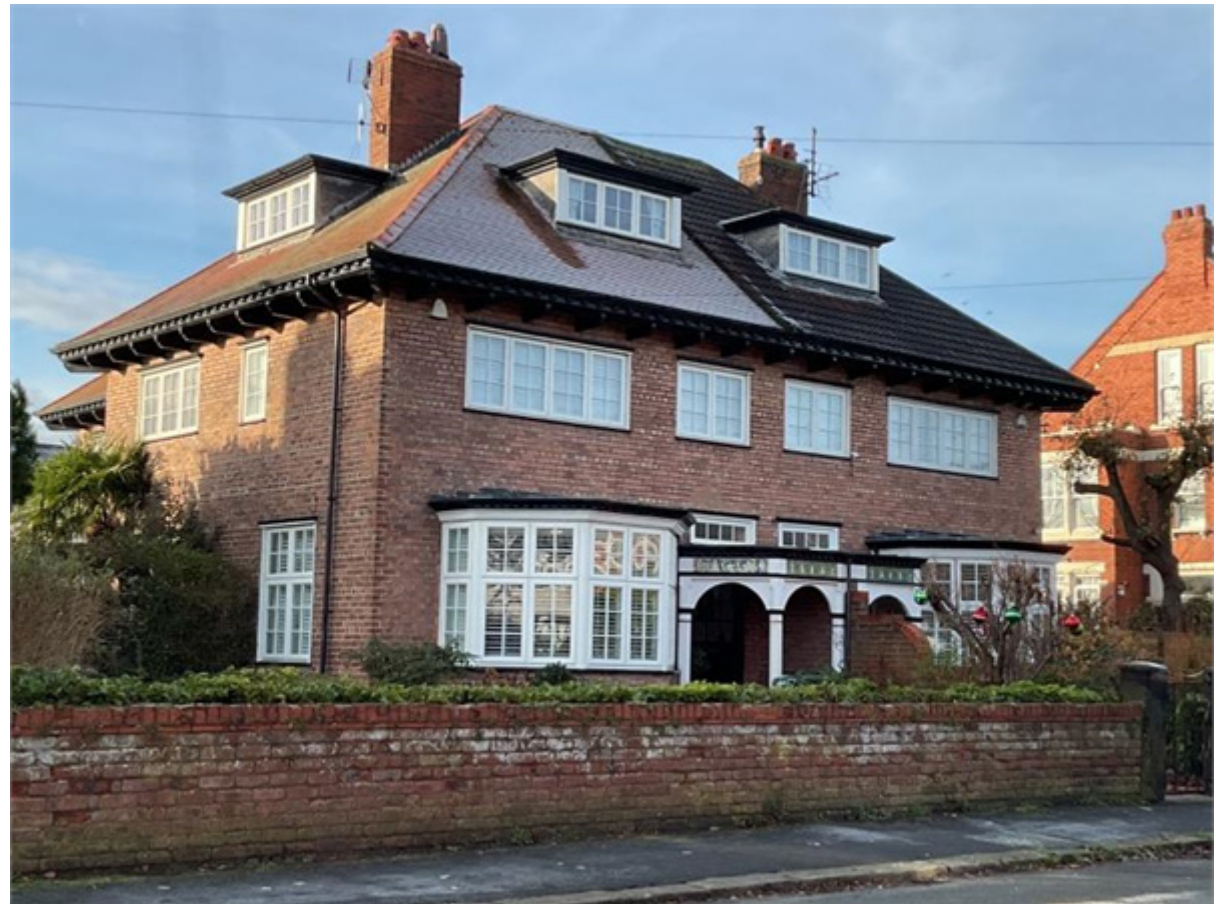
## Building ID: 121

R/h has concrete roof tiles. Low boundary brick wall to r/h replaced with piers and railings, and wide driveway.

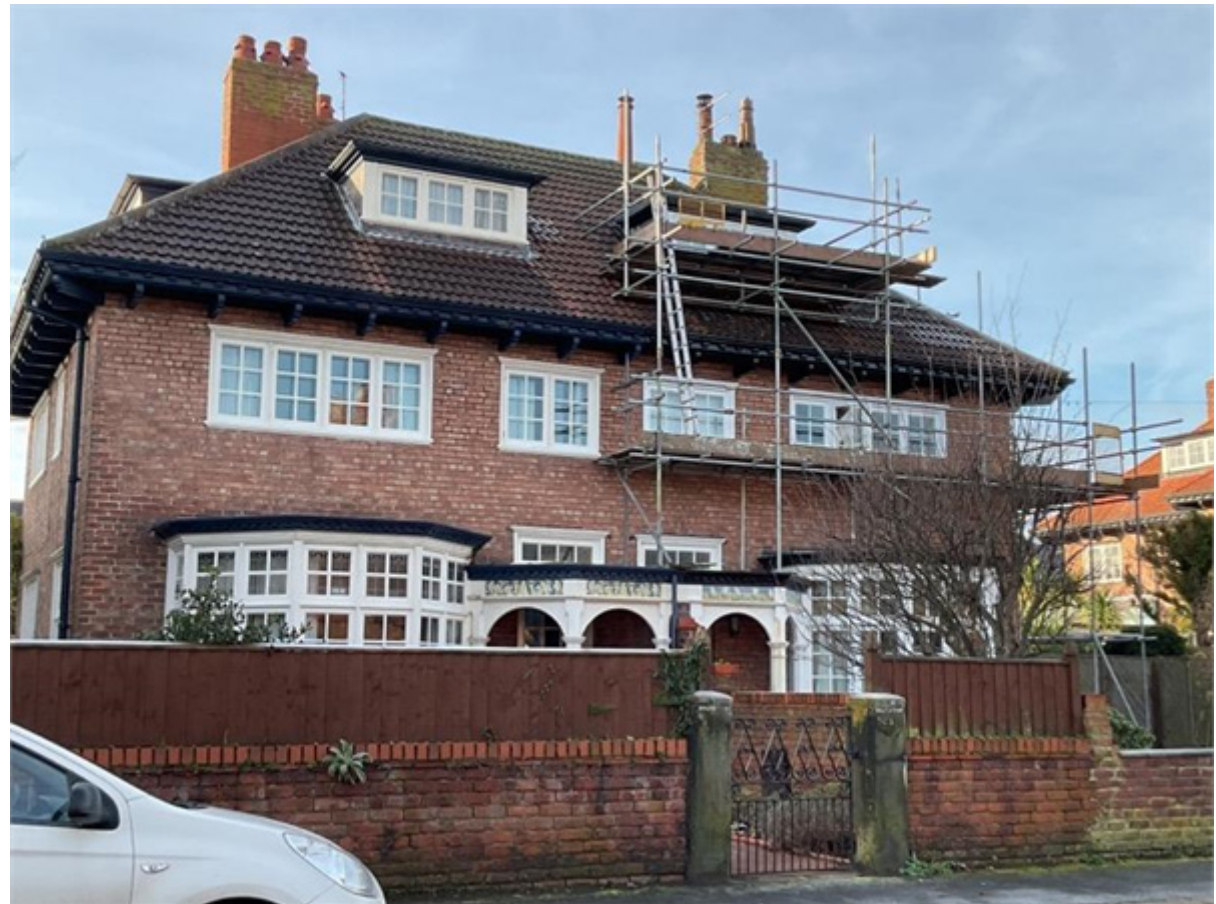
## Building ID: 122

Copings to brick wall replaced. Roof tiles replaced. Close board fencing added.

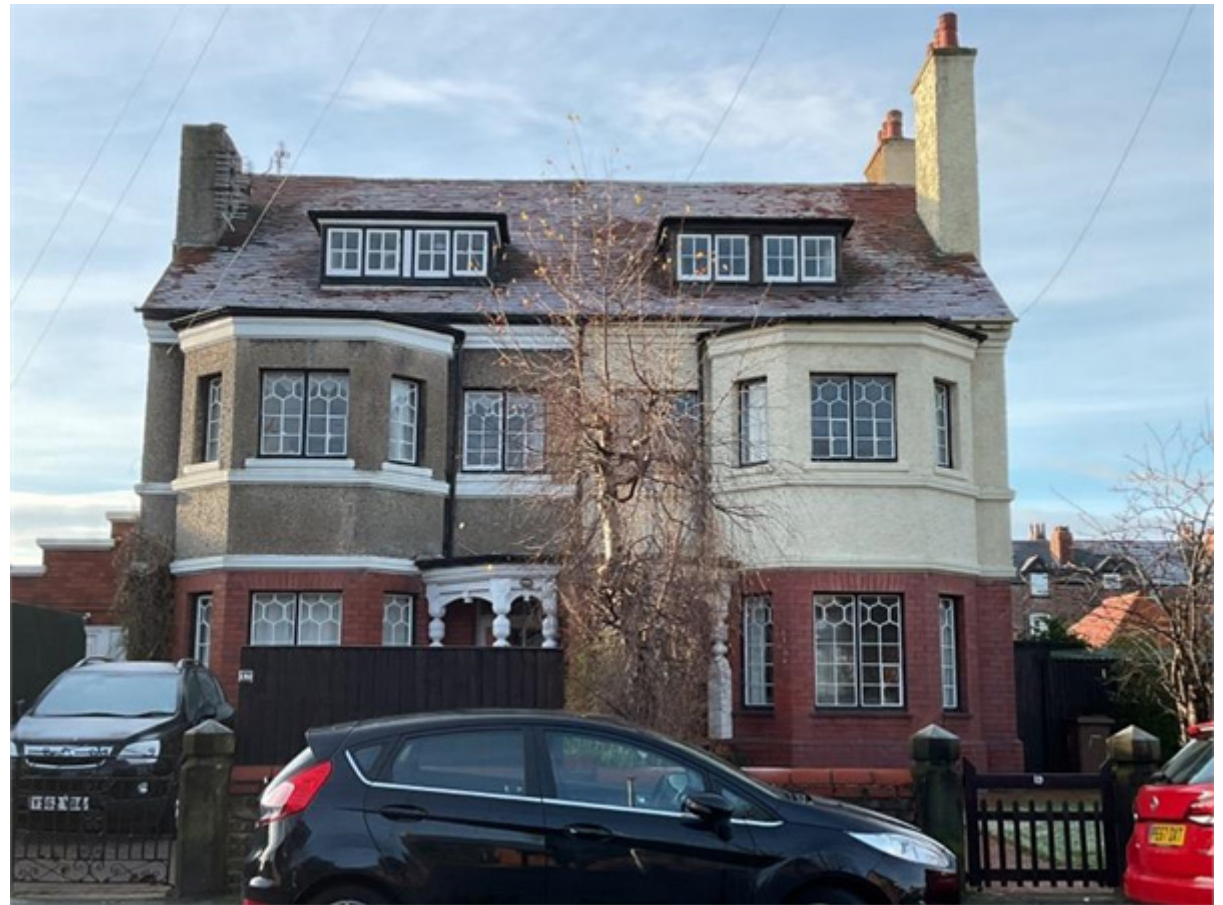
## Building ID: 124

L/h has truncated chimney. L/h has removed part of the brick boundary wall for driveway and introduced hardstanding.

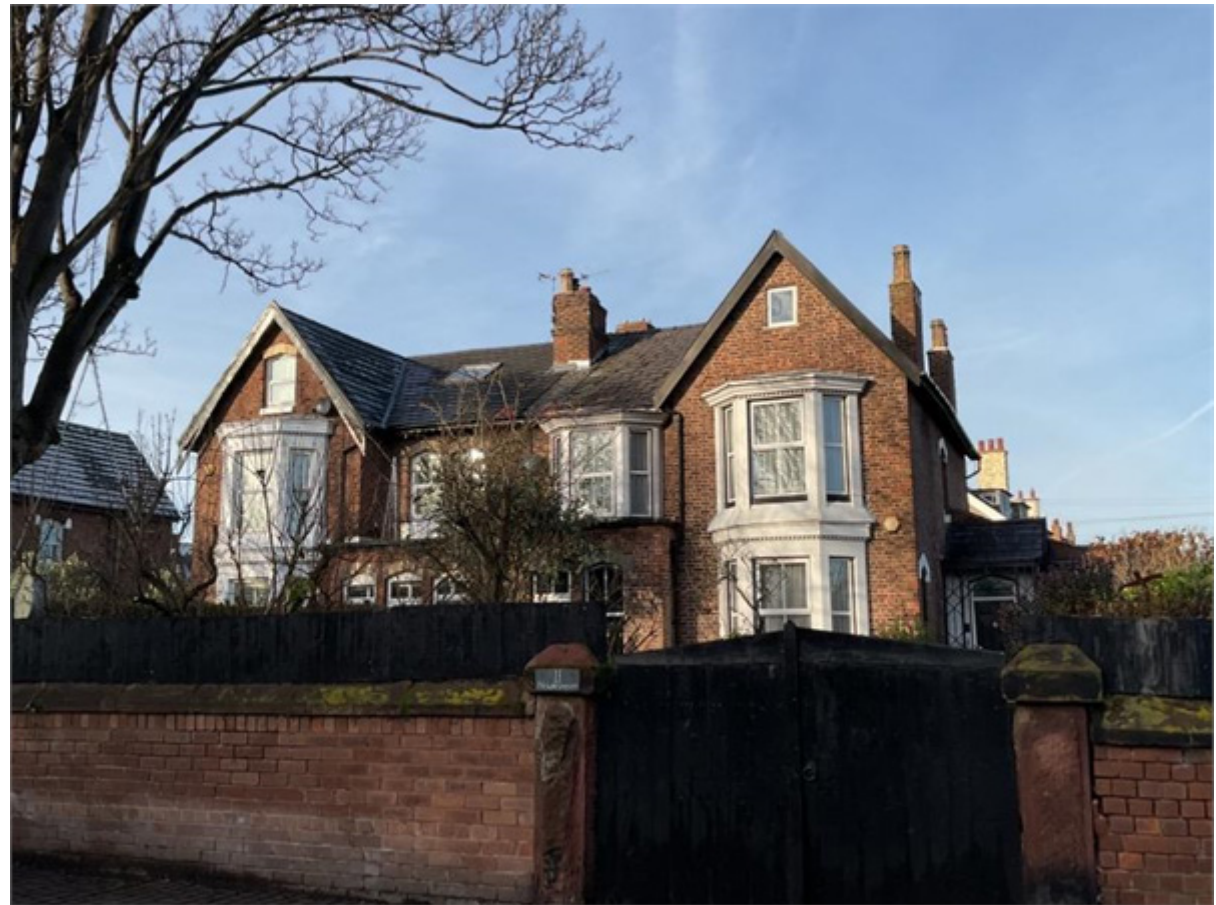
Windows replaced. Roof tiles replaced to l/h. Window to gable to r/h has lost its arch. Close board fencing added to front boundary wall.
