**Donald Insall Associates**  
Chartered Architects and Historic Building Consultants

The King's Gap Gazetteer

## Introduction

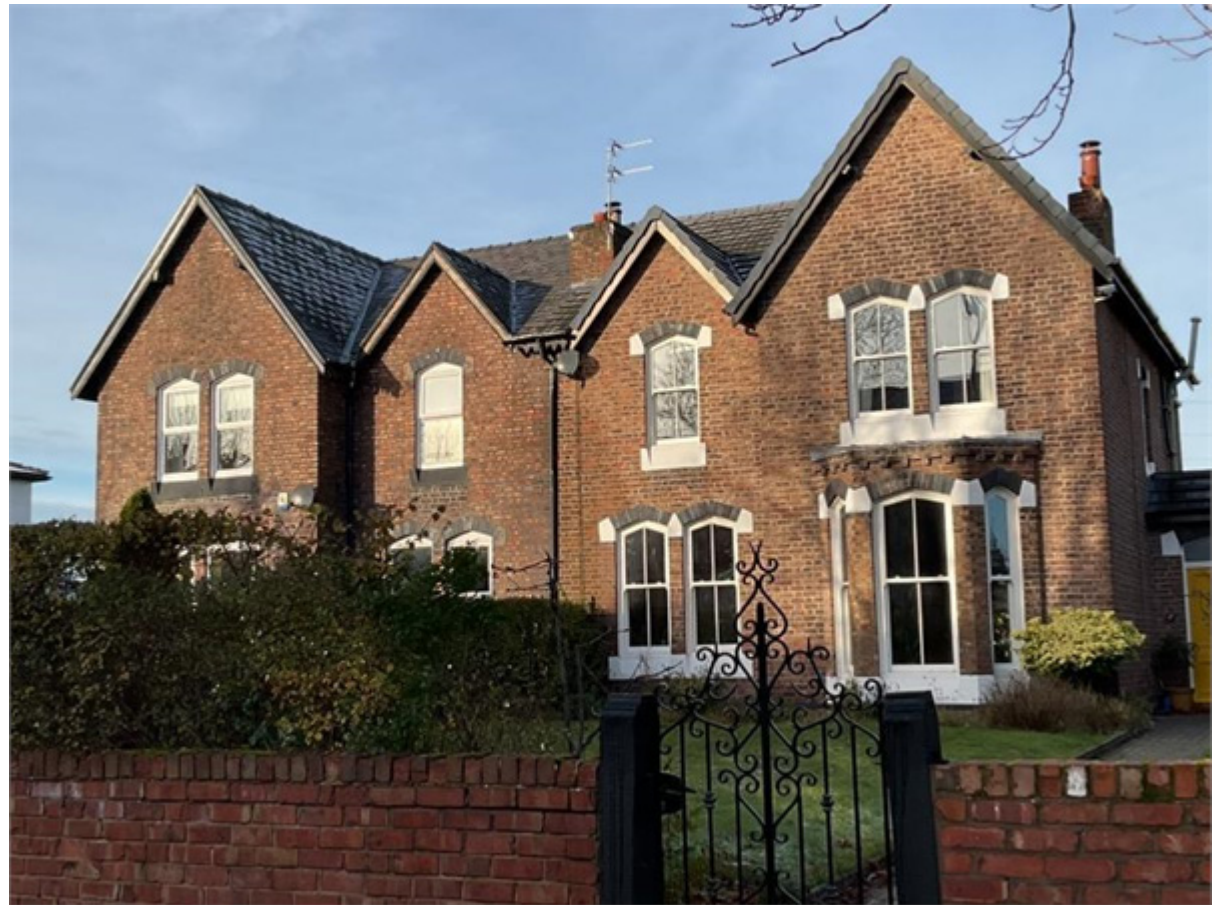
## Building ID: 126

R/h has concrete roof tiles and has lost chimneystacks. Hardstanding to l/h prominent, and wall appears to have been replaced and stone piers lost.

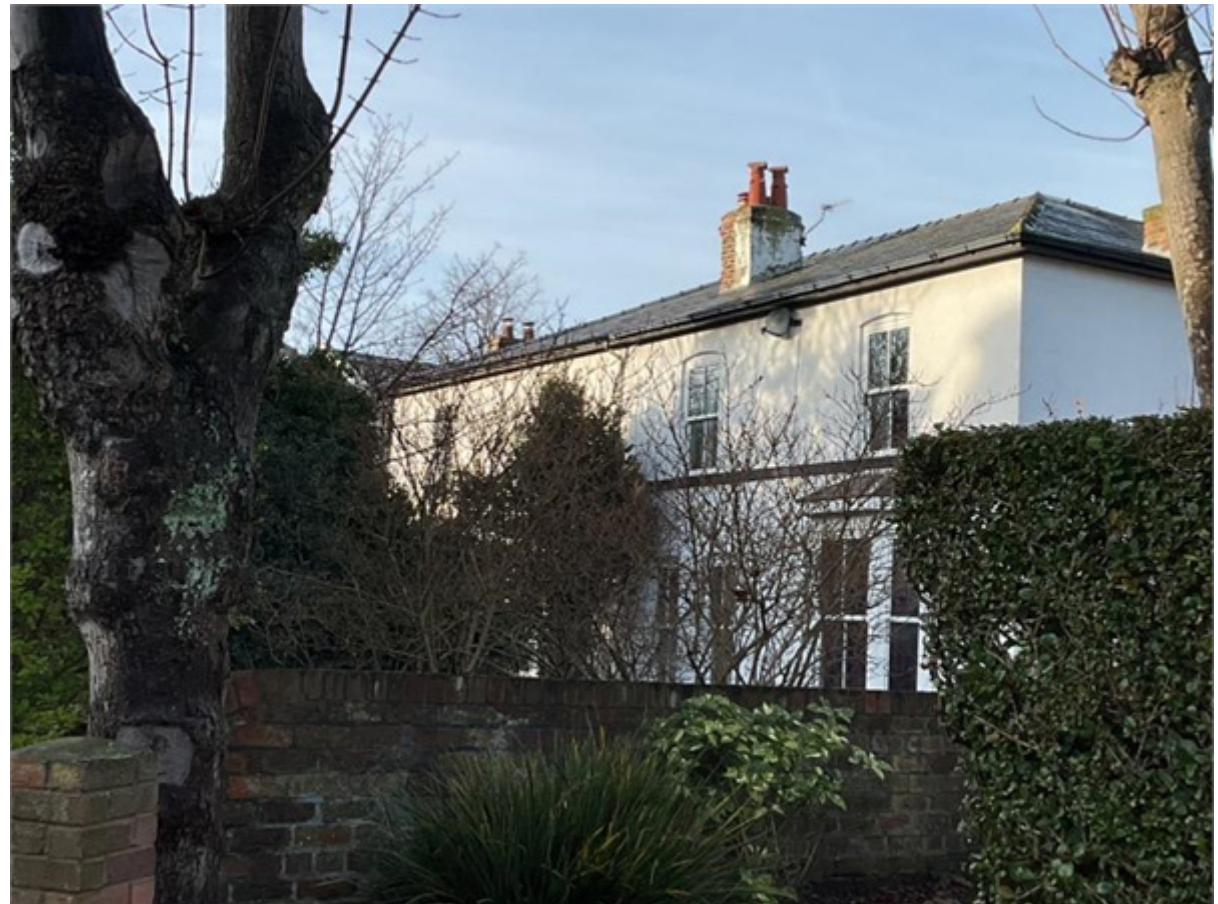
## Building ID: 127

Both appear neglected and in poor condition. Windows replaced. Gate piers lost and poor quality muddy hardstanding to r/h is prominent. Garden to l/h is overgrown.

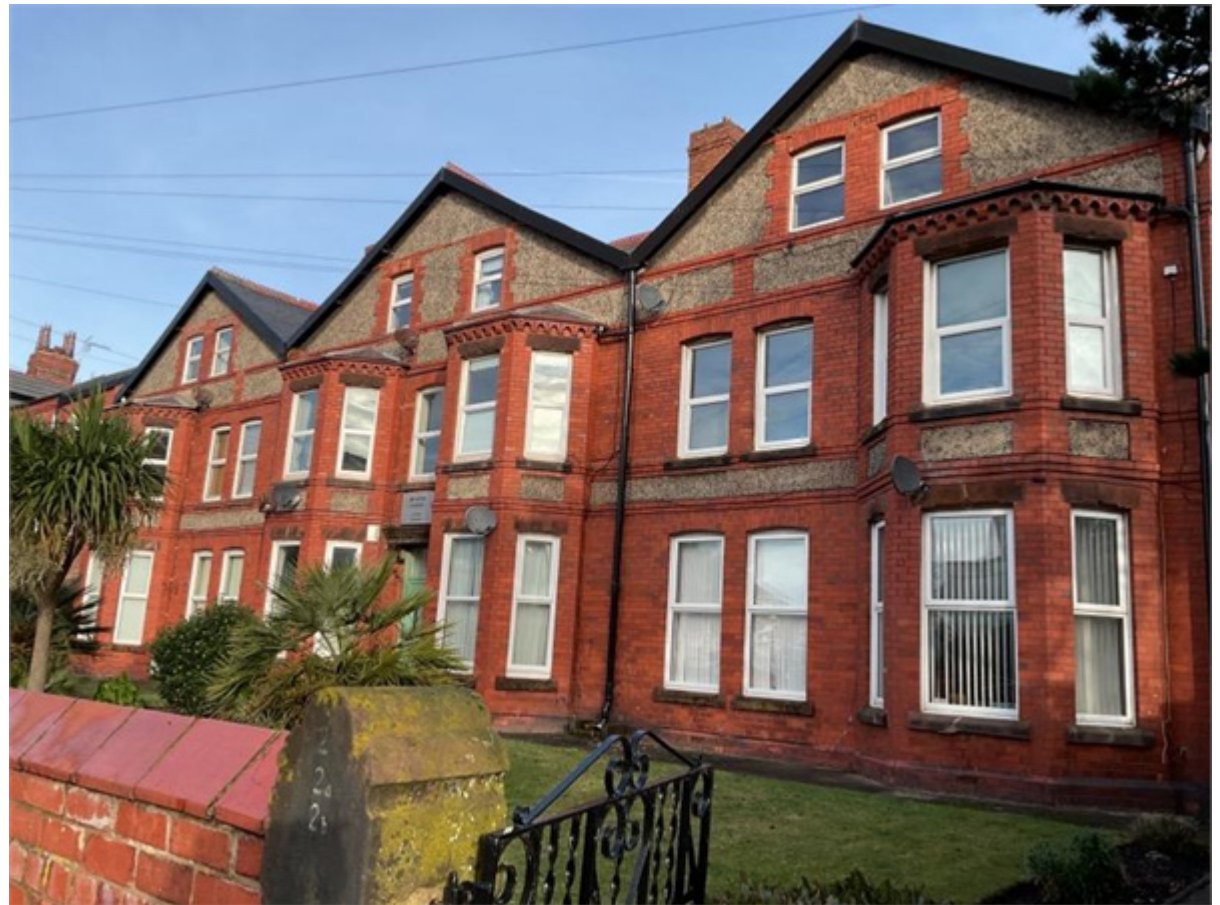
## Building ID: 128

Windows replaced.

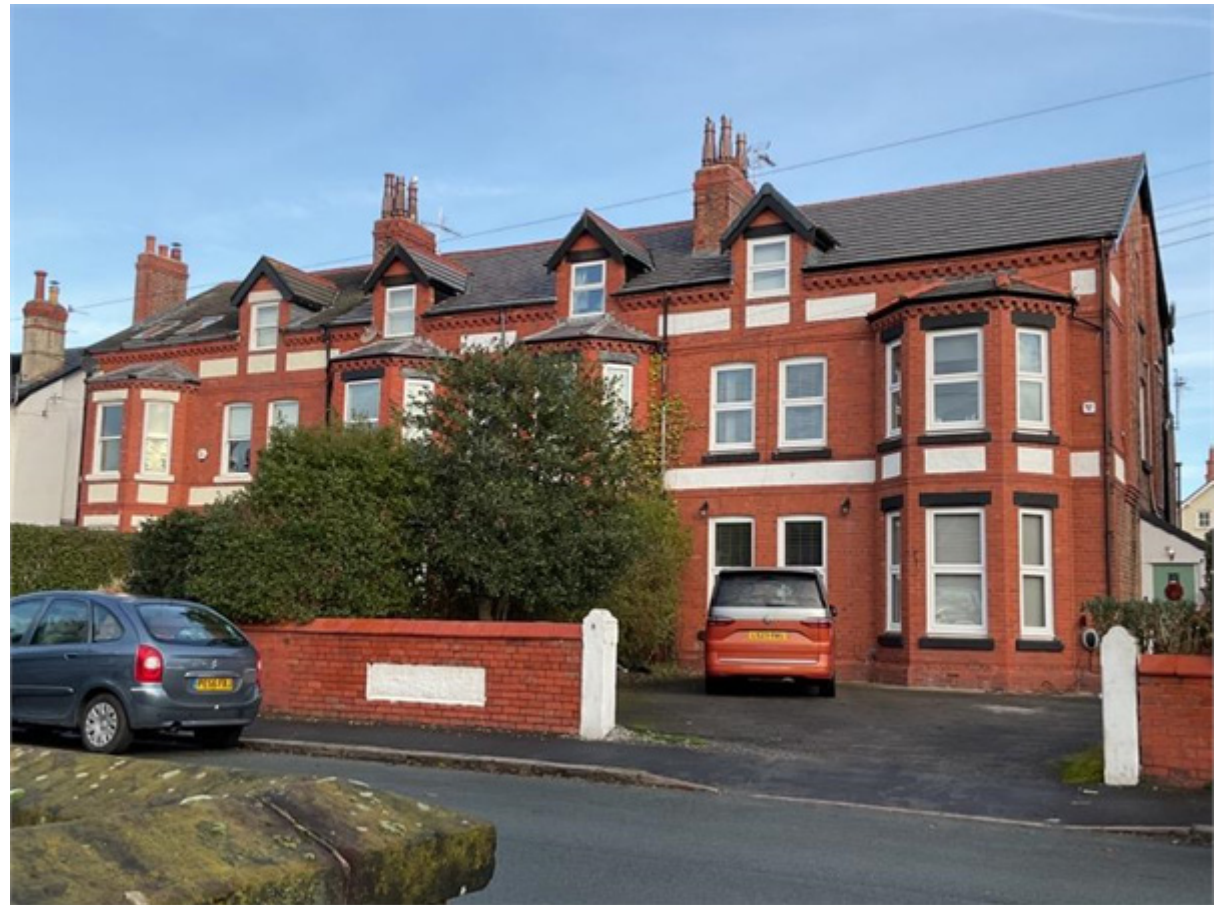
## Building ID: 129

Windows replaced, roof tiles replaced with concrete.  
One chimney lost. Section of wall removed for driveway.

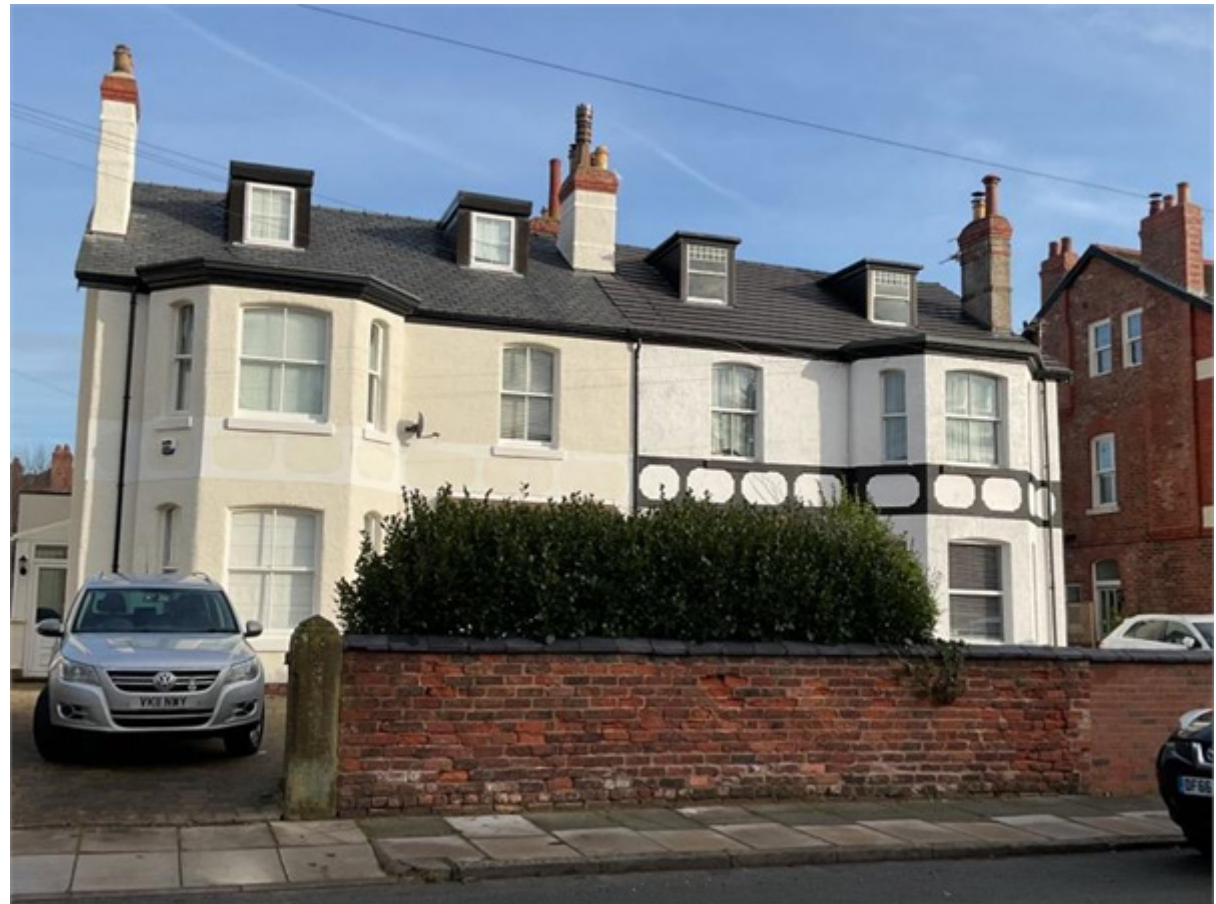
## Building ID: 130

Roof tiles replaced to r/h. Boundary wall replaced to r/h with section removed for driveway, although piers retained.

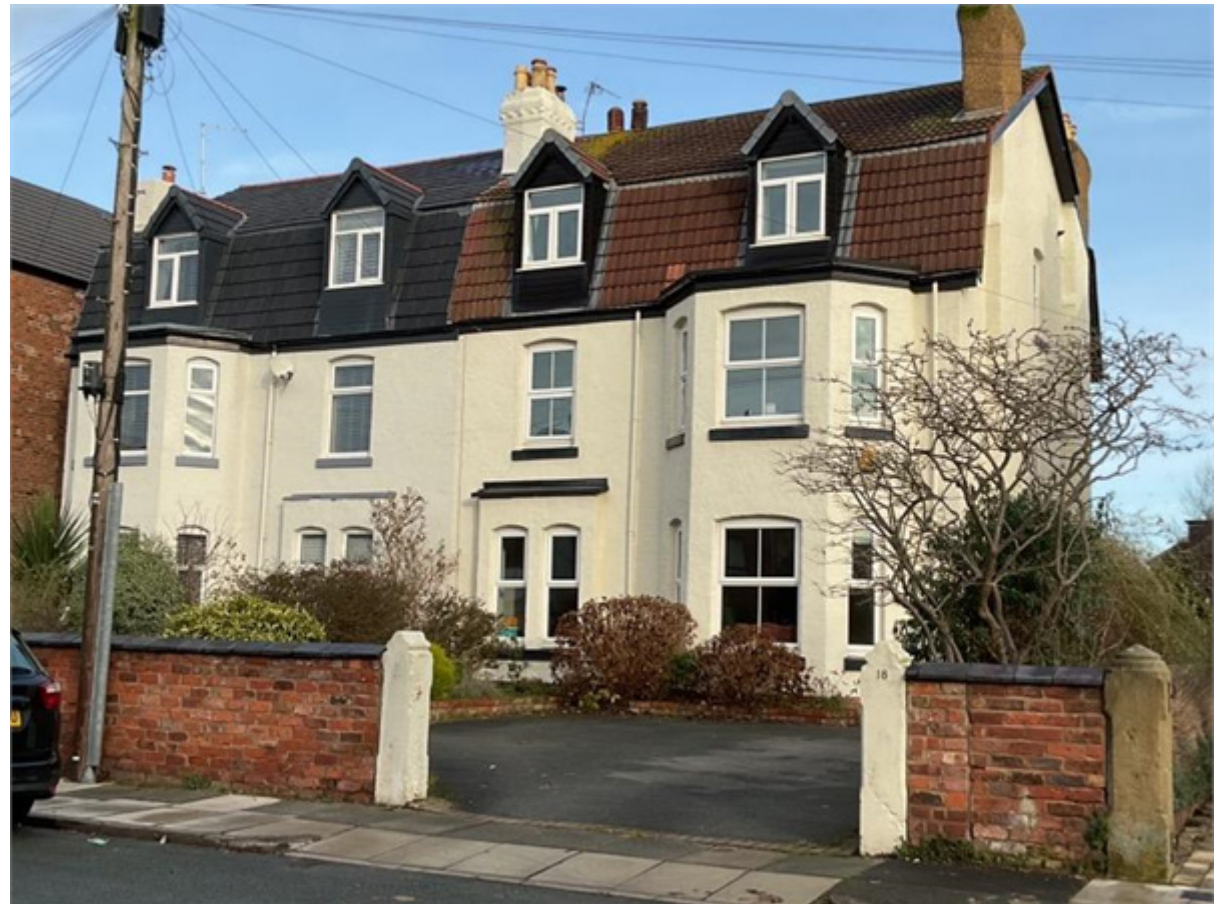
## Building ID: 131

Modern roof tiles. Replacement windows throughout. Sections of boundary wall removed for driveway (with hardstanding).

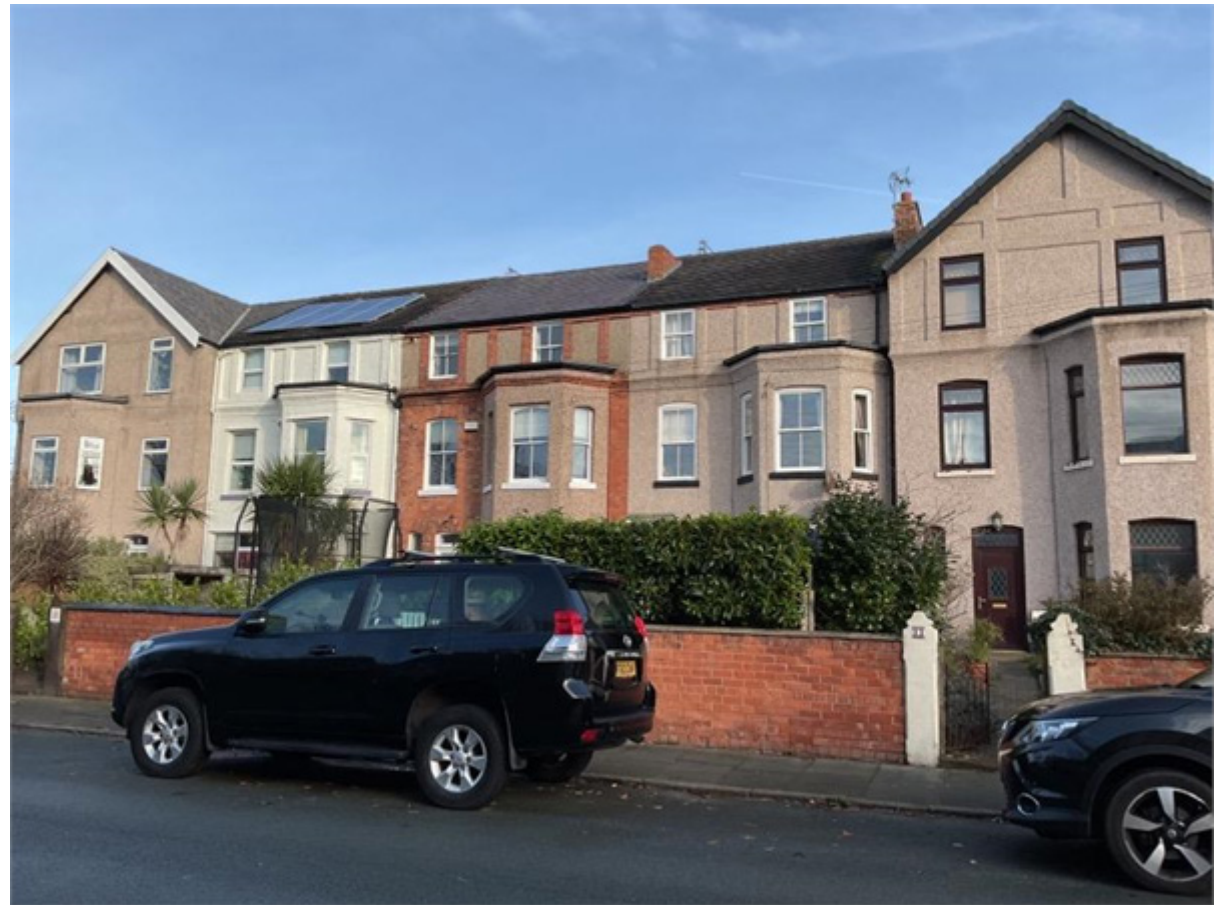
## Building ID: 132

Major alteration across the frontage. Most sections rendered, and exposed brickwork covered. Windows replaced. Roof tiles replaced. Sections of walling rendered. Chimneys lost or truncated. Sections of fencing added.

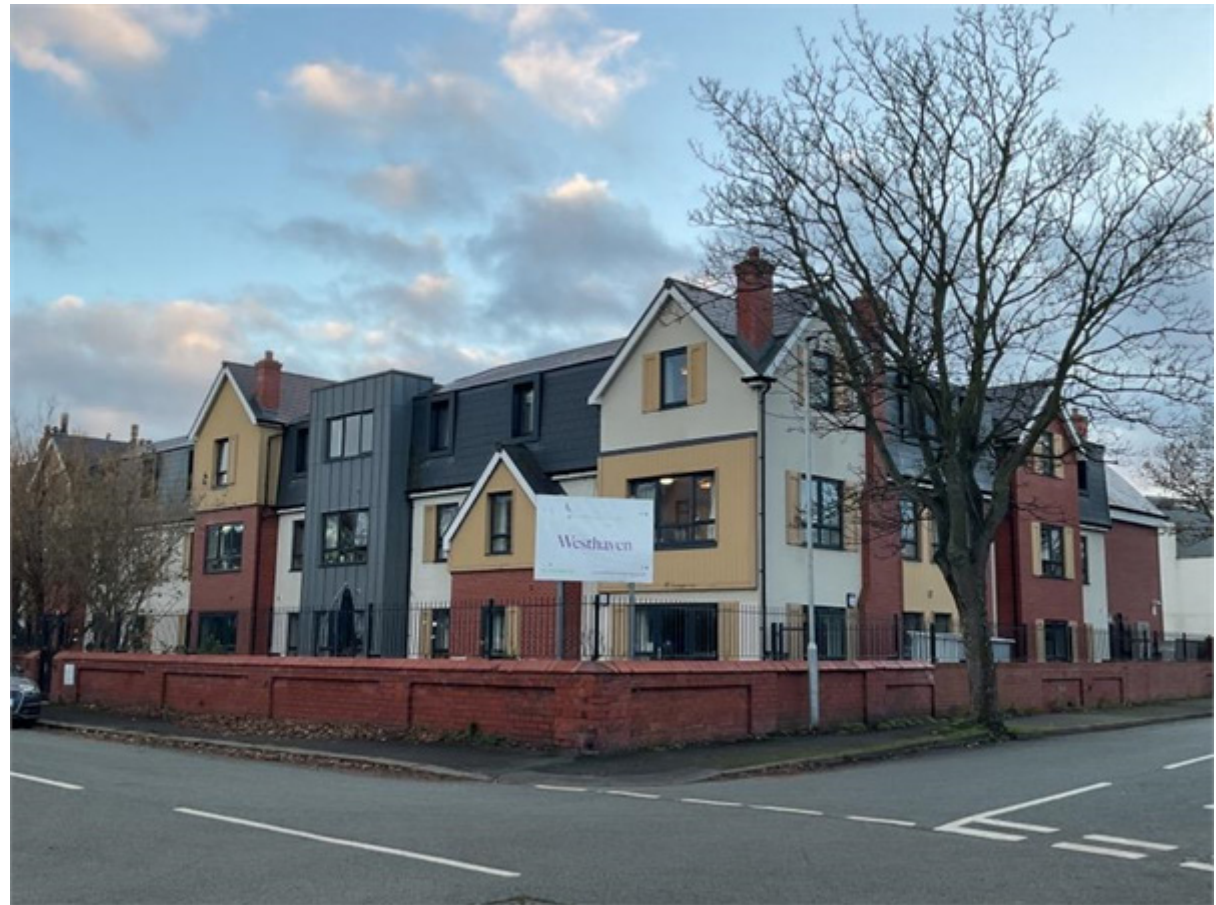
## Building ID: 133

High volume and mass and has intensified the plot, with poor quality modern materials. Has replaced a historic terrace.

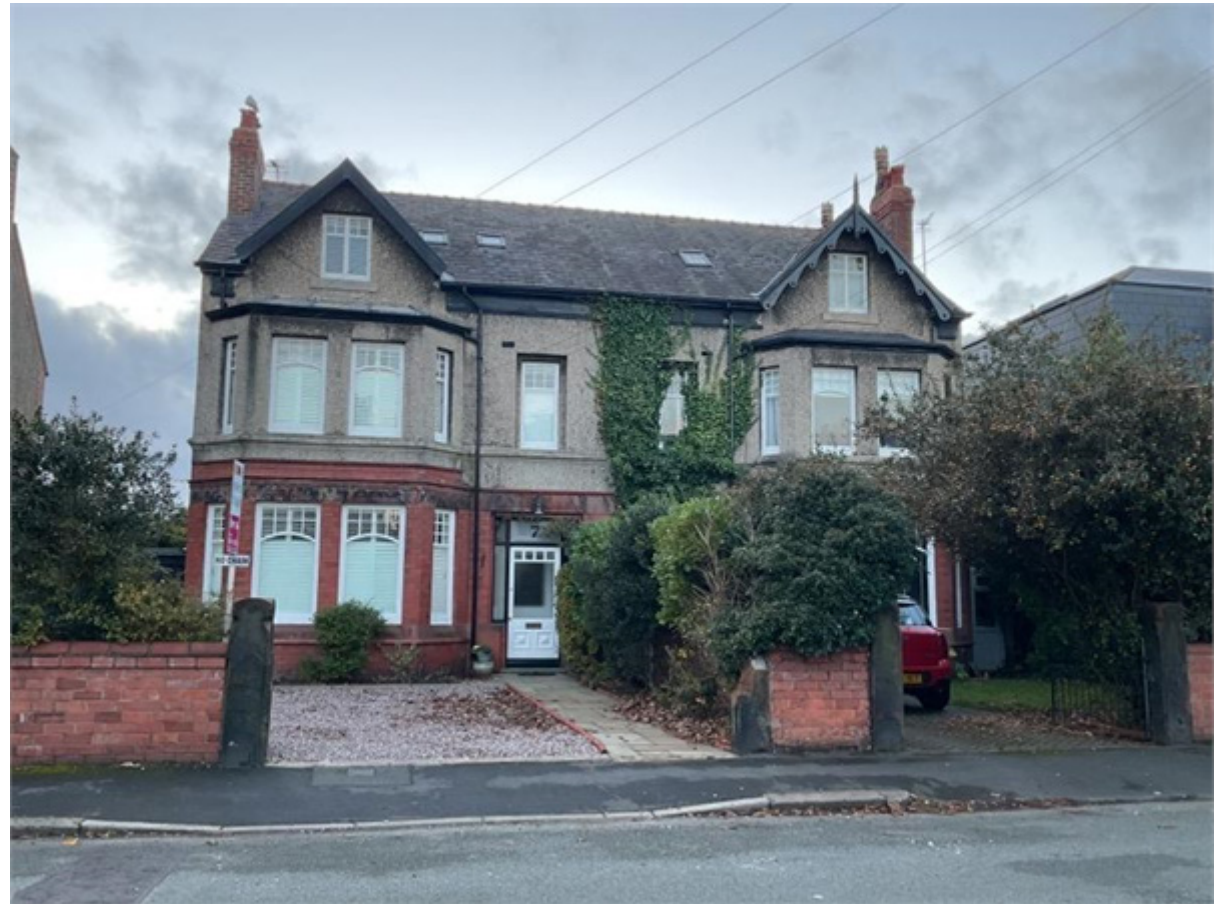
## Building ID: 134

Plain barge board to l/h. Whilst some boundary wall retained, parts removed for driveway. Gravel paving in place of soft landscaping.

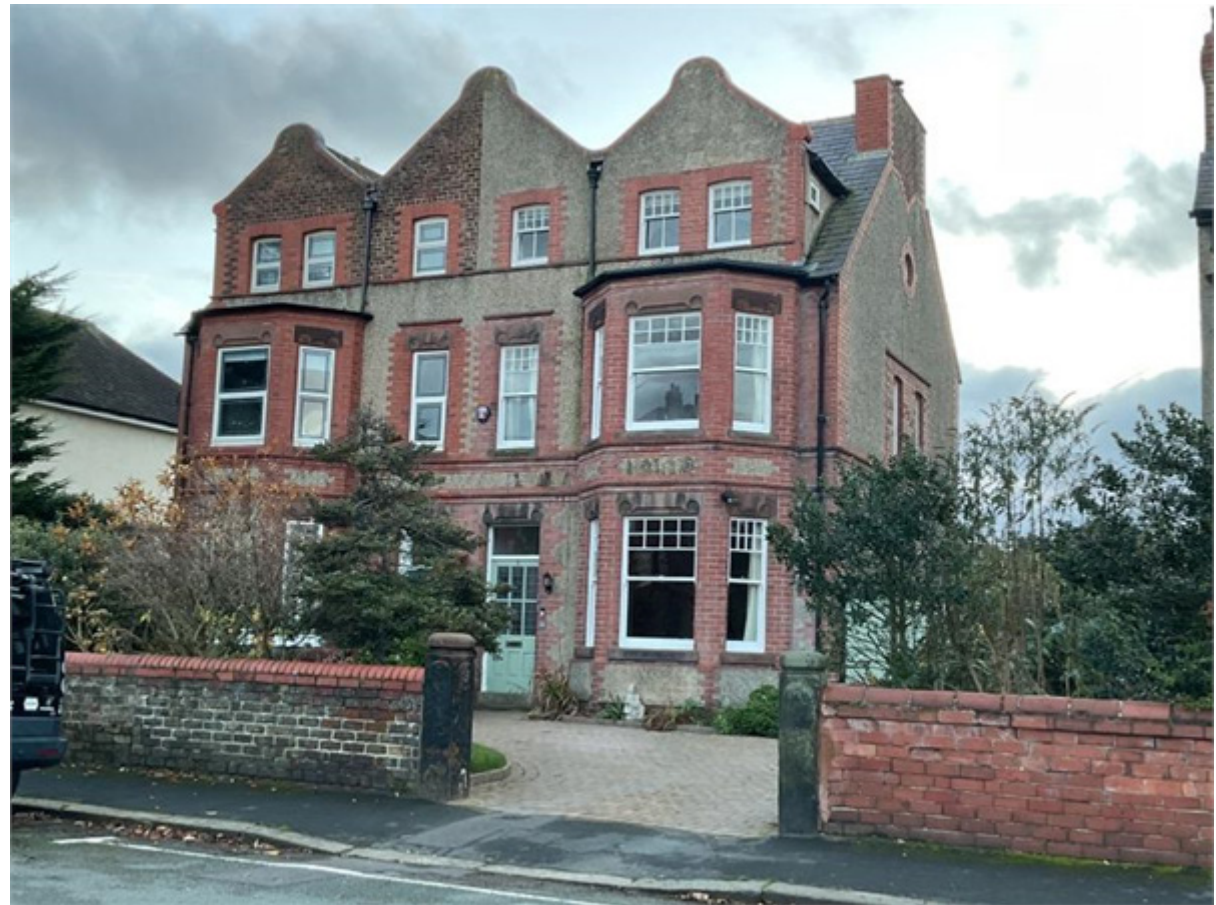
## Building ID: 135

Windows replaced to l/h in uPVC. Chimneys truncated. Part of the wall to r/h removed for driveway.

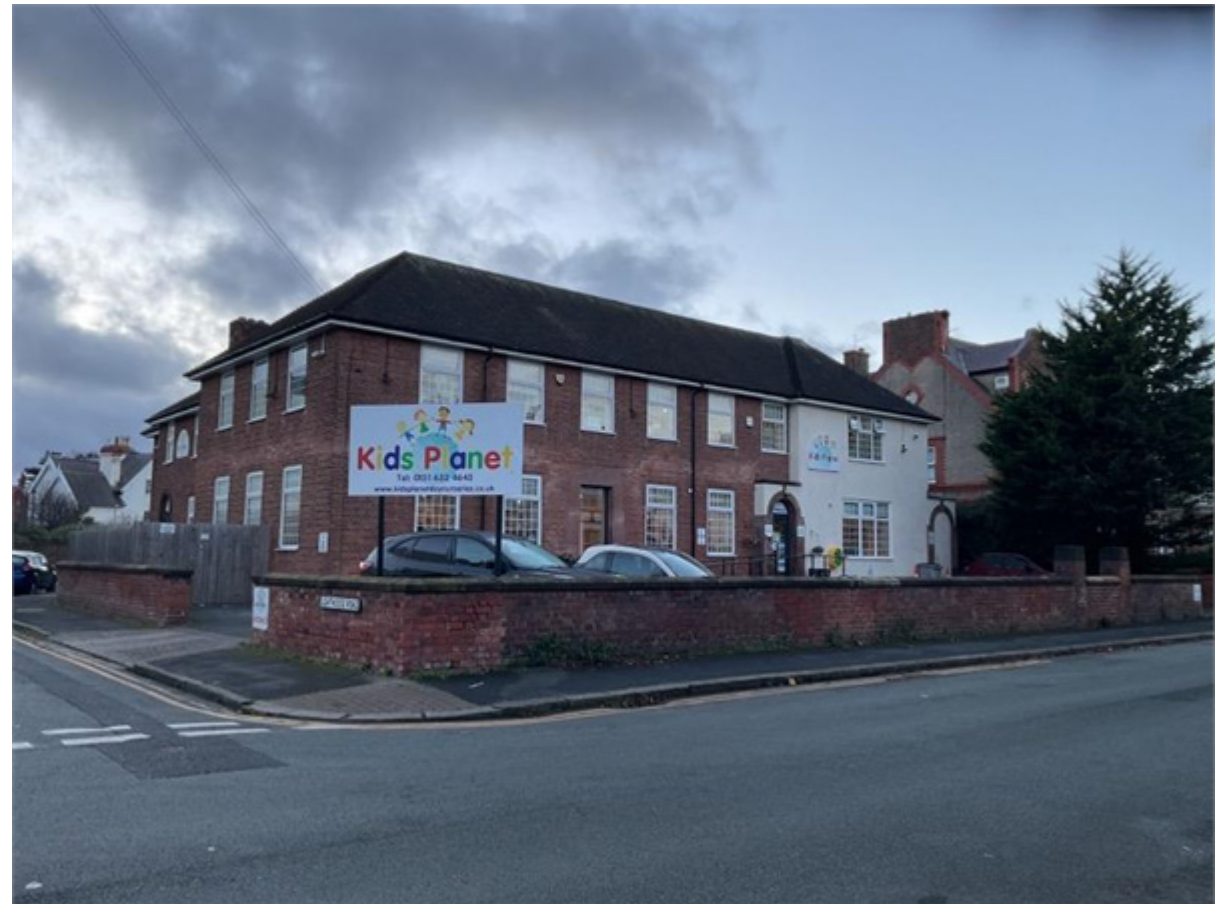
## Building ID: 136

Sections rendered. Windows replaced. Large areas of hardstanding for car parking prominent to road.

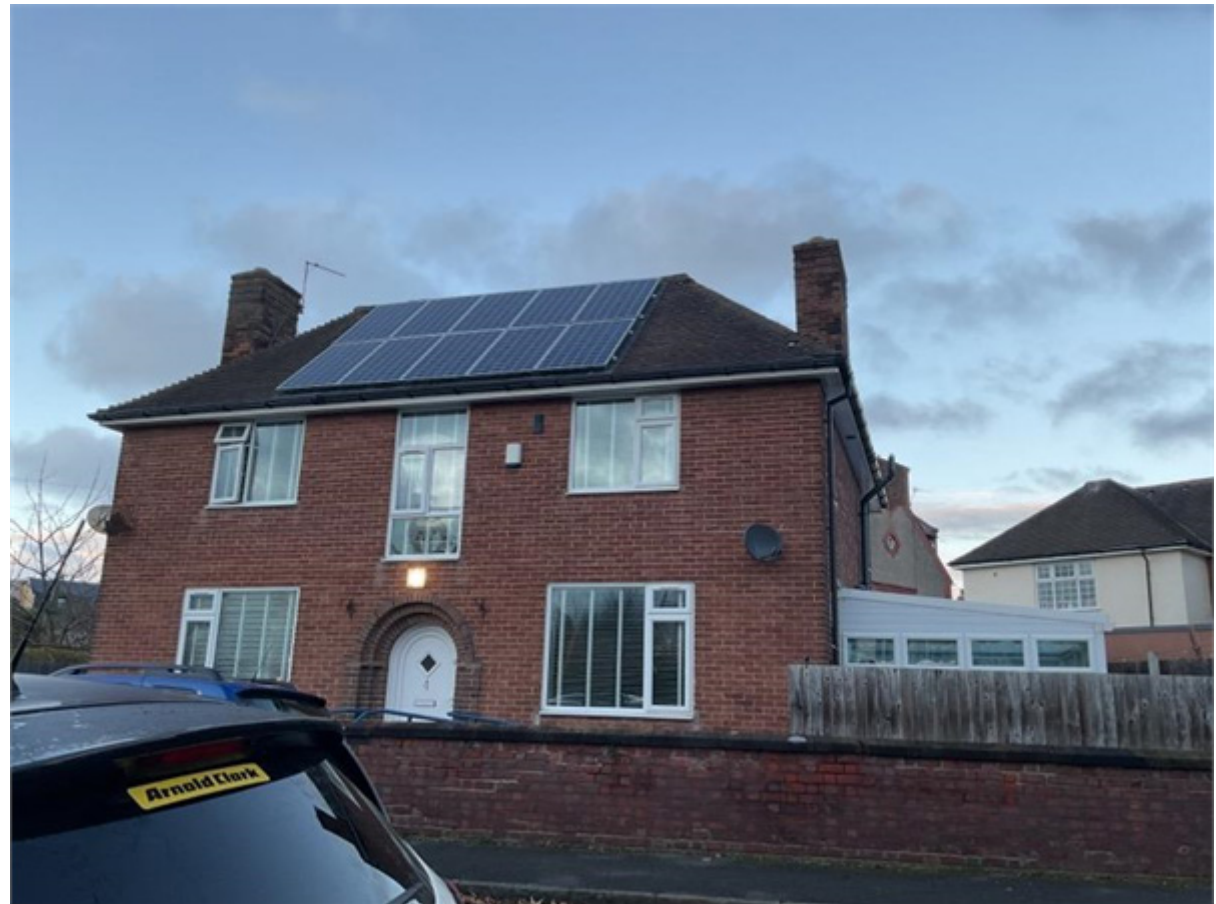
## Building ID: 137

UPVC windows and side extension. Prominent solar panels to the front roof pitch.

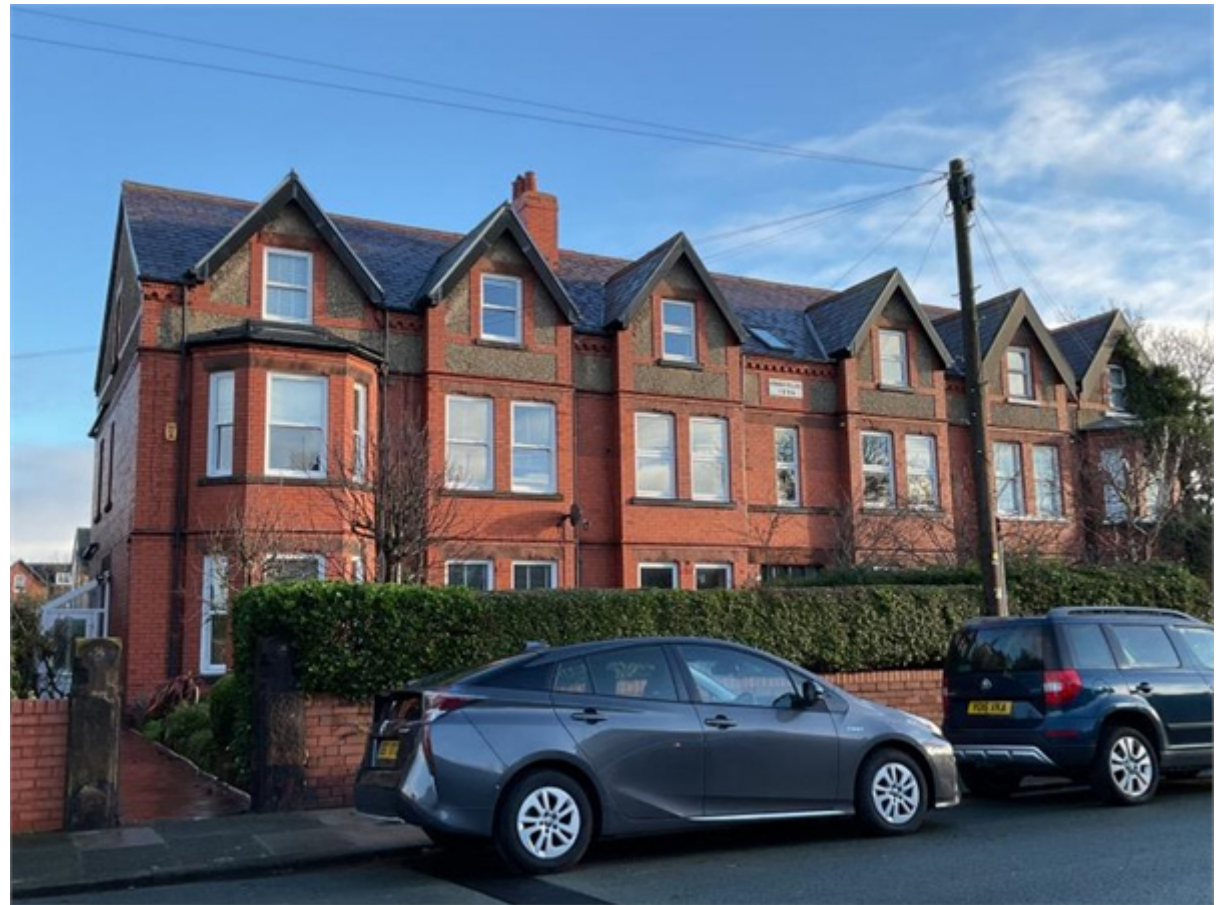
## Building ID: 138

Ad hoc window replacements. Some chimneystacks lost. Close boarded fence at junction with Valentina Road.

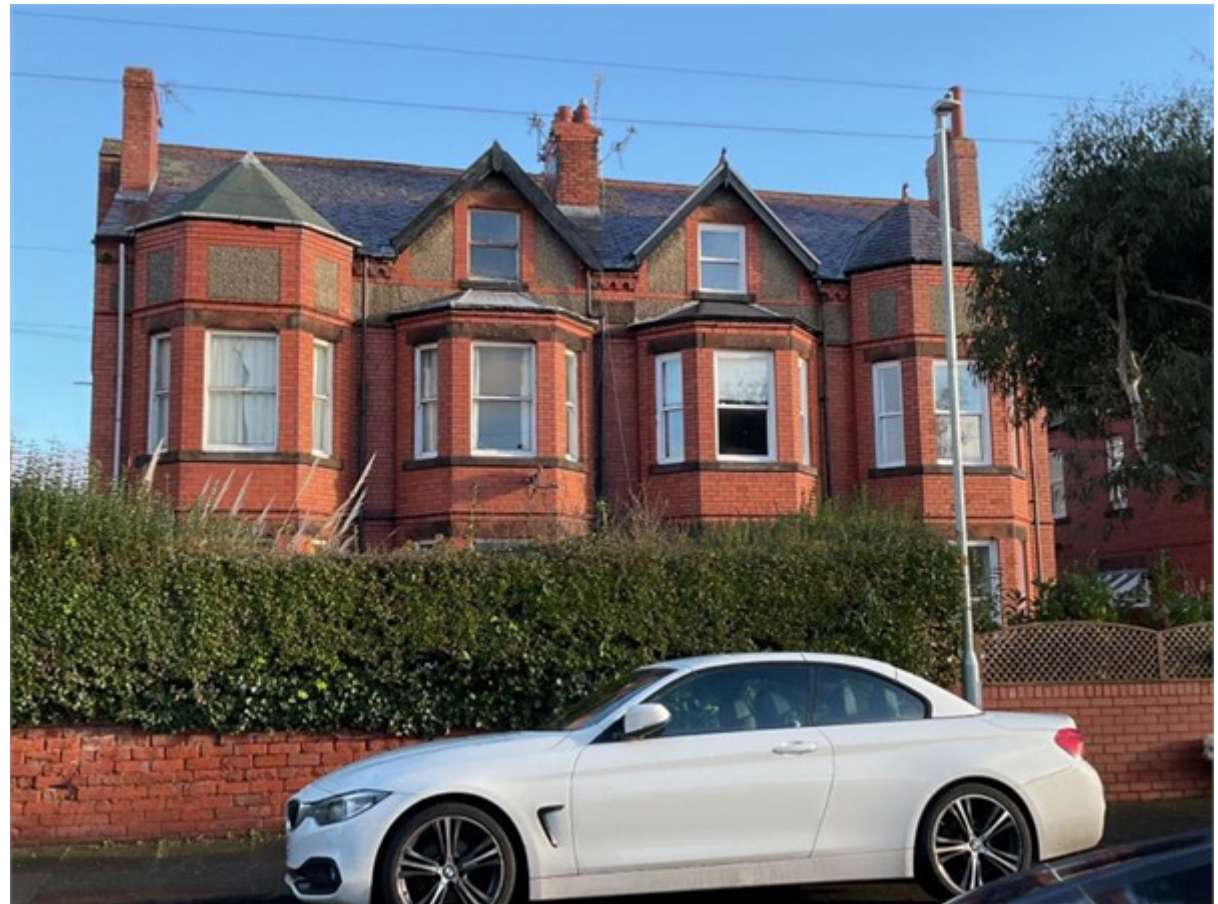
## Building ID: 139

Mixture of red brick and render, with canted bays incorporating turrets to ends and gables with bargeboards to the centre (one retains a finial). Forms a group with Buildings 140 and 141. Large chimneystacks, one retaining large pot. Slate roof. Stone cill and lintel detailing, with brick cornice detail to eaves. Sash windows (some modern). Brick boundary wall and stone gate piers retained, although replacement brick to r/h. Hedgerow to l/h.

Felt roofing to l/h turret. Wall has been rebuilt to r/h, and fence added above.

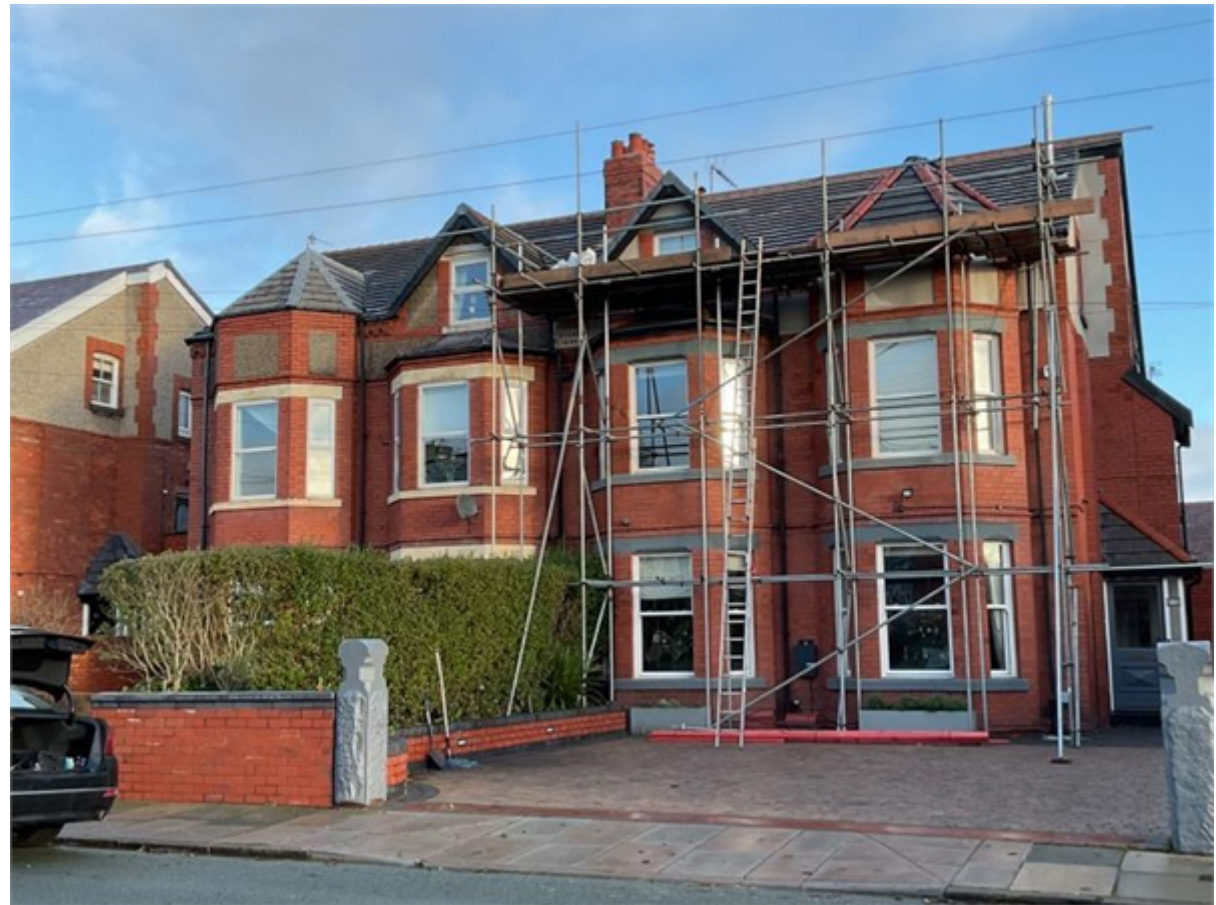
## Building ID: 140

Roof tiles replaced, along with bargeboards. Replacement windows to l/h. Missing chimney to r/h. L/h wall replaced in poor brick.

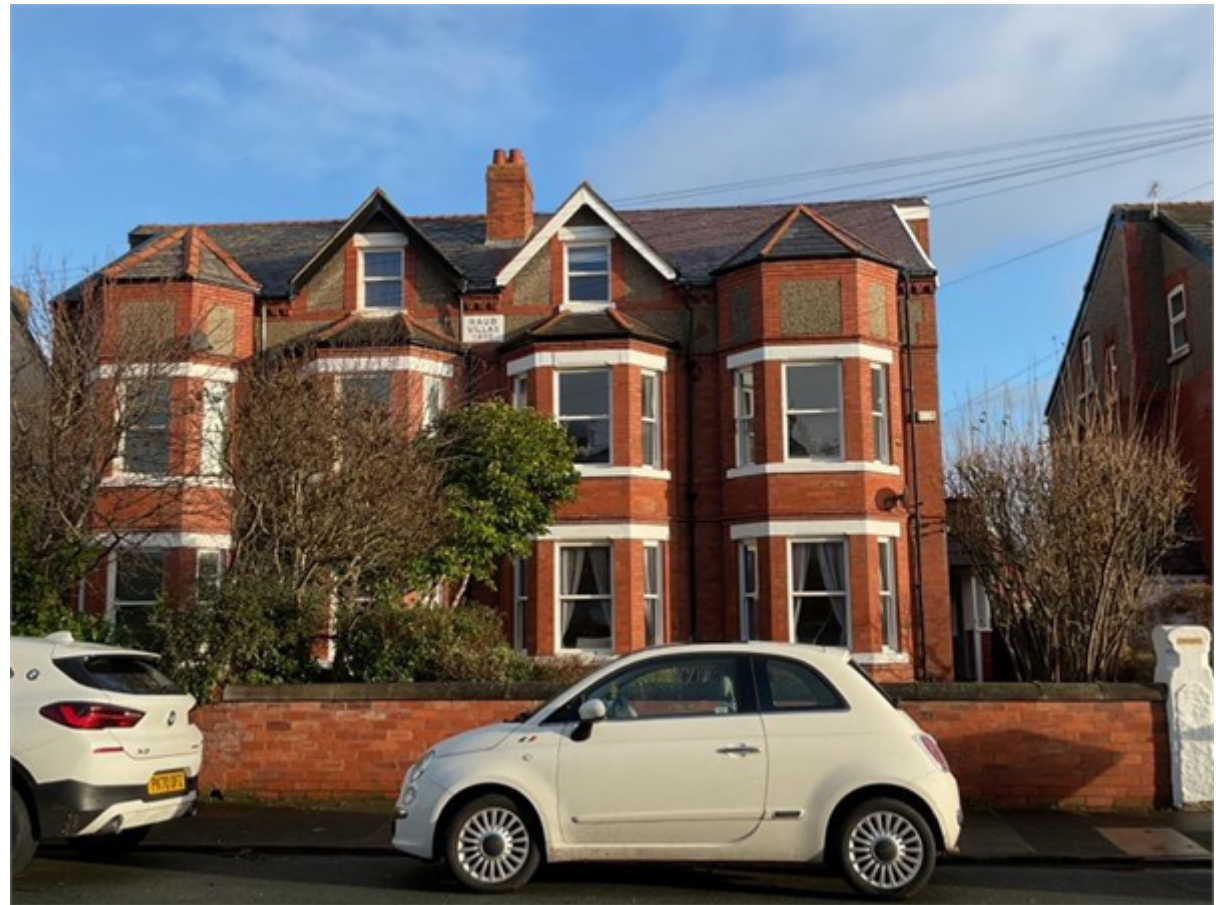
## Building ID: 141

Some chimneystacks lost.

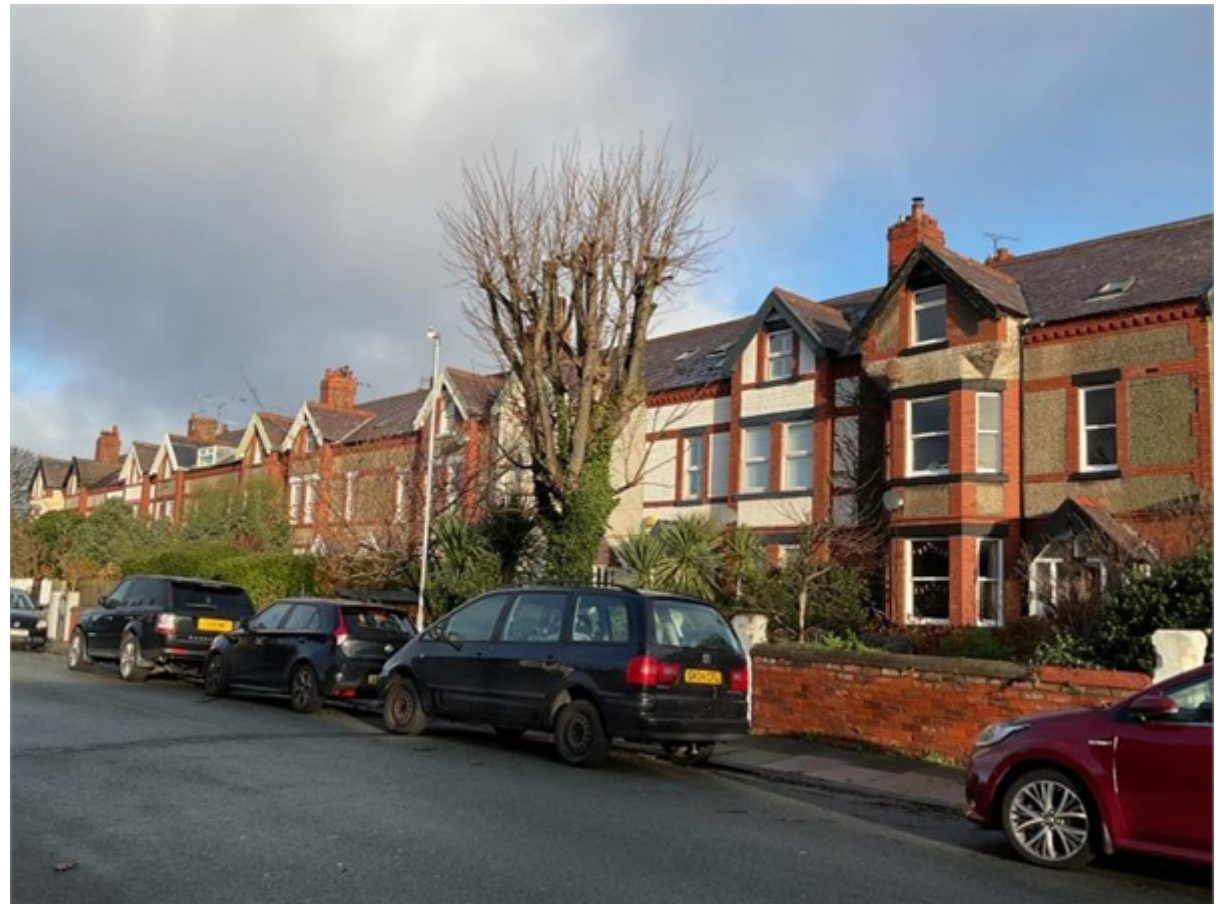
## Building ID: 142

Some ad hoc alterations across the terrace, including painting of brickwork and concrete tile roof. Other changes include window replacements and dormers. Most retain low brick boundary wall but some sections rendered, raised, gate widened or fencing added.

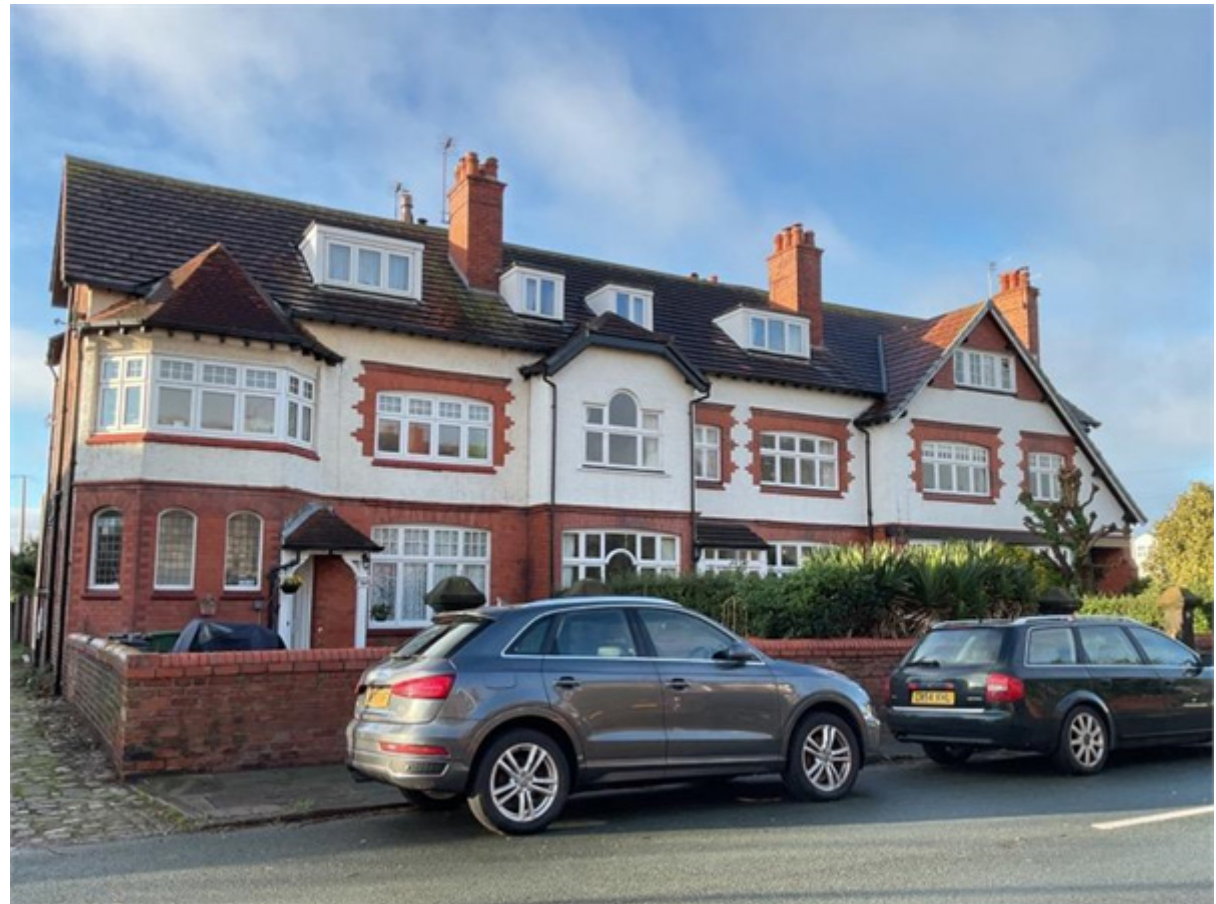
## Building ID: 143

Concrete roof tiles, and some windows replaced.

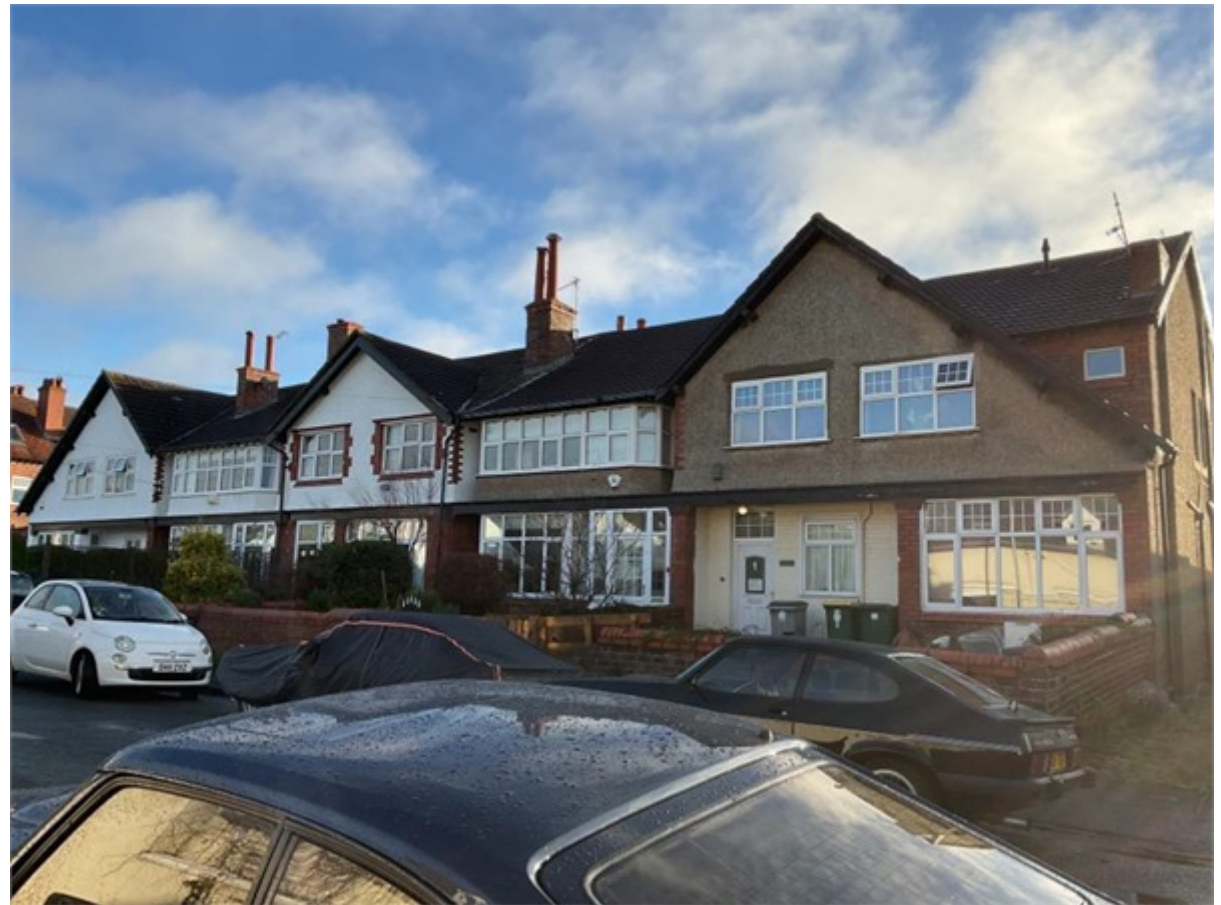
## Building ID: 144

Symmetry affected by changes in render colour.  
Windows replaced and roof tiles replaced.

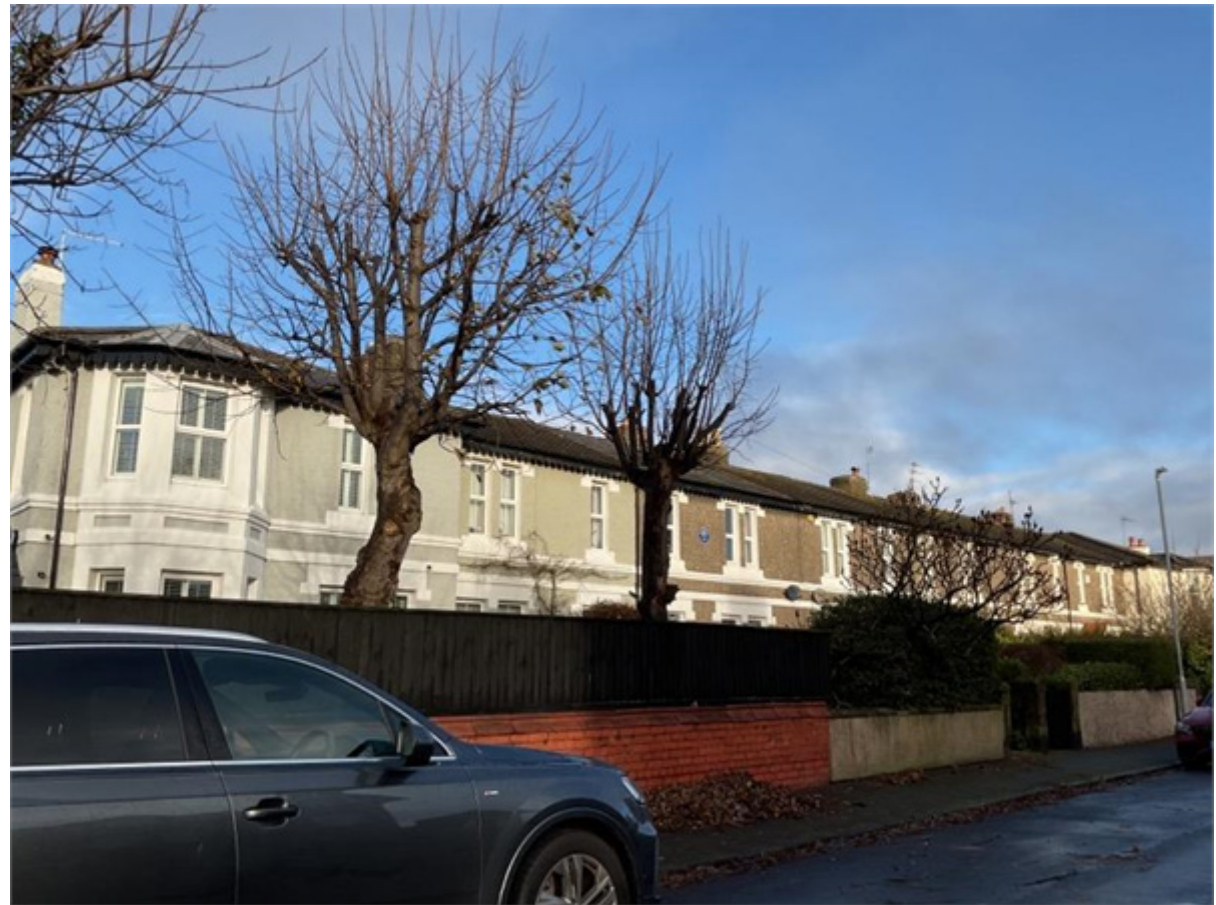
## Building ID: 145

Some alteration across the terrace. Likely originally exposed brick, now rendered. Most roof tiles and windows replaced. Boundary walls have been rendered, and part removed for driveways (the brick remains exposed to the l/h end terrace, but fencing has been added). Front gardens are retained in places but surface materials poor.
