**Donald Insall Associates**  
Chartered Architects and Historic Building Consultants

The King's Gap Gazetteer

## Introduction

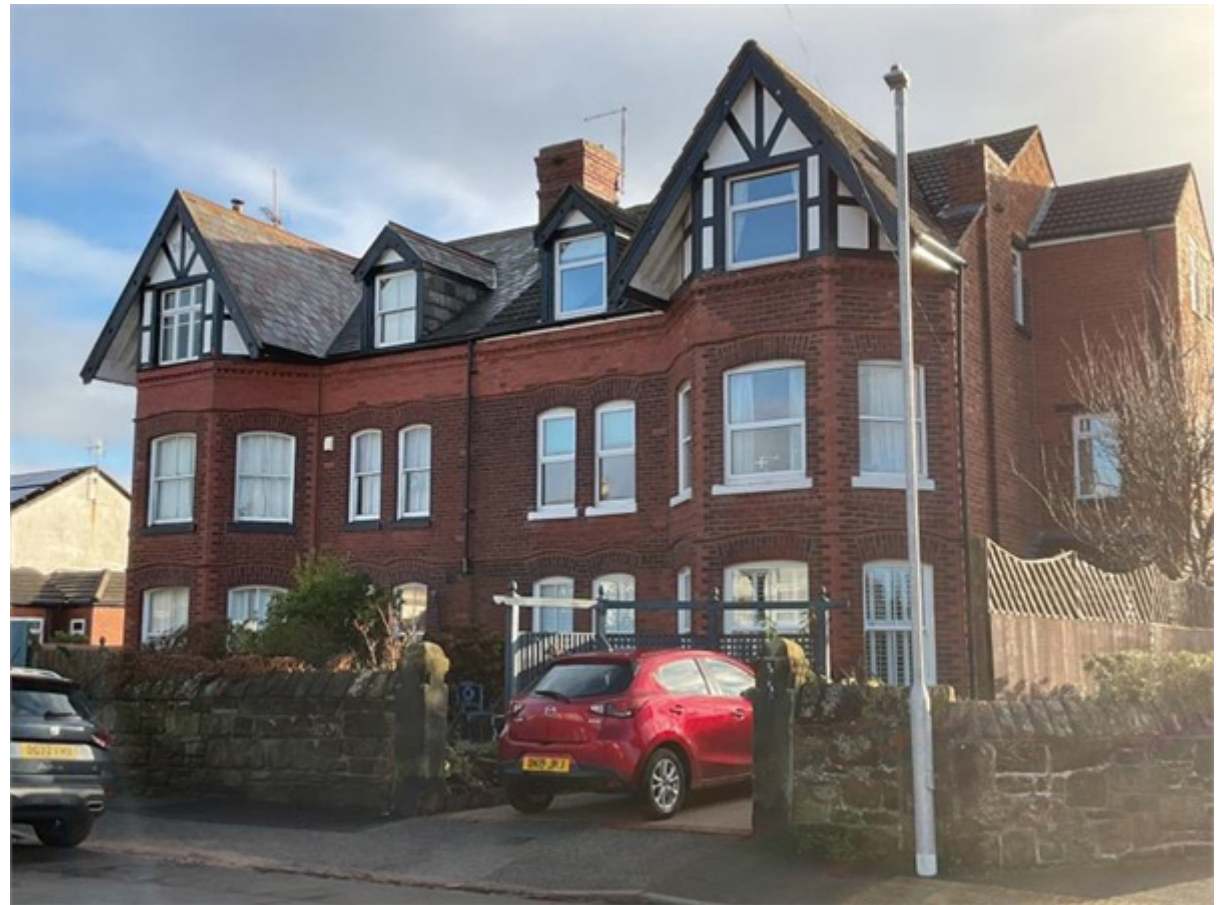
## Building ID: 146

Roof tiles replaced (concrete to r/h). Sections of wall removed for driveway, and fence added behind.

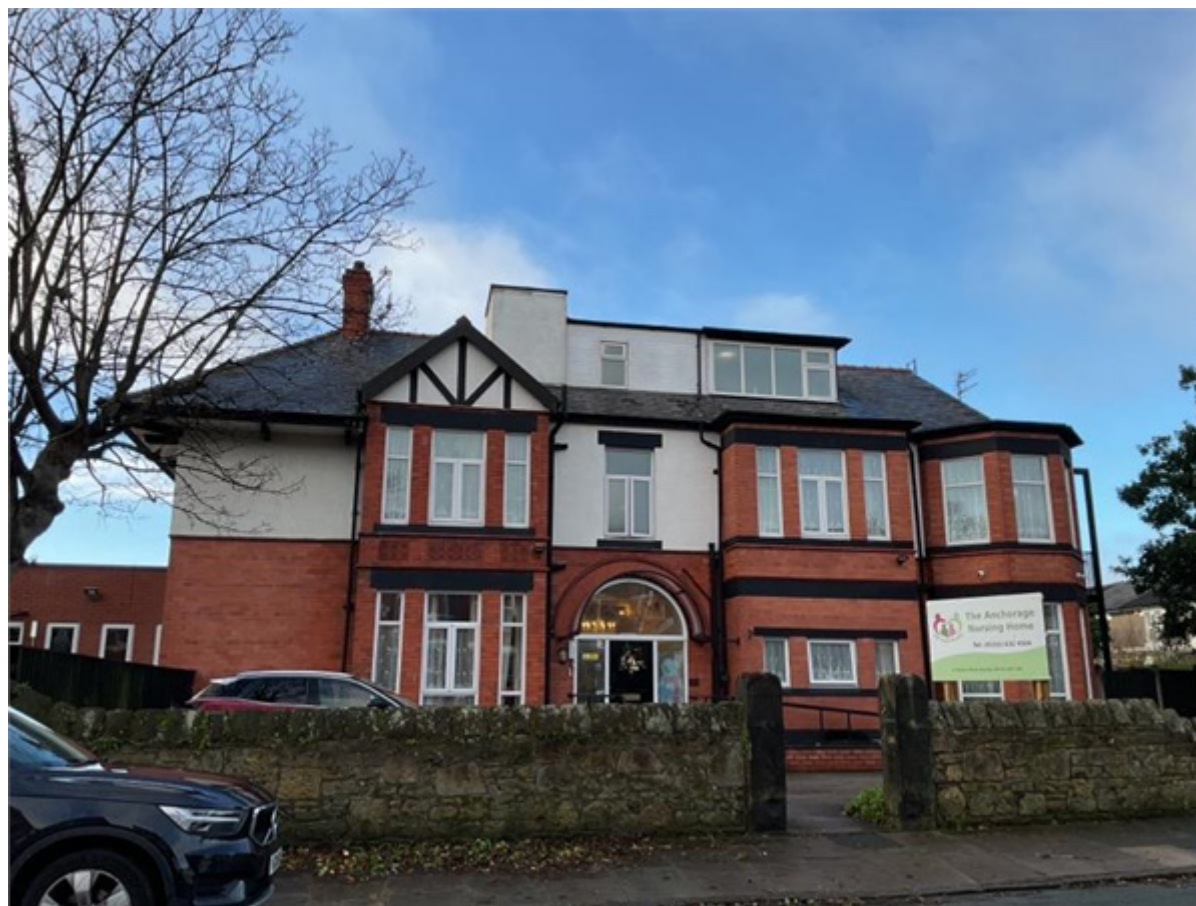
## Building ID: 147

Use as a nursing home has resulted in substantial accretions and extensions of poor-quality, including dormers, extensions to the rear (prominent from the street due to the corner plot), fire escape stairs, and large monolithic and utilitarian offshoots. Setting largely given over to hardstanding for car parking, very visible from the road. Identified as B given legibility of historic frontage.

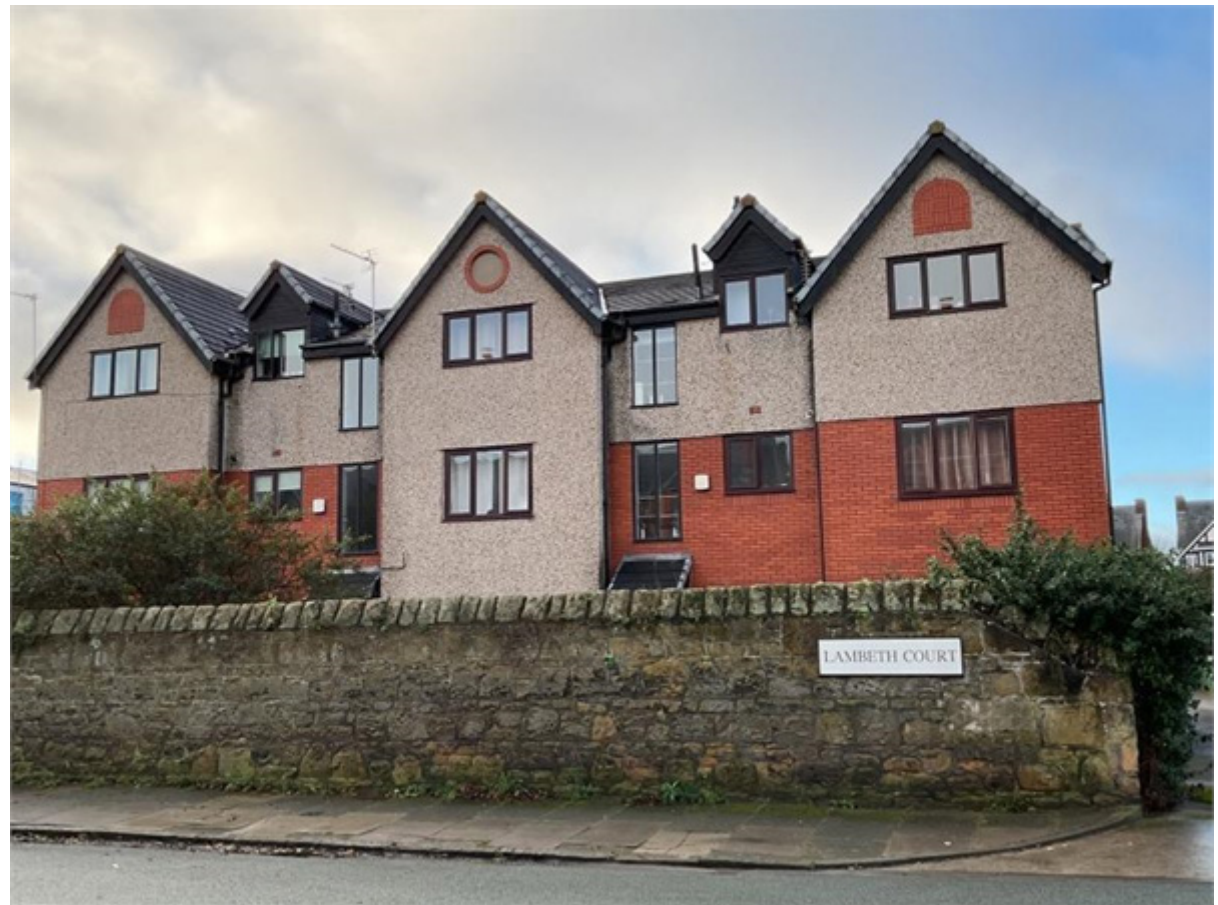
## Building ID: 148

Intensified plot. Prominent in views from Queen's Road to the Hoylake Lighthouse.

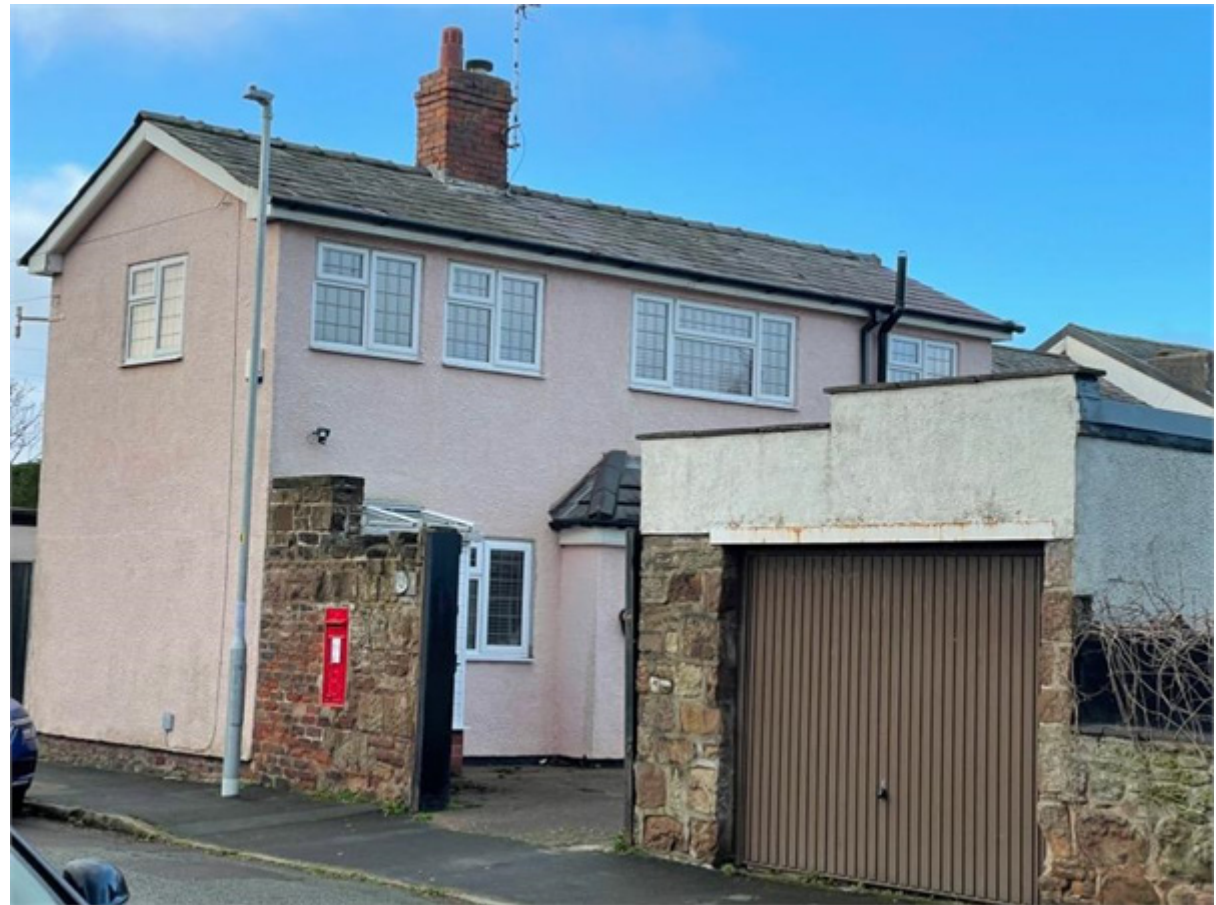
## Building ID: 149

**Features of Interest:**  
Potentially an earlier outbuilding. Slate roof.

**Detrimental Elements:**  
Modern render and uPVC windows.

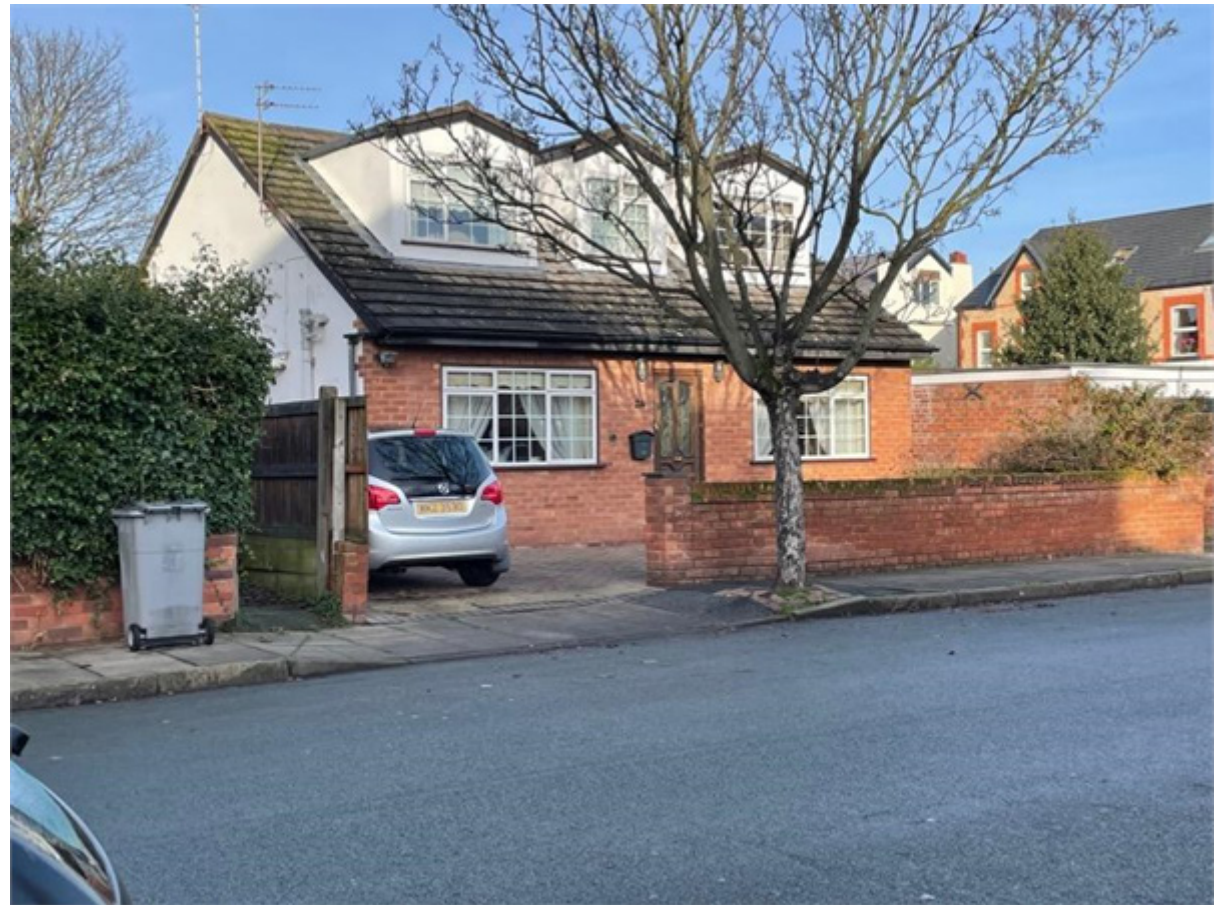
## Building ID: 150

Modern form with bulky dormers. Plot formed in former rear garden of 32 Queens Road (Building 138).

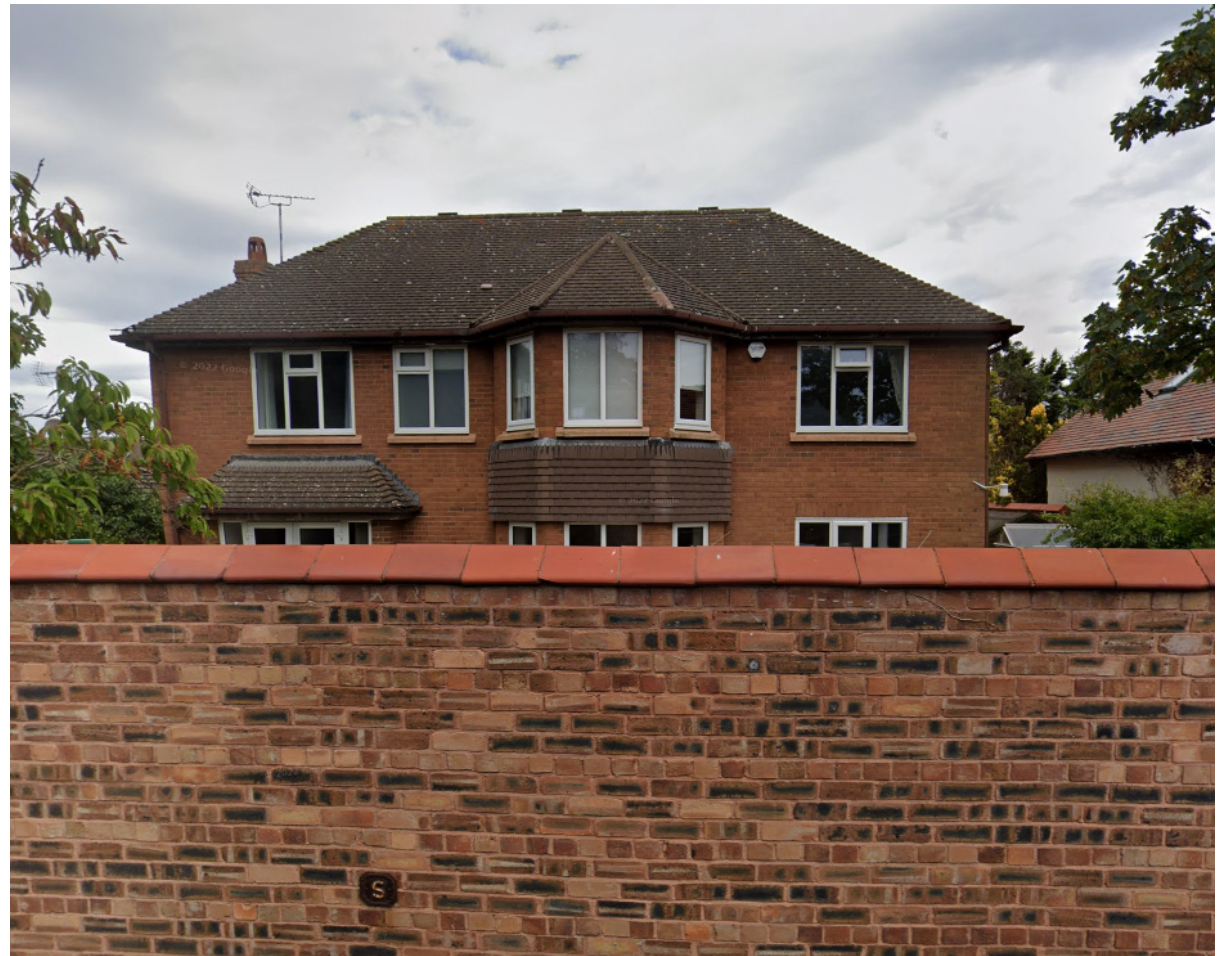
## Building ID: 151

Modern form, with concrete roof tiles and heavy massing. High brick boundary wall and gate.
