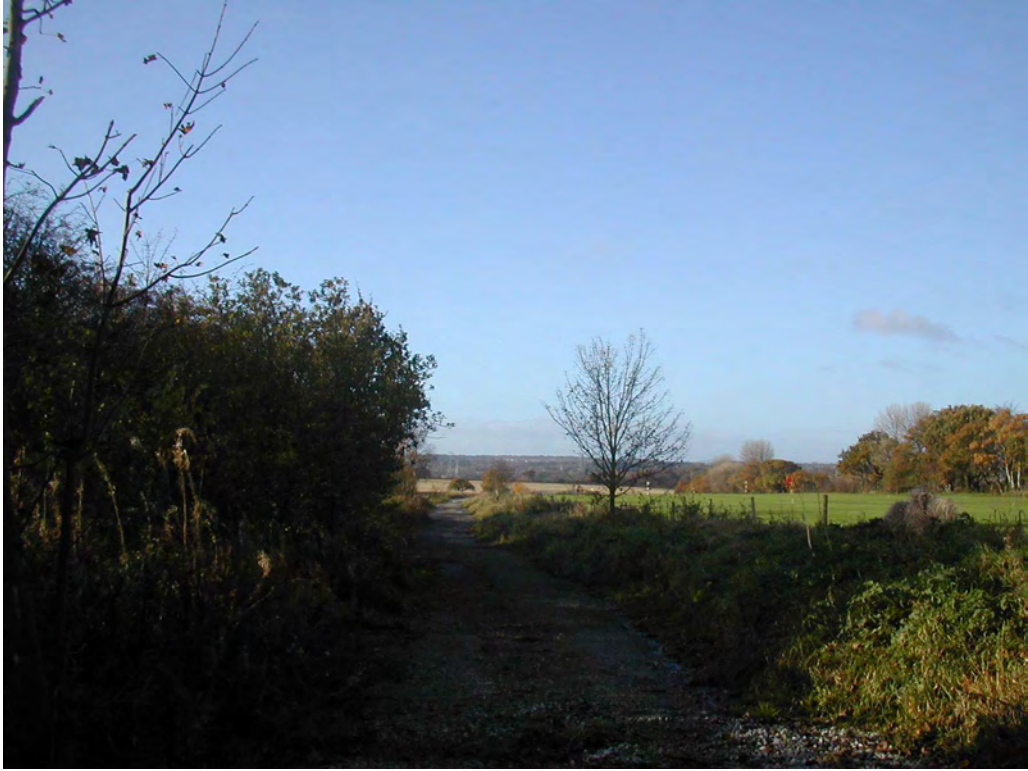
Section: 4.0	Plan Ref No. : S.V.005
Address / Location :	Building Age : N/A
View west beyond the gates at the end of Stanley Avenue	Architect : N/A
Significance Category : N/A	Listed : N/A
Positive / Negative / Neutral : P	Use - current : N/A - original :
Photographs :

Description :	
<p>Stanley Avenue eventually peters out, becoming unsurfaced. The road terminates in a pair of galvanised palisade gates, beyond which are views across the golf course and west Wirral towards to the Welsh hills.</p>	
Features of Particular Interest : N/A	Detrimental alterations / additions :
	Unsympathetic galvanised palisade gates

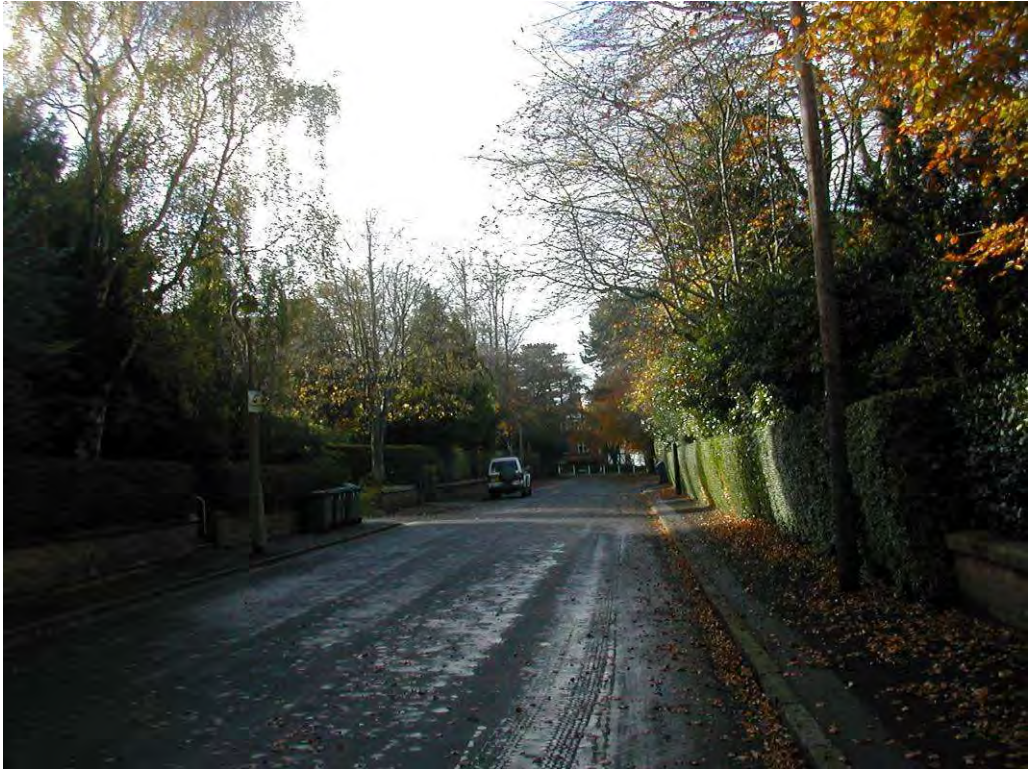
Section : 4.0	Plan Ref No. : T.V.001
Address / Location :	Building Age : N/A
View west up Tower Road from the junction with Prospect Road	Architect : N/A
Significance Category : N/A	Listed : N/A
Positive / Negative / Neutral : P	Use - current : N/A - original :
Photographs :

Description :	
<p>A wide tarmac'd road with tarmac pavements kerbed with stone. The road is steep leading to the summit of the ridge. The hedges and mature trees and planting within the front gardens continue the wooded characteristics of the other roads in the area.</p>	
Features of Particular Interest : N/A	Detrimental alterations / additions : N/A

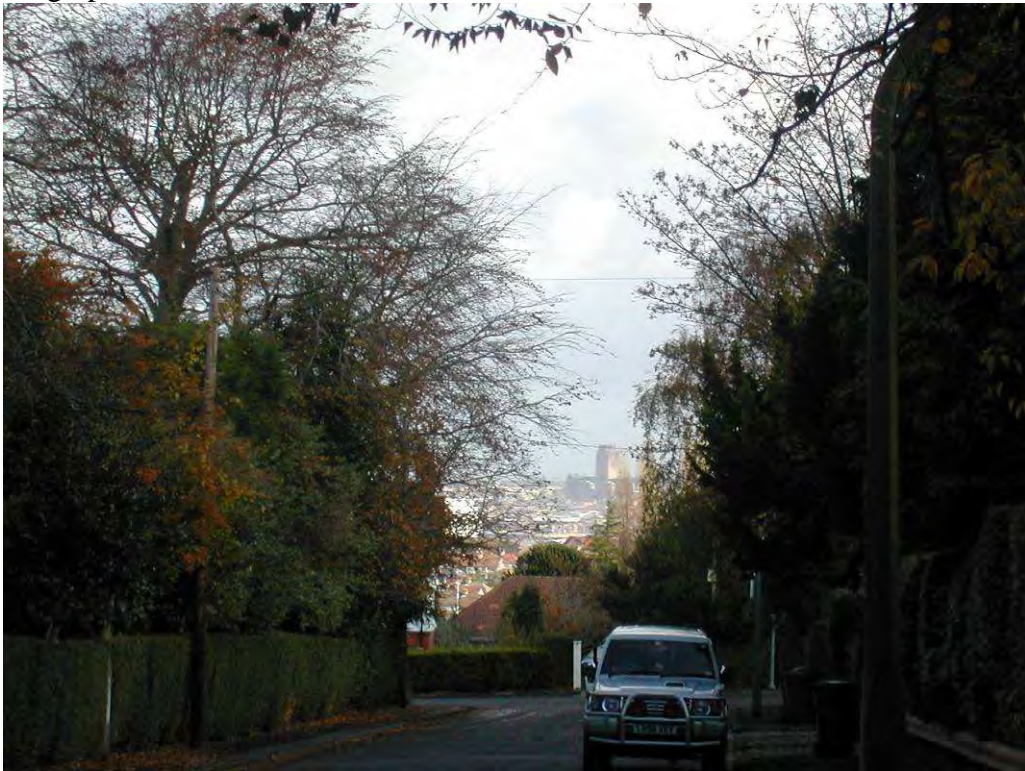
Section : 4.0	Plan Ref No. : T.V.002
Address / Location :	Building Age : N/A
View east down Tower Road from the junction with Reservoir Road	Architect : N/A
Significance Category : N/A	Listed : N/A
Positive / Negative / Neutral : P	Use - current : N/A - original :
Photographs :

Description :	
<p>The elevated position of this road provides a long view across the Wirral to Liverpool. The view of the urban areas in the distance enhances the contrast with the wooded, more rural qualities of the Mount Wood area.</p>	
Features of Particular Interest : N/A	Detrimental alterations / additions : N/A

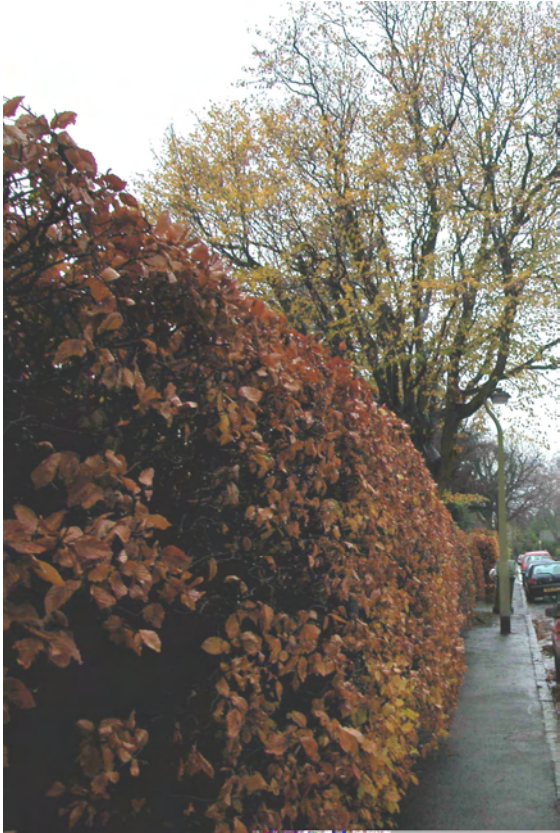
Section: 4.0 / 5.0	Plan Ref No. : A.BS.001	
Address / Location: Adjacent to 1 Acrefield Road	Building Age : N/A	
	Architect : N/A	
Significance Category : N/A	Listed : N/A	
Positive / Negative / Neutral : P	Use - current : N/A - original :	
Photographs:

Description : <u>Example of boundary treatment</u> Full height hedge.	
Features of Particular Interest: N/A	Detrimental alterations / additions : N/A

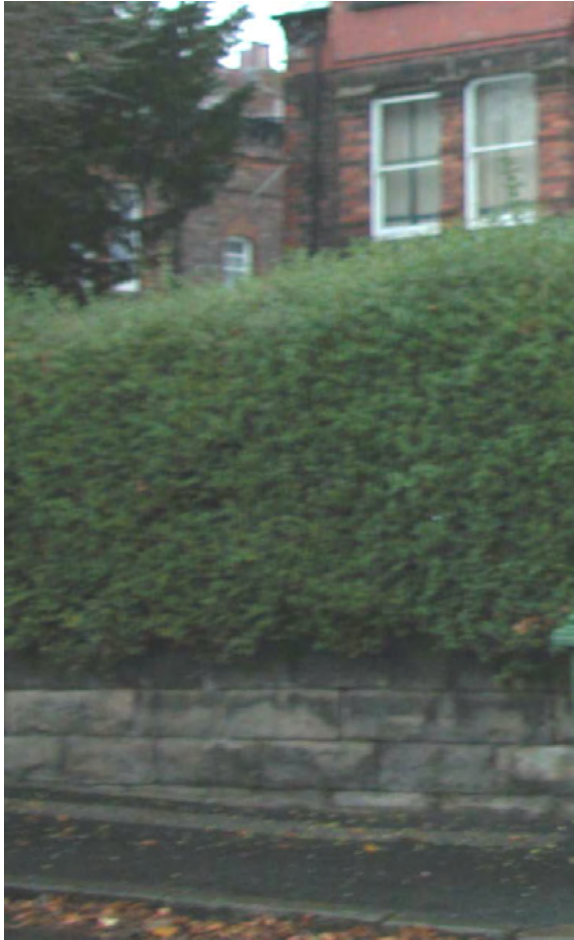
Section : 4.0 / 5.0	Plan Ref No. : A.BS.002
Address / Location :	Building Age : N/A
Adjacent to 6 Acrefield Road	Architect : N/A
Significance Category : N/A	Listed : N/A
Positive / Negative / Neutral : P	Use - current : N/A - original : N/A
Photographs :	Description :

<u>Example of Boundary Treatment</u> Dense hedge over a dwarf sandstone wall.
Features of Particular Interest : N/A	Detrimental alterations / additions : N/A

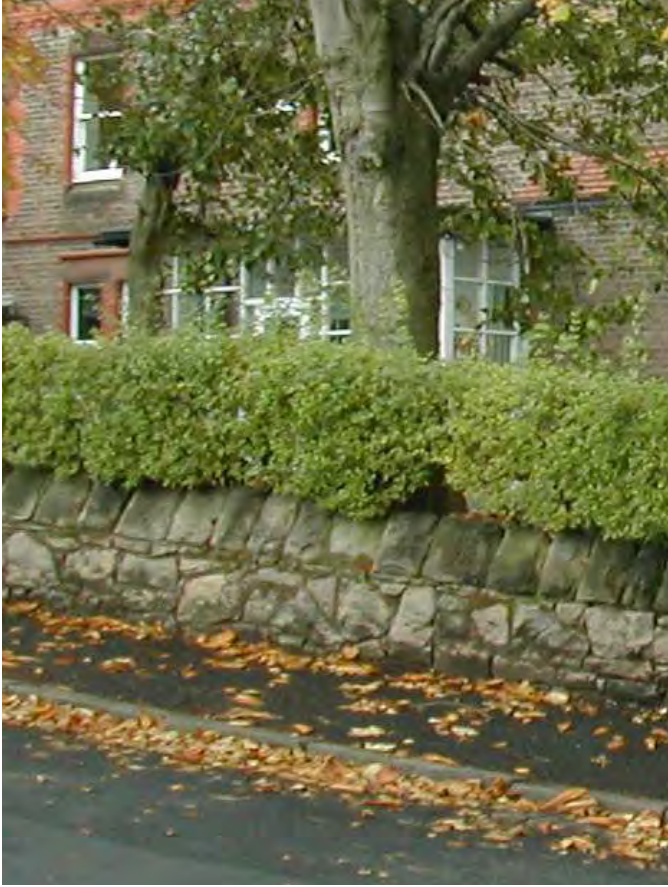
Section : 4.0 / 5.0	Plan Ref No. : B.BS.001	
Address / Location : Burrell Road, at junction with Storeton Road	Building Age : N/A	
	Architect : N/A	
Significance Category : N/A	Listed : N/A	
Positive / Negative / Neutral : P	Use - current : N/A - original :	
Photographs :

Description : <u>Typical Boundary Treatment</u> Sandstone wall with hedge above.	
Features of Particular Interest : N/A	Detrimental alterations / additions : N/A

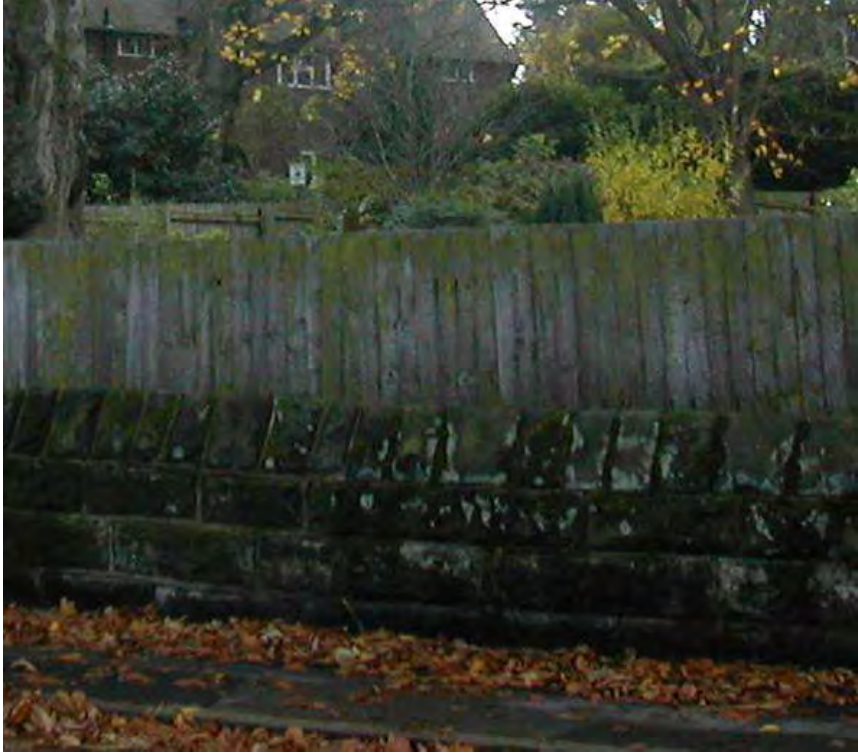
Section : 4.0 / 5.0	Plan Ref No. : B.BS.002
Address / Location :	Building Age : N/A
Burrell Road (boundary of 18 Prospect Road)	Architect : N/A
Significance Category : N/A	Listed : N/A
Positive / Negative / Neutral : P	Use - current : N/A - original :
Photographs :

Description :	
<u>Typical Boundary Treatment</u>	
Sandstone dwarf wall with close-boarded timber fence above.	
Features of Particular Interest : N/A	Detrimental alterations / additions : N/A

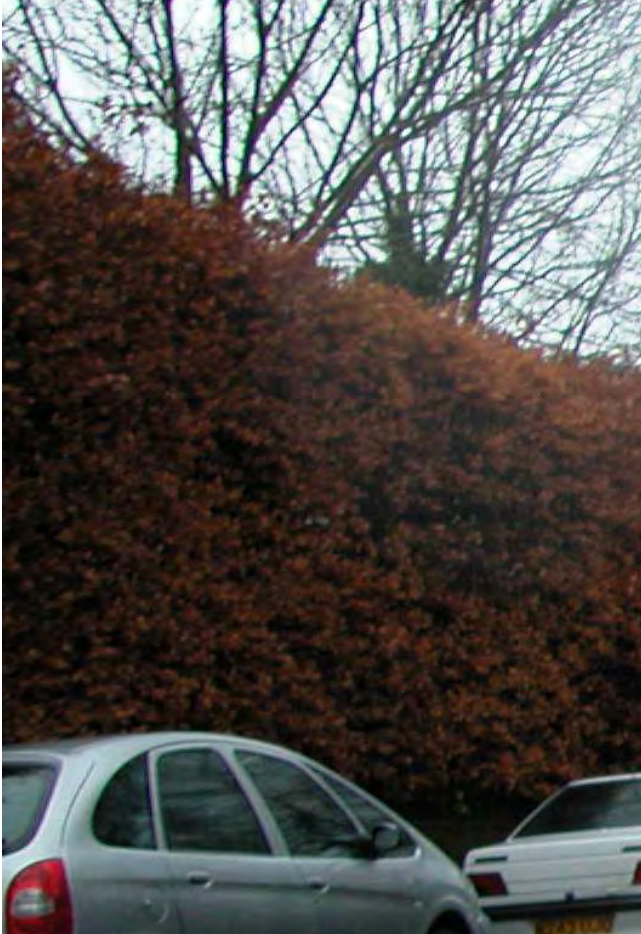
Section : 4.0 / 5.0	Plan Ref No. : G.BS.001	
Address / Location : Golf Links Road, at junction with Prenton Lane	Building Age : N/A	
Significance Category : N/A	Architect : N/A	
Positive / Negative / Neutral : P	Listed : N/A	
Photographs :	Use - current : N/A - original : Description : <u>Example of Boundary Treatment</u> High beech hedge.

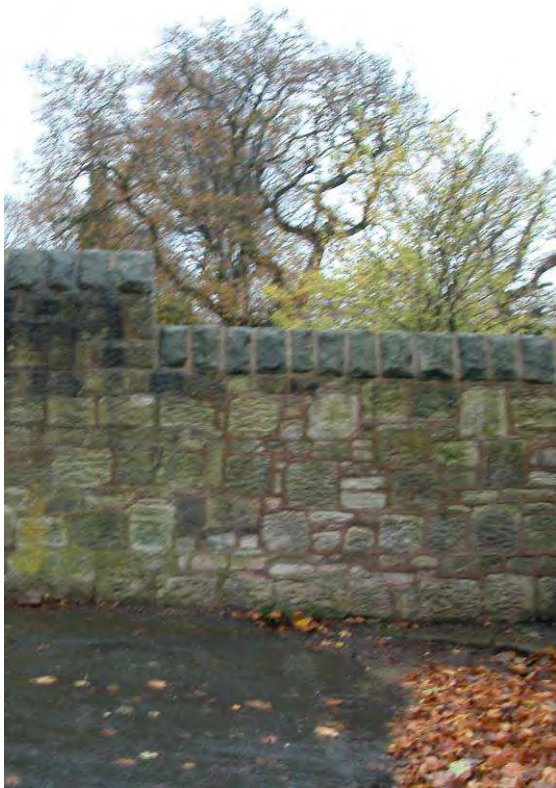
Section : 4.0 / 5.0	Plan Ref No. : G.BS.002
Address / Location :	Building Age : N/A
Adjacent to Rydal House Golf Links Road	Architect : N/A
Significance Category : N/A	Listed : N/A
Positive / Negative / Neutral : P	Use - current : N/A - original :
Photographs :	Description :

<u>Example of boundary treatment</u> High stone wall with simple angled coping.
Features of Particular Interest : N/A	Detrimental alterations / additions : N/A

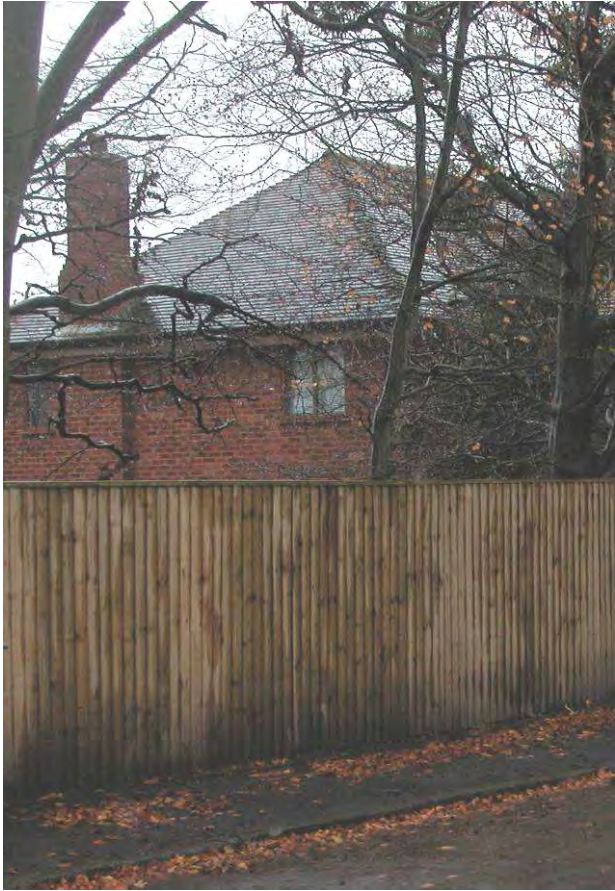
Section : 4.0 / 5.0	Plan Ref No. : G.BS.003	
Address / Location :	Building Age : N/A	
Golf Links Road (property adjacent to Rydal House)	Architect : N/A	
Significance Category : N/A	Listed : N/A	
Positive / Negative / Neutral : P	Use - current : N/A - original :	
Photographs :

Description : <u>Example of boundary treatment</u> Full height close-boarded timber fence.	
Features of Particular Interest : N/A	Detrimental alterations / additions : N/A

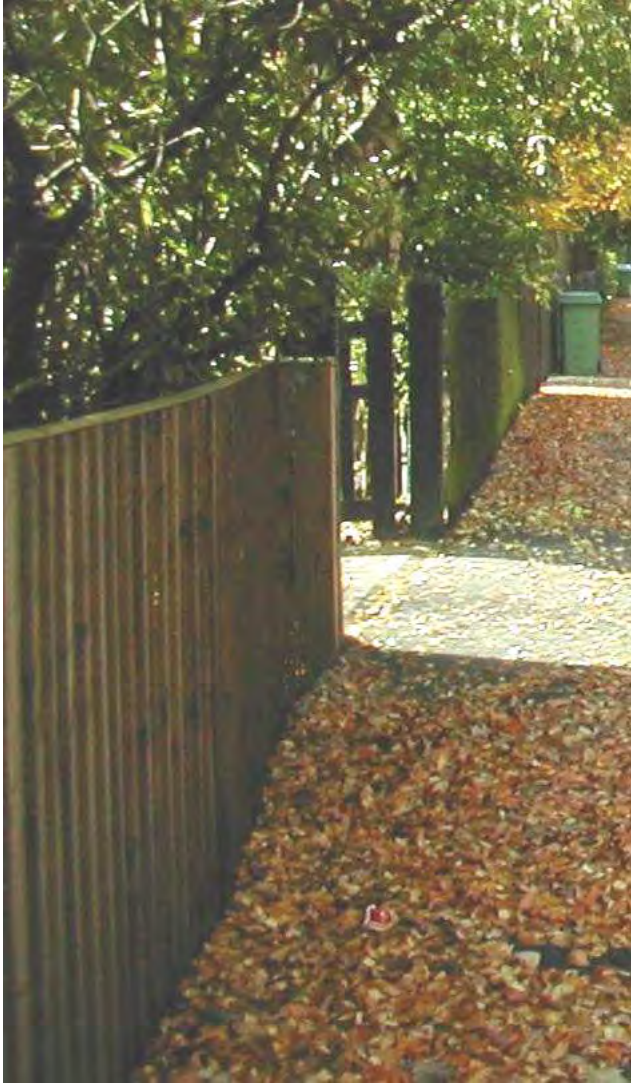
Section : 4.0 / 5.0	Plan Ref No. : MW.BS.001	
Address / Location : 7 Mount Wood Road	Building Age : N/A	
	Architect : N/A	
Significance Category : N/A	Listed : N/A	
Positive / Negative / Neutral : P	Use - current : N/A - original :	
Photographs :

Description : <u>Typical Boundary Treatment</u> Boundaries in Mount Wood Road are almost exclusively timber fences. The close-boarded style predominates, but there are also examples of picket-style fences.	
Features of Particular Interest : N/A	Detrimental alterations / additions : N/A

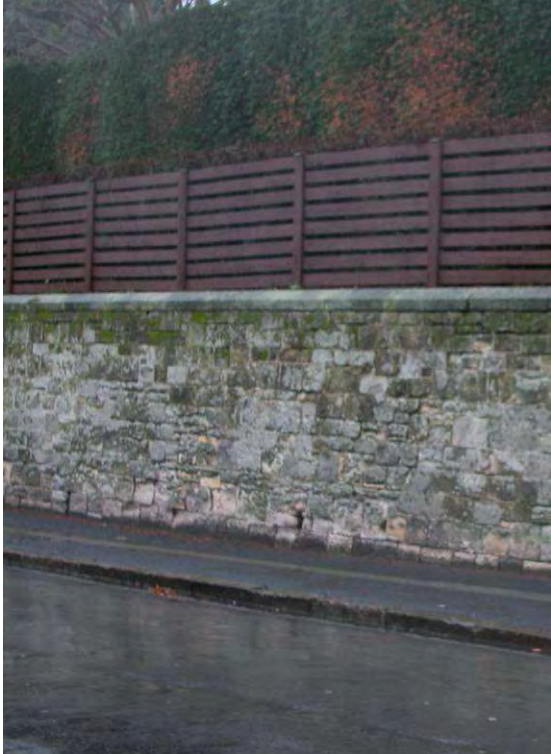
Section : 4.0 / 5.0	Plan Ref No. : PW.BS.001
Address / Location : Adjacent to 1 Pine Walks	Building Age : N/A
	Architect : N/A
Significance Category : N/A	Listed : N/A
Positive / Negative / Neutral : P	Use - current : N/A - original :
Photographs :

Description : <u>Example of Boundary Treatment</u> High stone wall topped with timber fence.
Features of Particular Interest : N/A	Detrimental alterations / additions : The use of horizontal slatted fence panels is not characteristic of the area, but does not detract sufficiently from the dominance of the stone wall below.

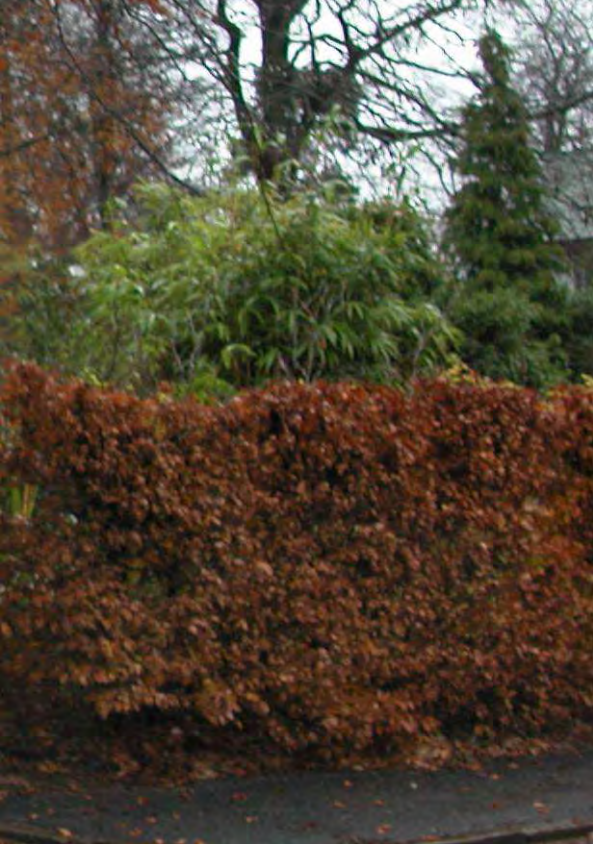
Section : 4.0 / 5.0	Plan Ref No. : PW.BS.002	
Address / Location : 25 Pine Walks	Building Age : N/A	
	Architect : N/A	
Significance Category : N/A	Listed : N/A	
Positive / Negative / Neutral : P	Use - current : N/A - original :	
Photographs :

Description : <u>Example of boundary treatment</u> Full-height hedge.	
Features of Particular Interest : N/A	Detrimental alterations / additions : N/A

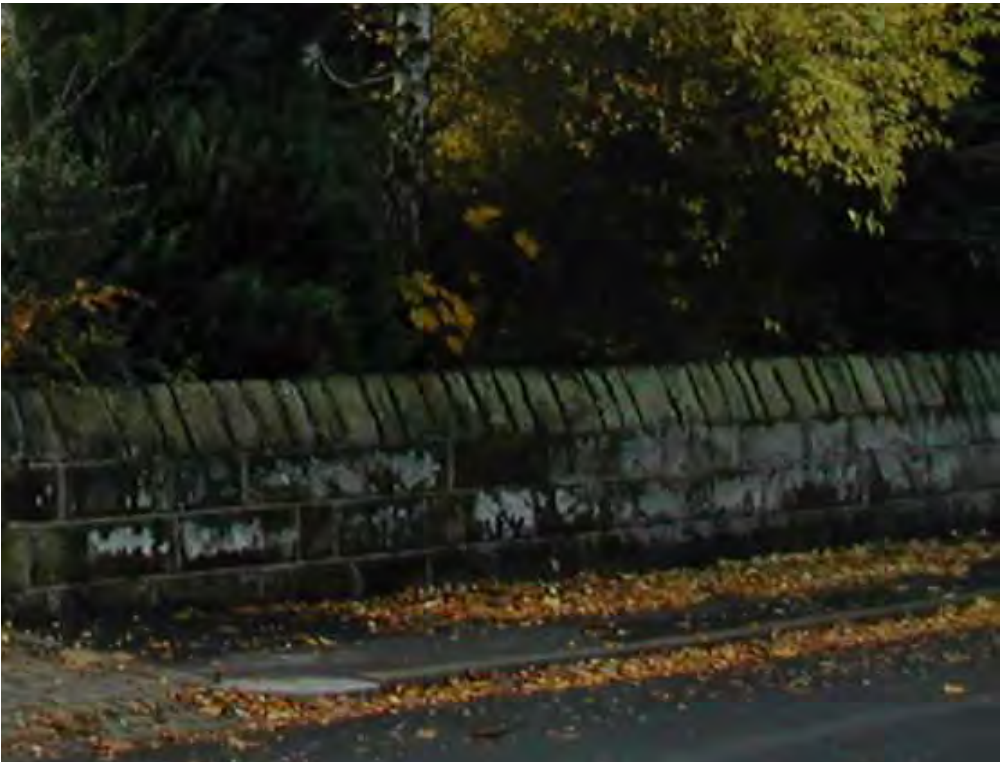
Section : 4.0 / 5.0	Plan Ref No. : P.BS.001
Address / Location : 16 Prospect Road	Building Age : N/A Architect : N/A
Significance Category : N/A	Listed : N/A
Positive / Negative / Neutral : P	Use - current : N/A - original :
Photographs :

Description :	
<u>Typical Boundary Treatment</u>	
Large block sandstone wall with angled block coping.	
Features of Particular Interest : N/A	Detrimental alterations / additions : N/A

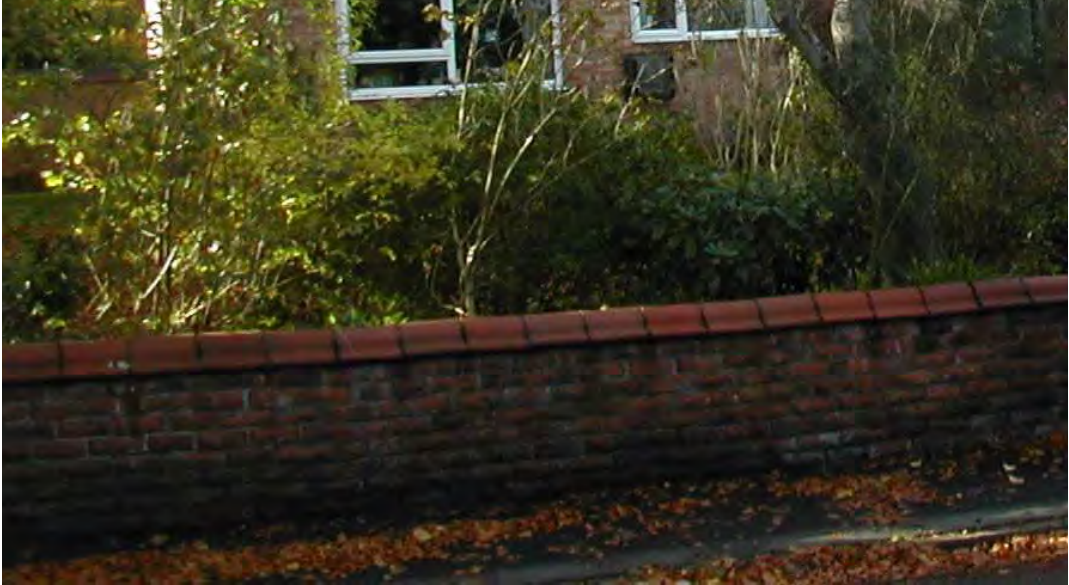
Section : 4.0 / 5.0	Plan Ref No. : P.BS.002
Address / Location :	Building Age : N/A
Prospect Road (at the junction with Tower Road)	Architect : N/A
Significance Category : N/A	Listed : N/A
Positive / Negative / Neutral : P	Use - current : N/A - original :
Photographs :

Description :	
Brick with terracotta coping. This example is retained although the related historic property has been demolished and replaced.	
Features of Particular Interest : N/A	Detrimental alterations / additions : N/A

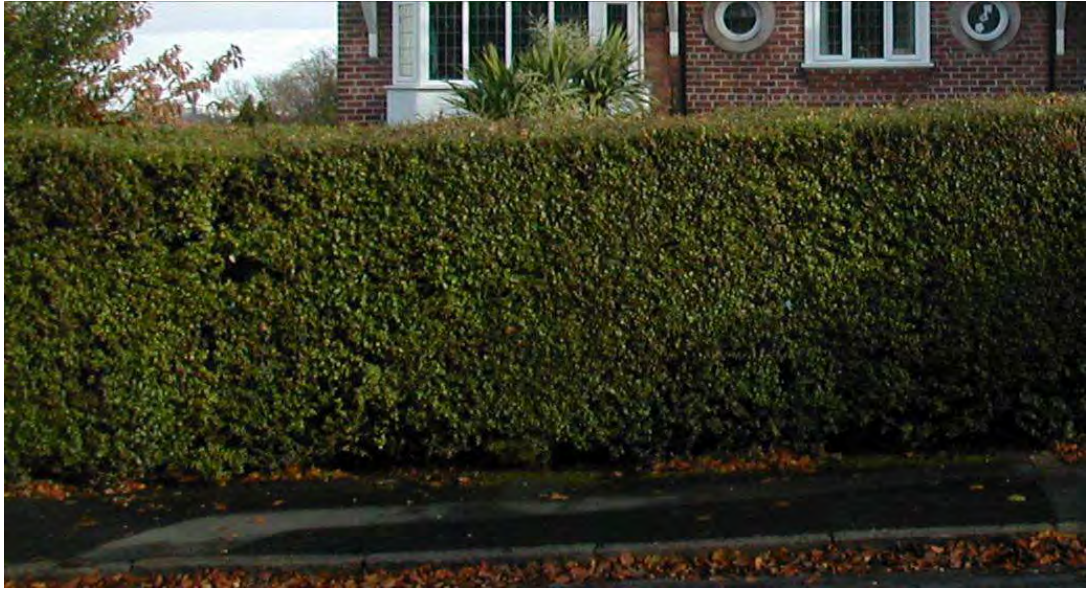
Section : 4.0 / 5.0	Plan Ref No. : P.BS.003
Address / Location :	Building Age : N/A
Prospect Road (east side)	Architect : N/A
Significance Category : N/A	Listed : N/A
Positive / Negative / Neutral : P	Use - current : N/A - original :
Photographs :

Description :	
Full height hedge.	
Features of Particular Interest : N/A	Detrimental alterations / additions : N/A

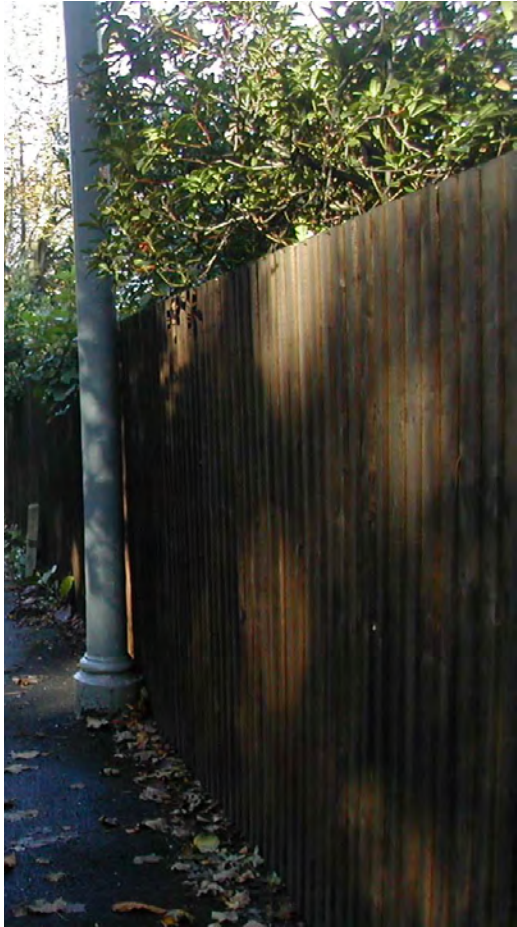
Section : 4.0 / 5.0	Plan Ref No. : R.BS.001
Address / Location :	Building Age : N/A
Picardy, Reservoir Road	Architect : N/A
Significance Category : N/A	Listed : N/A
Positive / Negative / Neutral : P	Use - current : N/A - original :
Photographs :	Description :

<u>Typical Boundary Treatment</u> Close-boarded timber fence with planting behind / above.
Features of Particular Interest : N/A	Detrimental alterations / additions : N/A

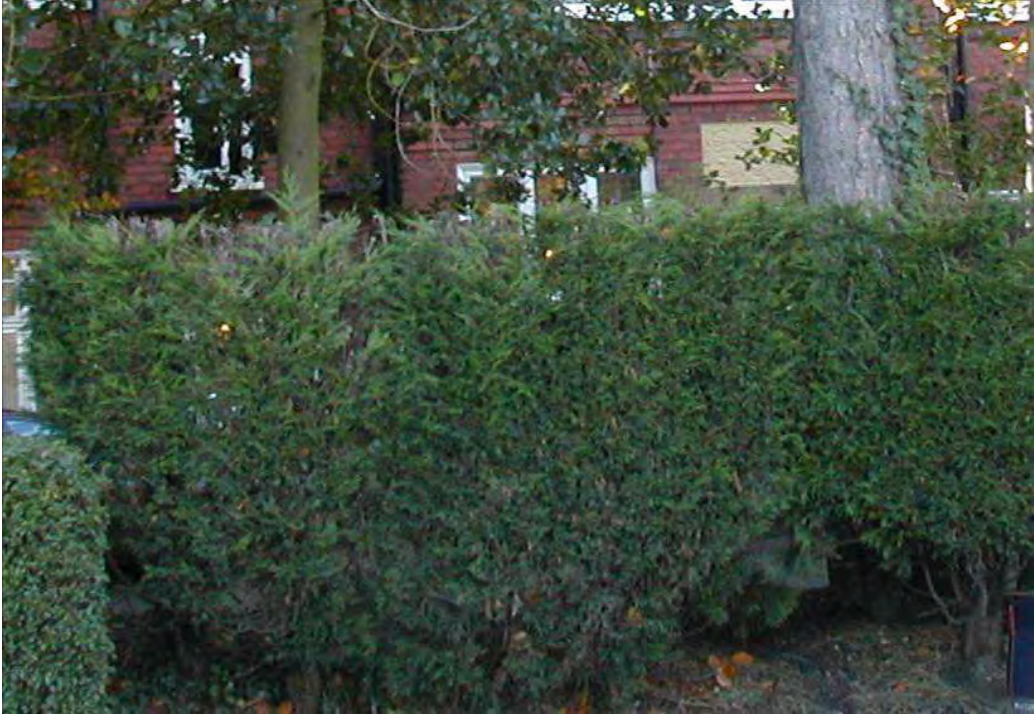
Section : 4.0 / 5.0	Plan Ref No. : R.BS.002
Address / Location :	Building Age : N/A
8 Reservoir Road	Architect : N/A
Significance Category : N/A	Listed : N/A
Positive / Negative / Neutral : P	Use - current : N/A - original :
Photographs :

Description :	
<u>Typical Boundary Treatment</u>	
Full height densely planted hedge. (Hedge species varies).	
Features of Particular Interest : N/A	Detrimental alterations / additions : N/A

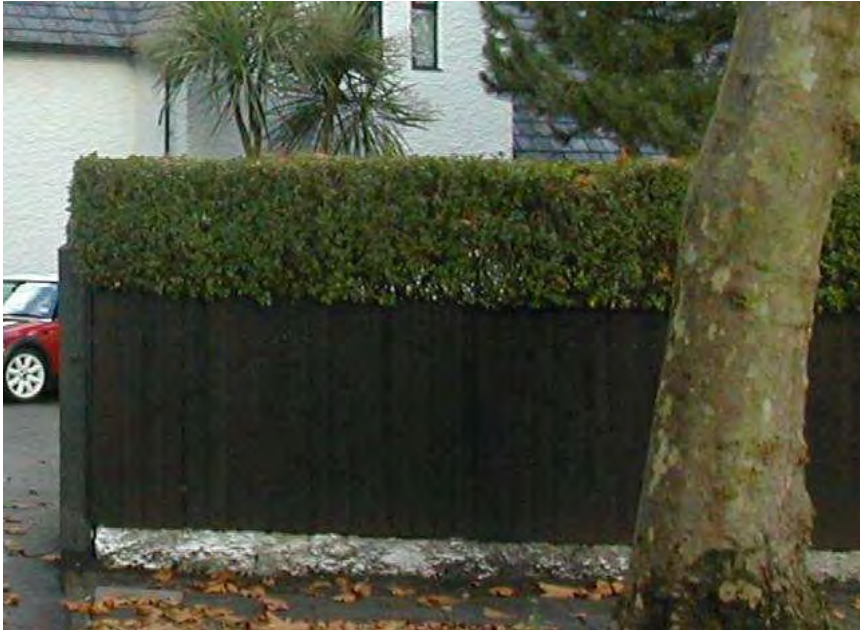
Section: 4.0 / 5.0	Plan Ref No. : S.BS.001
Address / Location :	Building Age : N/A
Pine Lodge Stanley Avenue	Architect : N/A
Significance Category : N/A	Listed : N/A
Positive / Negative / Neutral : P	Use - current : N/A - original :
Photograph :

Description : <u>Typical Boundary Treatment</u> This type of boundary treatment consists of a small plinth wall with a close-boarded timber fence above, behind which a hedge has been cultivated.	
Features of Particular Interest : N/A	Detrimental alterations / additions : N/A

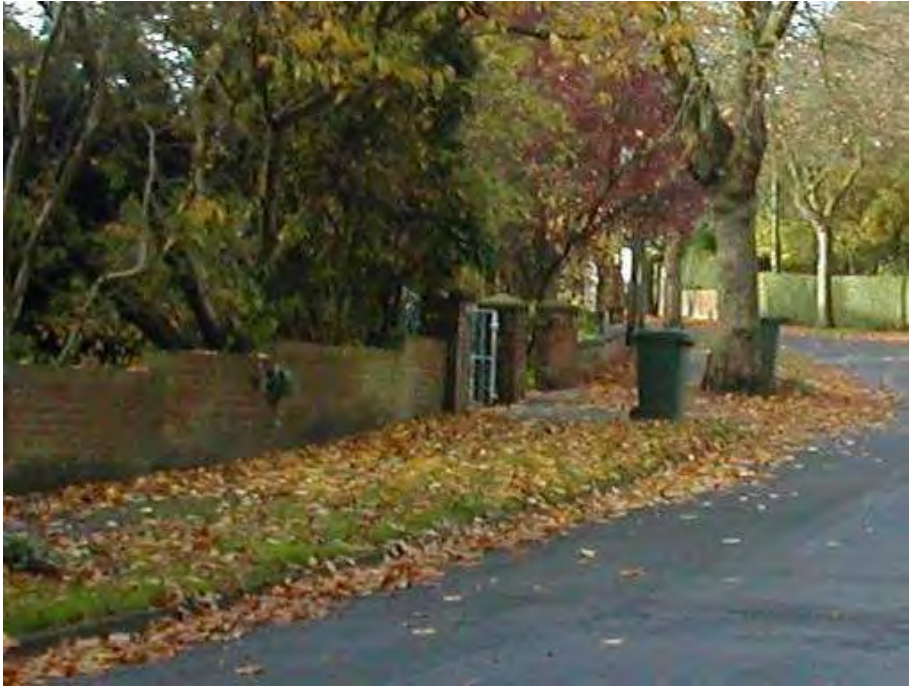
Section: 4.0 / 5.0	Plan Ref No. : S.BS.002
Address / Location : 1 Stanley Avenue	Building Age : N/A
	Architect : N/A
Significance Category : N/A	Listed : N/A
Positive / Negative / Neutral : P	Use - current : N/A - original :
Photographs :

Description :	
<u>Typical Boundary Treatment</u>	
Dwarf or plinth walls are a common boundary treatment, usually with brick on edge coping. The brick colour generally matches that of the associated house.	
In this example, the wall is stepped to follow the incline of the road.	
Features of Particular Interest : N/A	Detrimental alterations / additions : N/A

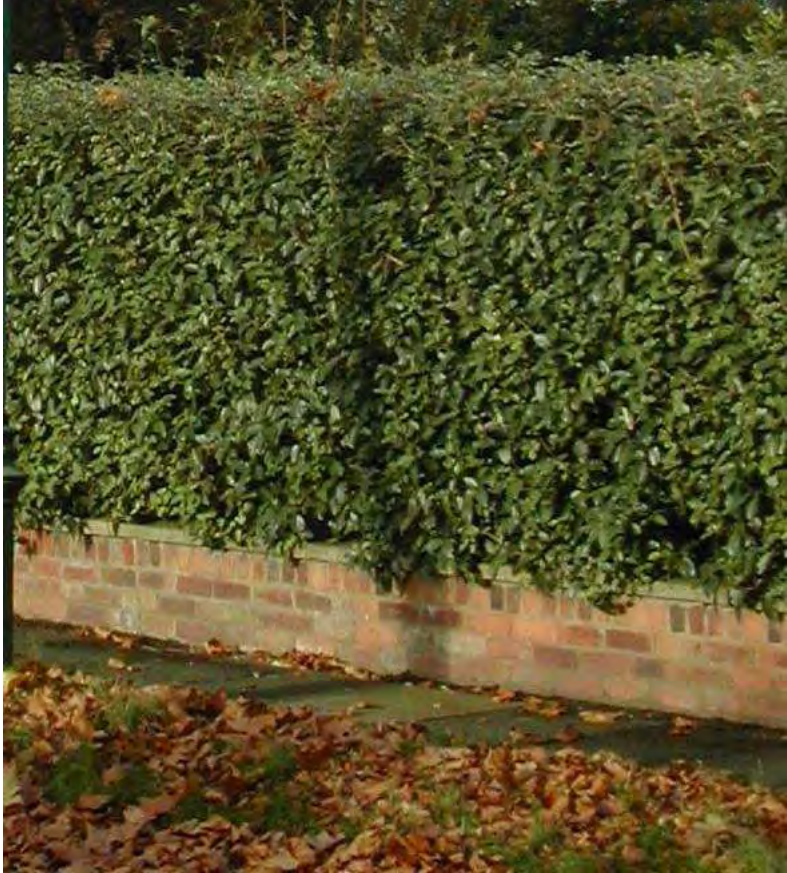
Section: 4.0 / 5.0	Plan Ref No. : S.BS.003
Address / Location : 18 Stanley Avenue	Building Age : N/A
	Architect : N/A
Significance Category : N/A	Listed : N/A
Positive / Negative / Neutral : P	Use - current : N/A - original :
Photographs :

Description :	
<u>Typical Boundary Treatment</u> Where plinth walls are not topped with a fence, a hedge has been cultivated behind. (Hedge species varies).	
Features of Particular Interest : N/A	Detrimental alterations / additions : N/A

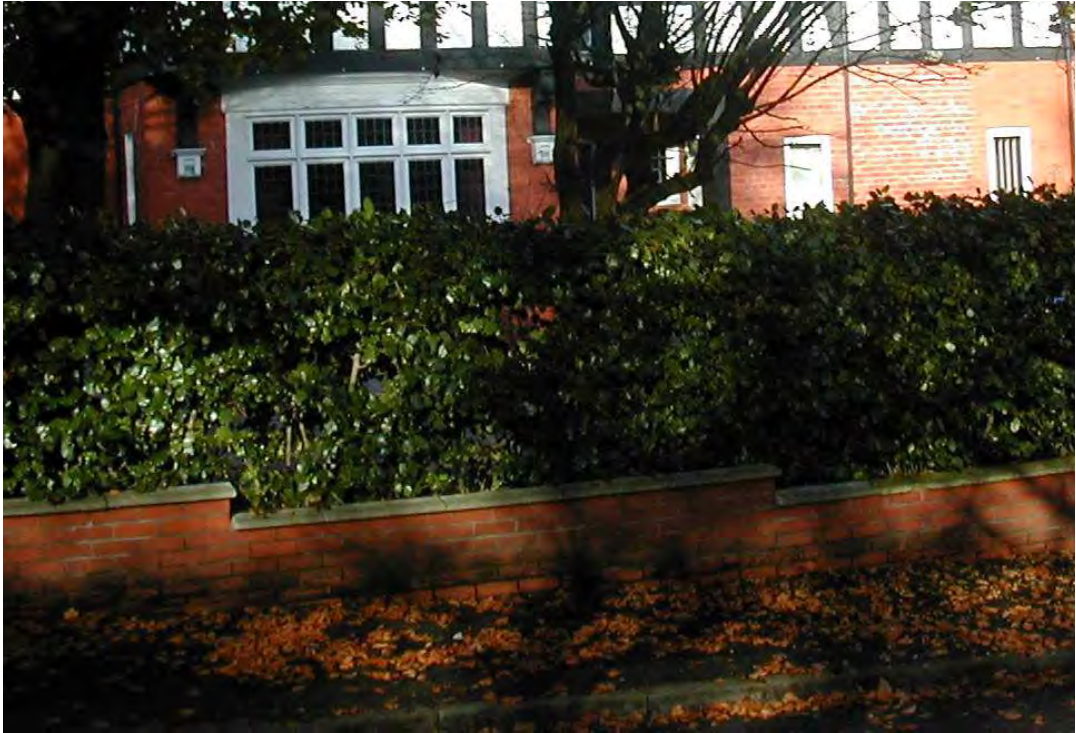
Section : 4.0 / 5.0	Plan Ref No. : T.BS.001
Address / Location :	Building Age : N/A
Alington 2 Tower Road	Architect : N/A
Significance Category : N/A	Listed : N/A
Positive / Negative / Neutral : P	Use - current : N/A - original :
Photographs :

Description :	
<u>Typical Boundary Treatment</u>	
Brick plinth wall with hedge above.	
Features of Particular Interest : N/A	Detrimental alterations / additions : N/A

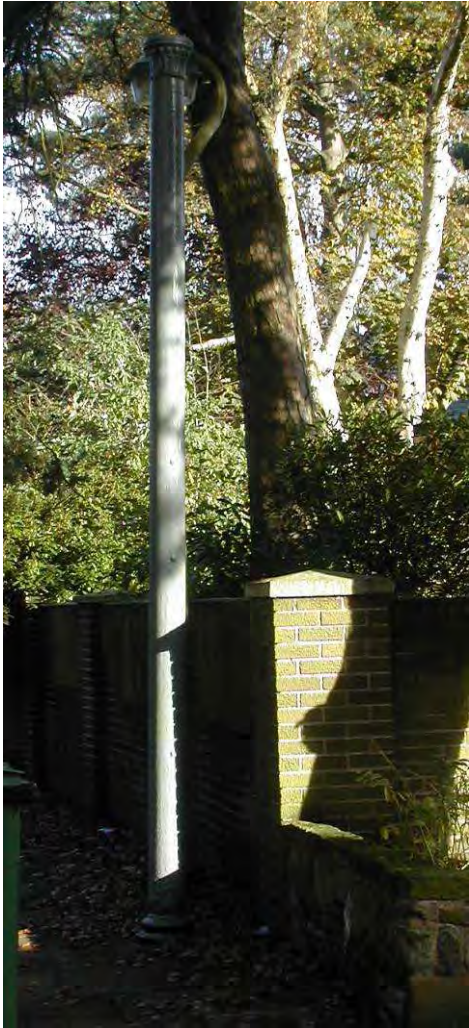
Section : 6.0	Plan Ref No. : B.F.001
Address / Location :	Building Age : N/A
Adjacent to no.7 Burrell Road	Architect : N/A
Significance Category : Local	Listed : N/A
Positive / Negative / Neutral : P	Use - current : N/A - original :
Photographs :	Description :

<p>Cast-iron lamp standard.</p> <p>This feature occurs elsewhere in the area and is painted various colours.</p> <p>Lamp-holders have been removed from all standards in the area.</p>
Features of Particular Interest : N/A	Detrimental alterations / additions : N/A

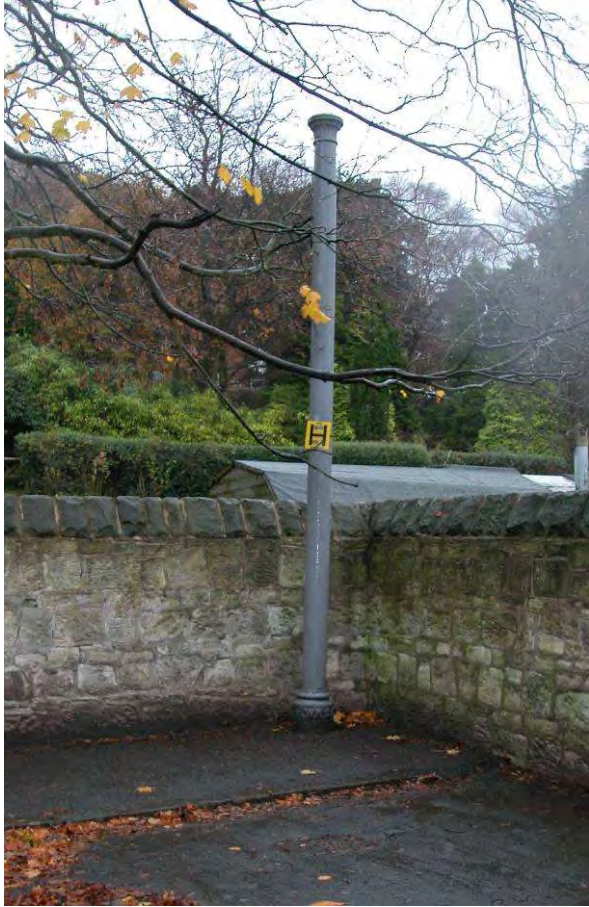
Section : 6.0	Plan Ref No. : G.F.001
Address / Location : End of Golf Links Road	Building Age : N/A Architect : N/A
Significance Category : Local	Listed : N/A
Positive / Negative / Neutral : P	Use - current : N/A - original :
Photographs :

Description : Cast-iron lamp standard. This feature occurs elsewhere in the area and is painted various colours. Lamp-holders have been removed from all standards in the area.
Features of Particular Interest : N/A	Detrimental alterations / additions: N/A

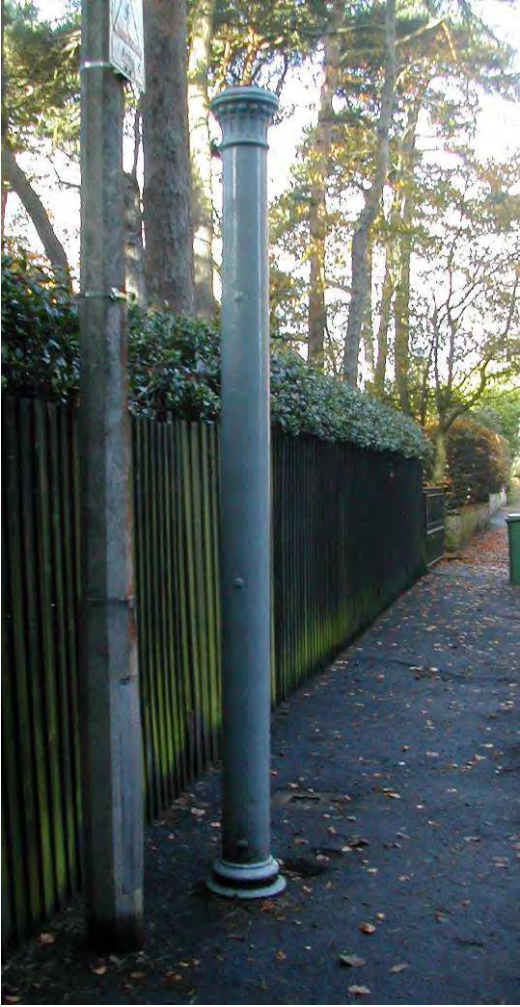
Section : 6.0	Plan Ref No. : PW.F.001
Address / Location : Adjacent to Pine Ridge Pine Walks	Building Age : N/A
Significance Category : Local	Architect : N/A
Positive / Negative / Neutral : P	Listed : N/A
Photographs :

Use - current : N/A - original : Description : Cast-iron lamp standard. This feature occurs elsewhere in the area and is painted various colours. Lamp-holders have been removed from all standards in the area.
Features of Particular Interest : N/A	Detrimental alterations / additions : N/A

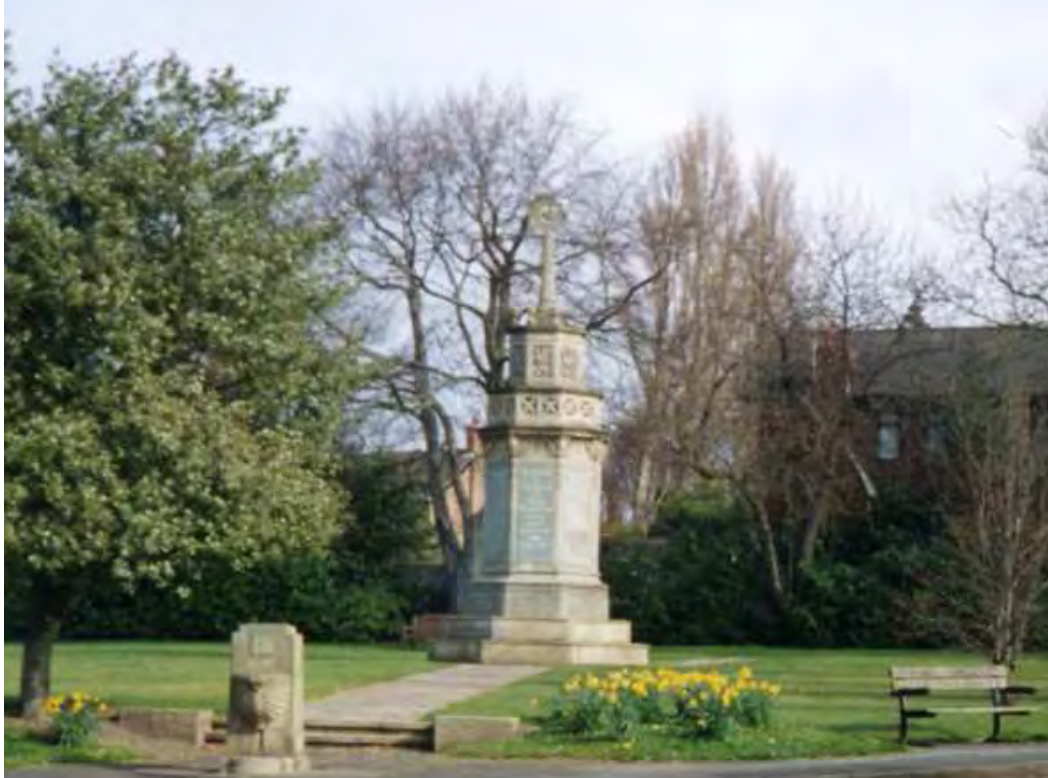
Section : 6.0	Plan Ref No. : PL.F.001
Address / Location :	Building Age : c1919
War Memorial Prenton Lane	Architect : Briggs & Thornley
Significance Category : Local / Regional	Listed : No
Positive / Negative / Neutral : P	Use - current : Memorial - original : Memorial
Photographs :

Description :	
Hubbards notes: "A really terrible design, by Briggs & Thornley from 1919" !!	
Pevsner and Hubbard : "An unfortunate design" !!! The memorial was reconstructed after WWII bomb damage.	
Features of Particular Interest :	Detrimental alterations / additions :

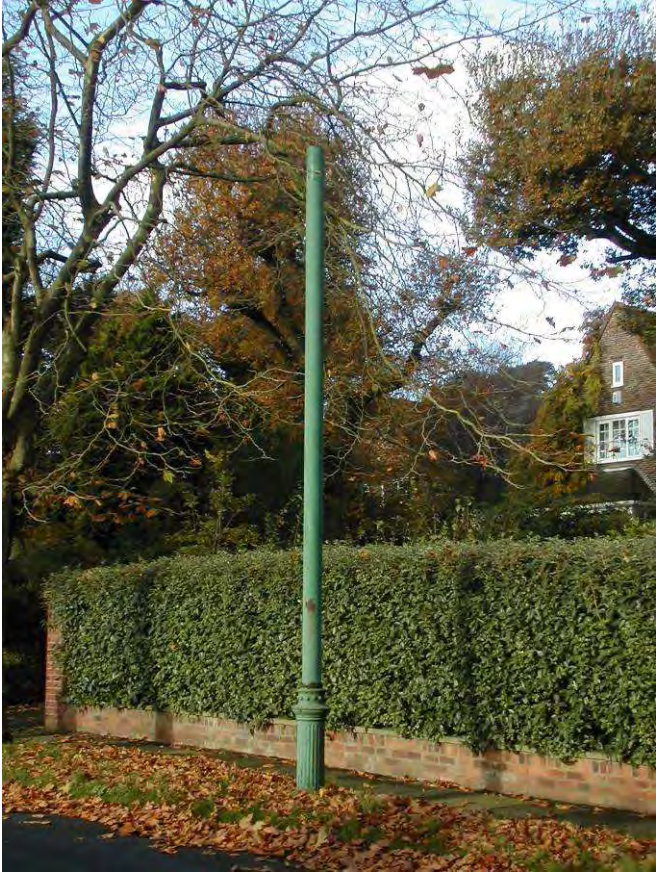
Section: 6.0	Plan Ref No. : S.F.001	
Address / Location : Adjacent to 18 Stanley Avenue	Building Age : N/A	
	Architect : N/A	
Significance Category : Local	Listed : N/A	
Positive / Negative / Neutral : P	Use - current : N/A - original :	
Photographs :

Description : Cast-iron lamp standard. This feature occurs elsewhere in the area and is painted various colours. Lamp-holders have been removed from all standards in the area. This example would suggest that they date from between 1910 and 1935 as Stanley Avenue was not laid out until after 1910.	
Features of Particular Interest : N/A	Detrimental alterations / additions : N/A
