## WELLINGTON ROAD CONSERVATION AREA APPRAISAL AND MANAGEMENT PLAN

### APPENDICES

Prepared for Wirral Council by Donald Insall Associates Ltd, 2007 – Wirral 2009

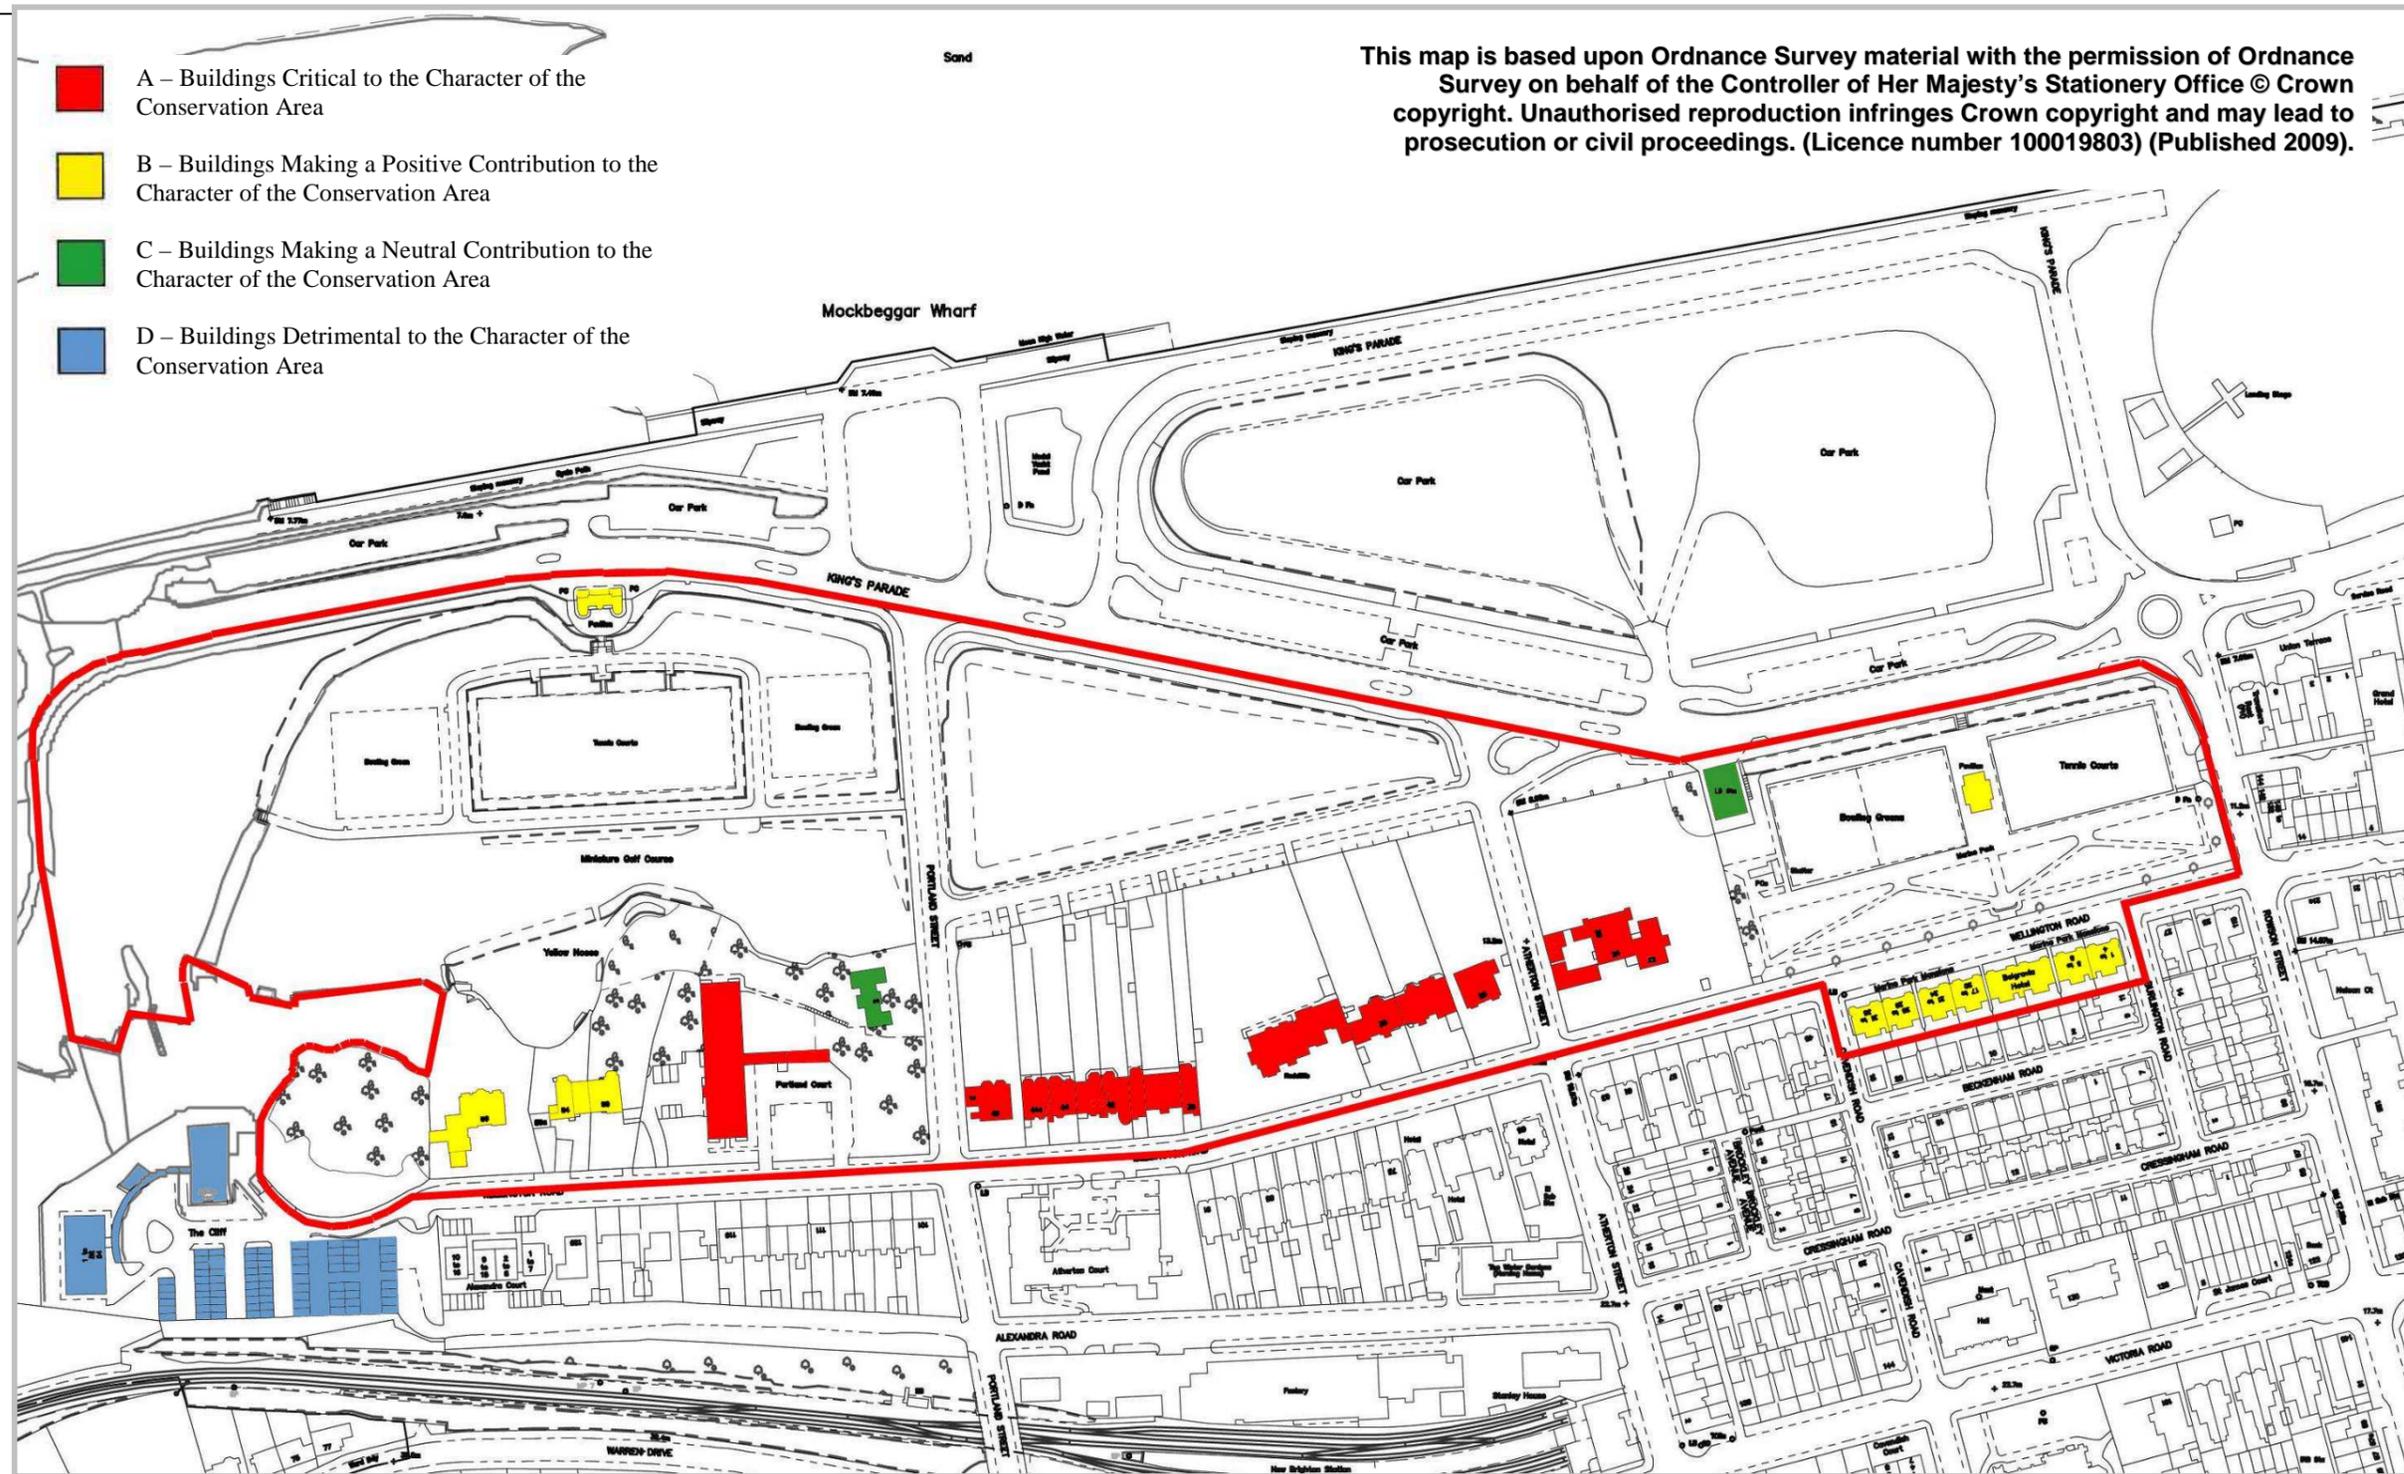
APPENDIX D – PLAN SHOWING BUILDING CONTRIBUTIONS

- A: (Red) – Buildings that are critical to the character of the area: typically these may be landmark buildings and / or buildings with most of their original character retained
- B: (Yellow) – Buildings that contribute positively to the character of the conservation area: buildings may have some alterations but original character is still prominent
- C: (Green) – Neutral - Either modern buildings of little interest or buildings where character has been lost beyond economic redemption.
- D: (Blue) – Buildings that detract from the significance or character of the area.
